Wedgetail Engine Corrosion

CFM56-7B27A

Boeing Defence Australia - Wedgetail ESI

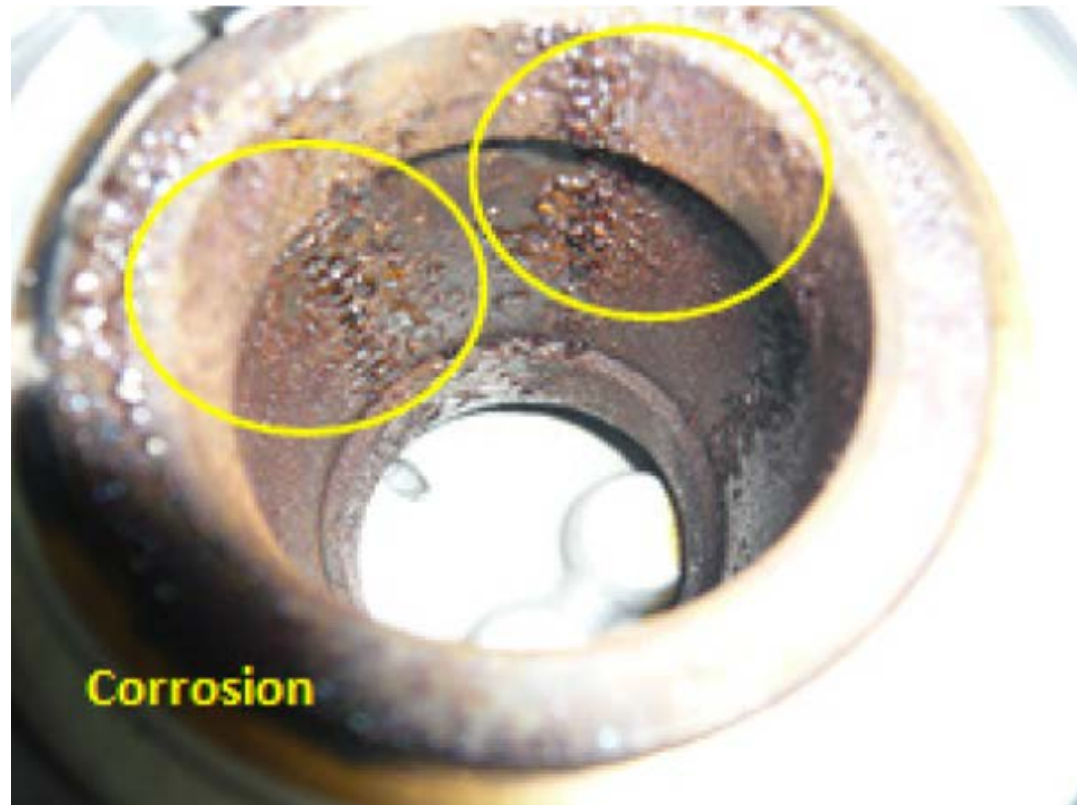
- During a shop visit for an unrelated issue, internal corrosion was discovered in a MFP in June 2015.
- The internal corrosion exhibited a “tide line” in the High Pressure section of the pump.
- The tide line indicated the presence of water in the MFP for an extended period of time of inactivity.
- Long term exposure to corrosion products have the ability to wear away the dry film lubricant present on the bearings and could result in bearing failure and subsequent loss of thrust control.

- Prior to the shop findings there no indications of a performance loss with the MFP.
- The MFP was installed on the same engine since manufacture.
- The MFP fitted to sister engine was removed to allow investigation.

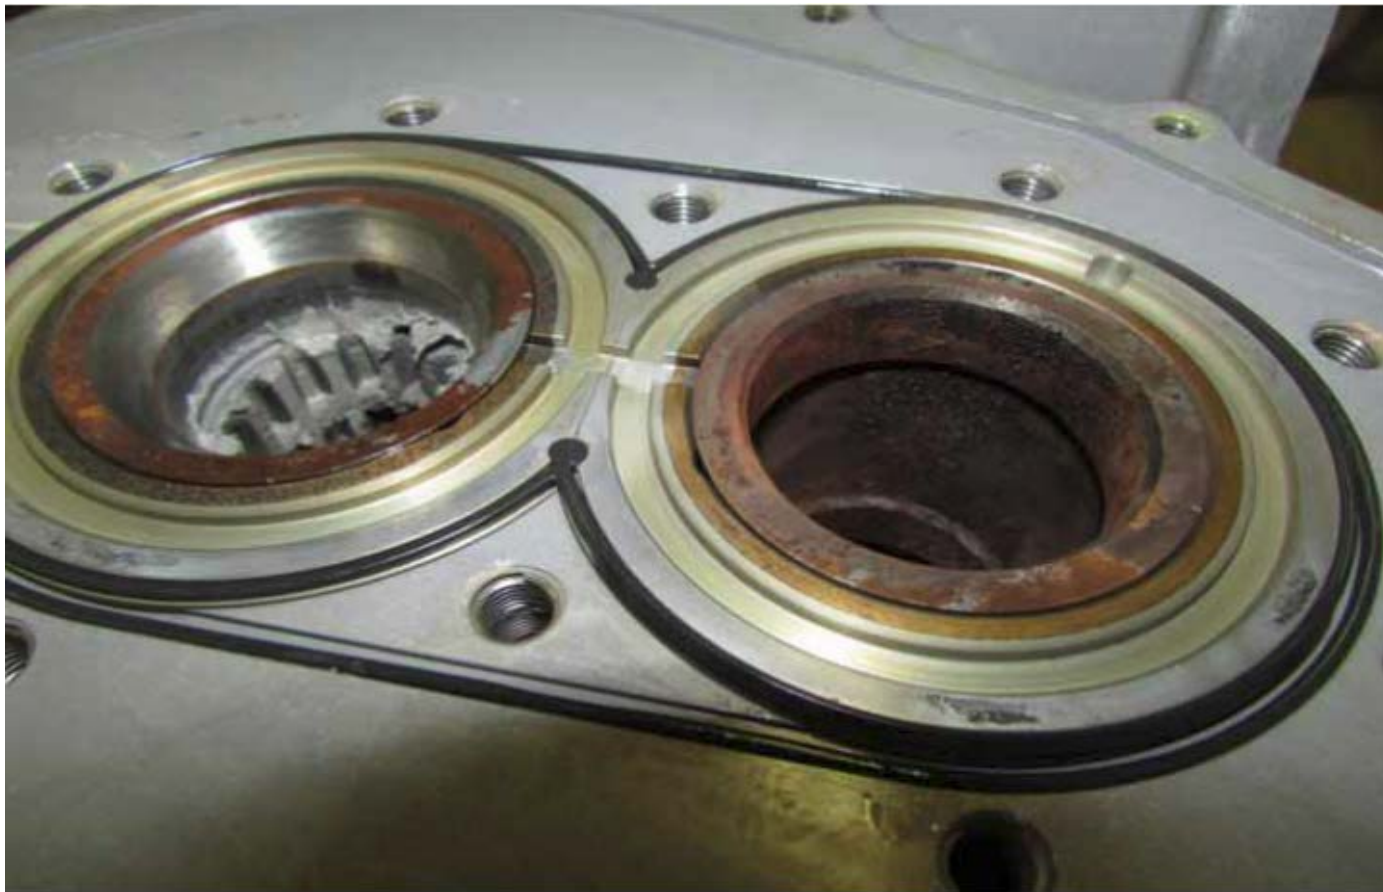
- Sister engine MFP findings were similar to first pump.

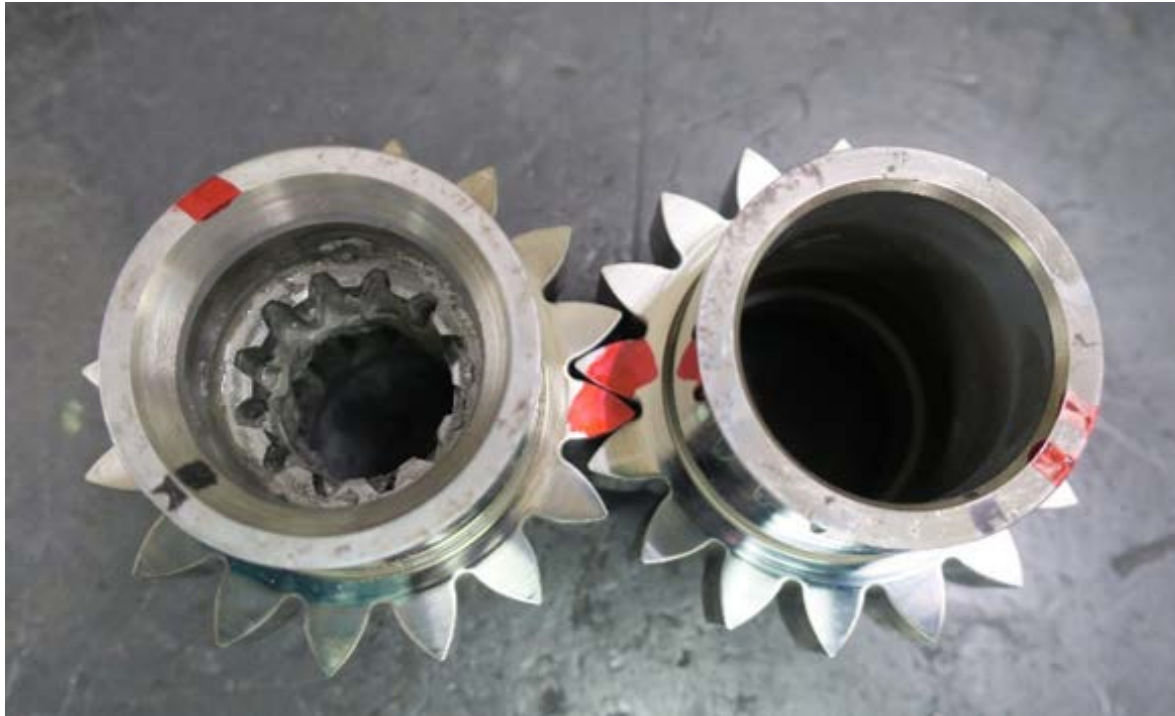
- Fleet wide inspection conducted to confirm fleet condition. Total of four additional suspect MFPs identified.
- The four suspect MFPs were removed and inspected. No internal corrosion or abnormal defects were found.

- As a result of the MFP corrosion, a number of changes have been incorporated to remove contributing factors and prevent recurrence:
 - Increase the minimum engine run time to 15 minutes. This provides sufficient time to clear any water from the fuel tanks that may not be identified by sumping.
 - Failure reporting requirement introduced on fuel tank sumping servicing. No water identified in fuel samples since.
 - Boeing SB to be incorporated that improves effectiveness of the fuel scavenge system.
- The importance of the regular fuel tank sumping has also been highlighted as a result of this investigation.

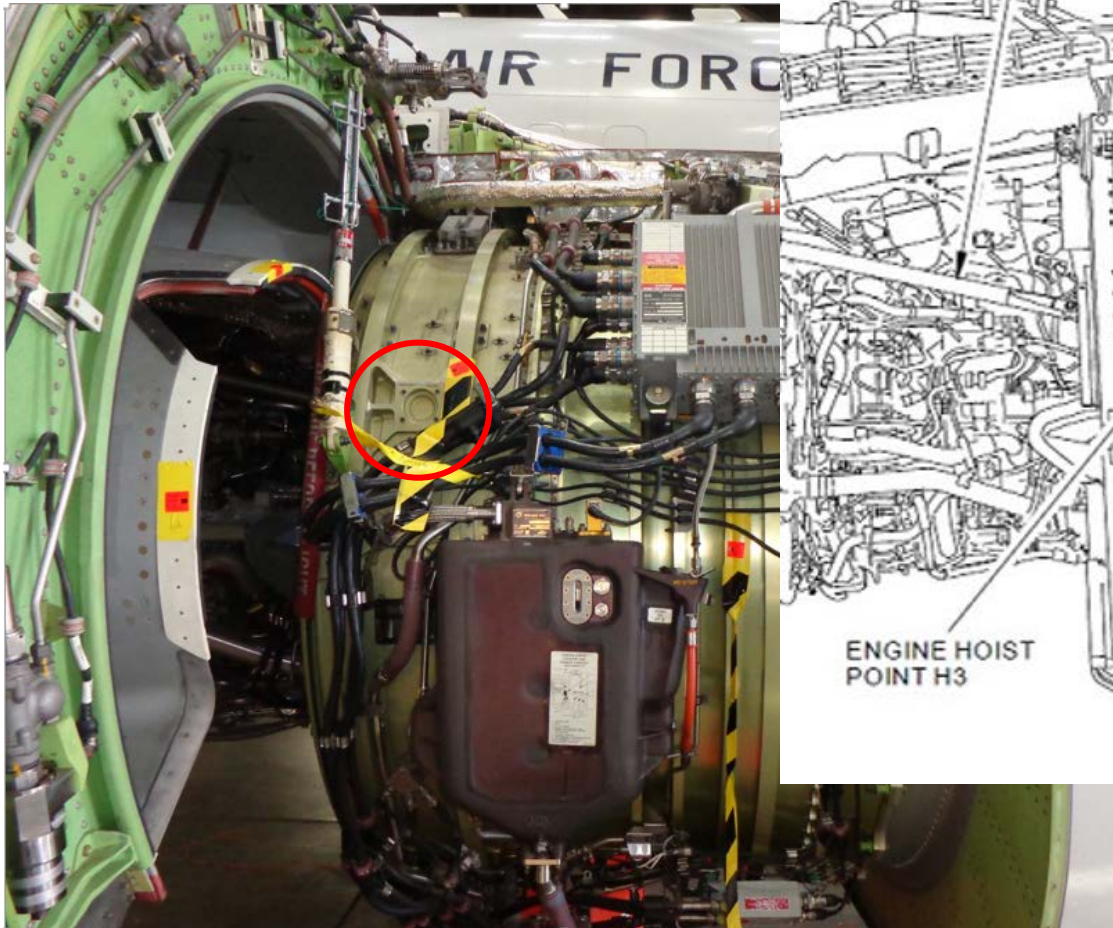
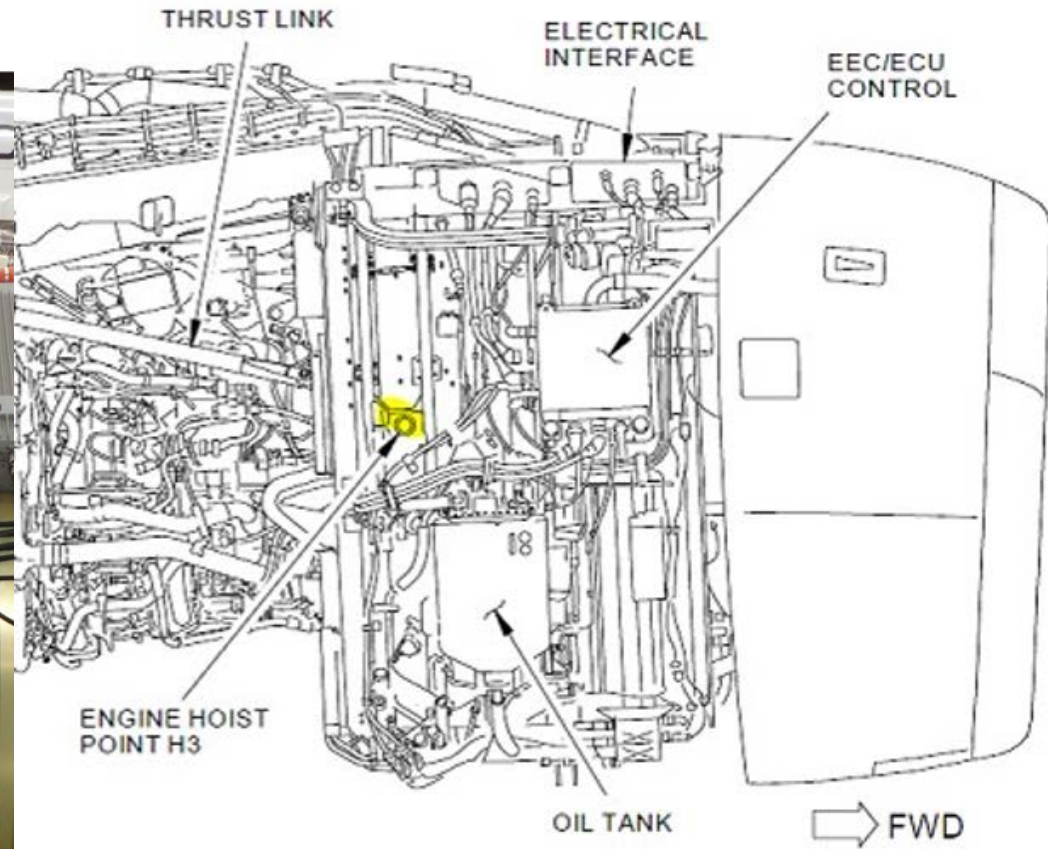
- The Fan Frame Handling Boss is an attachment point for GSE to allow engine removal/installation.
- The Fan Frame is manufactured from an aluminium alloy with an anodised coating.
- Corrosion was first identified during deeper maintenance. Minor corrosion removed (up to 0.014”) which did result in the wider removal of the original anodising coating.
- Standard OEM repair for the surface protection was to apply Alodine in lieu of restoring the anodising.
- OEM reported no previous experience of corrosion in this location in world fleet.

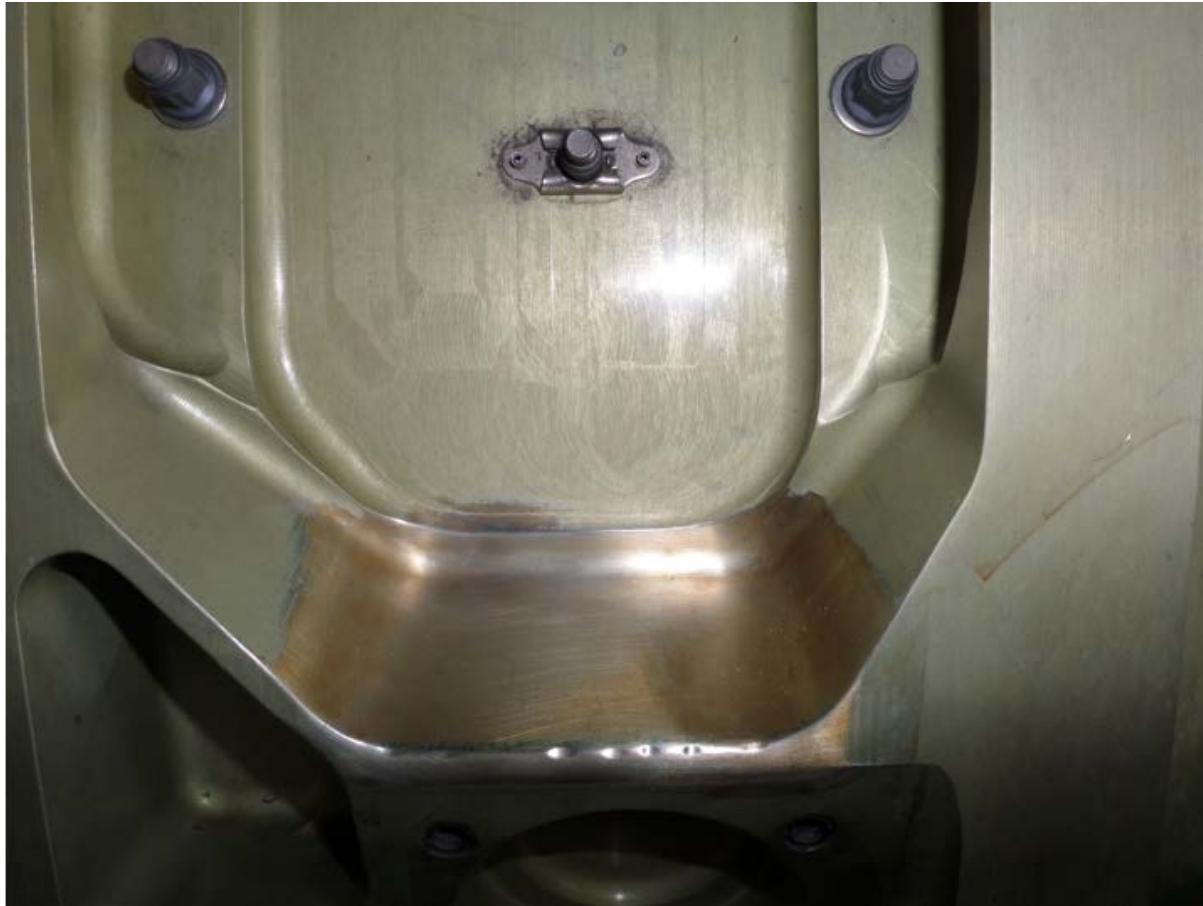
- Extent of original repair as of October 2015:

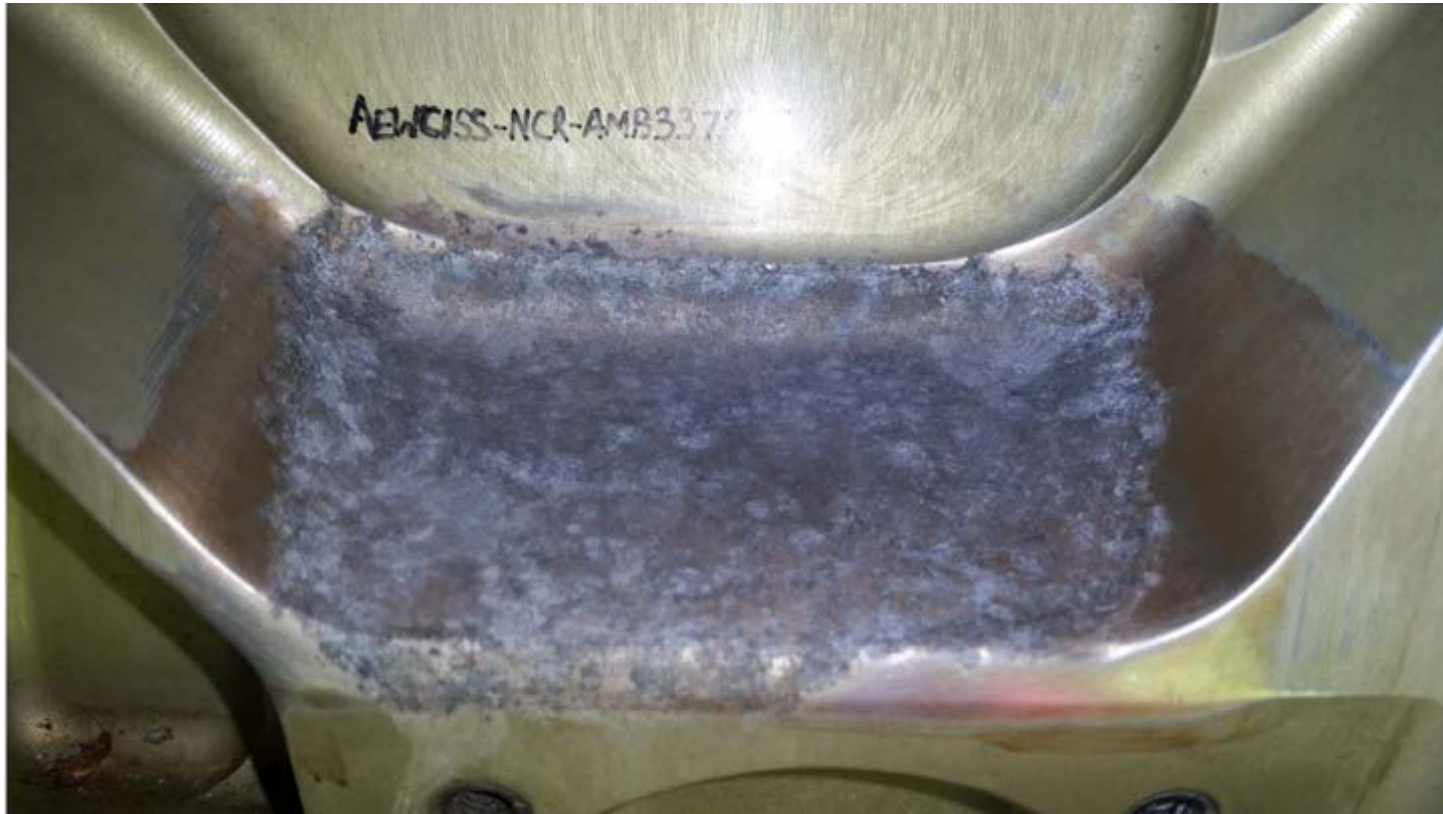
- Surface protection did not display suitable durability considering the E-7A location or operating environment.

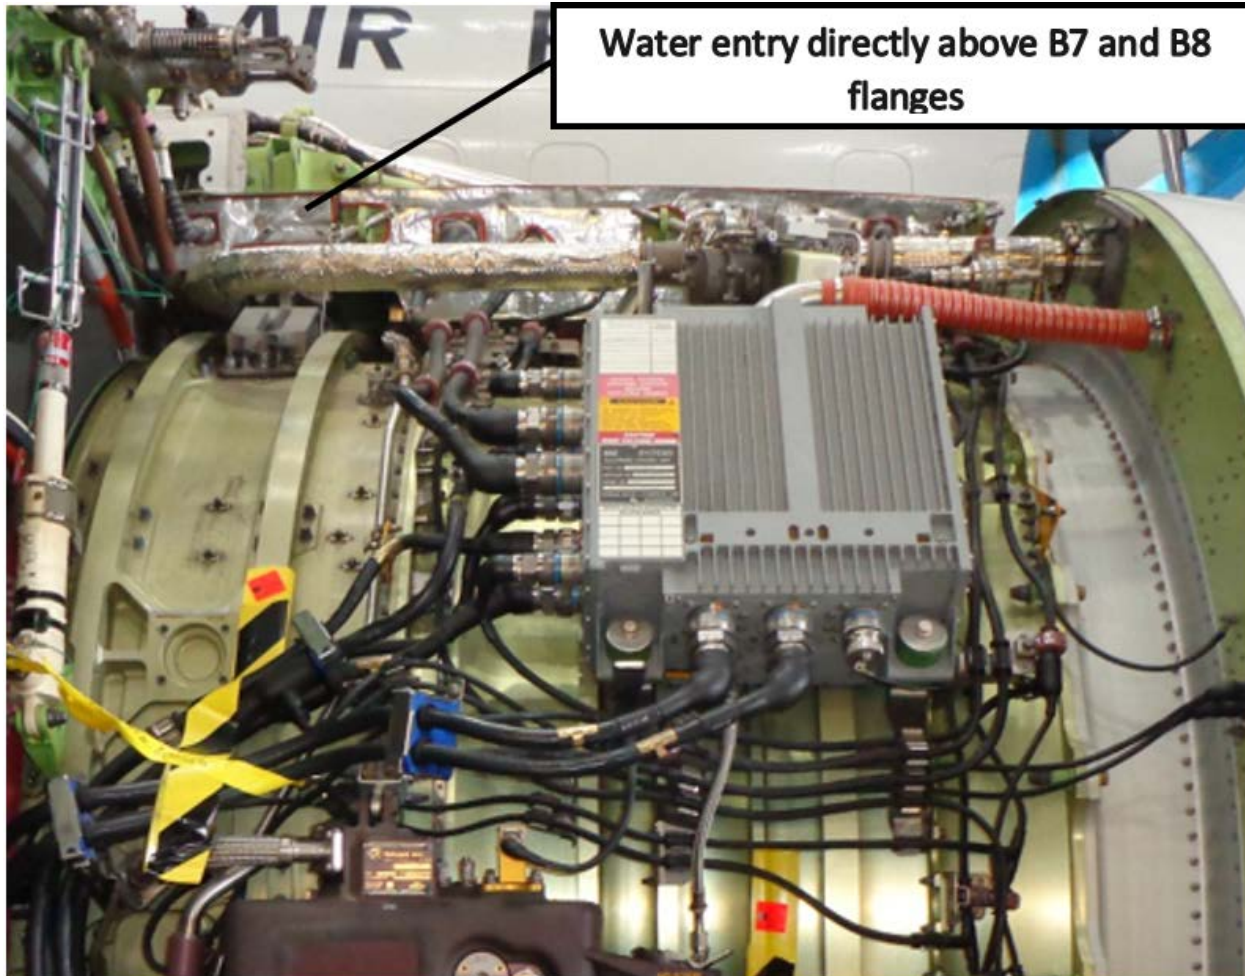
- Corrosion found to be still localised yet far more severe than original occurrence. Material removed up to 0.055” compared to 0.014” at original finding.
- The corrosion foot print of the secondary corrosion indicated pooling of water on the handling boss.
 - Leak path identified at the top of engine fan cowl. Insulation blanket and aerodynamic seal ends between B7 and B8 flanges, so water could drip from seal on to fan frame.
- A total of six engines have experienced this condition, requiring a more robust repair method.
 - Worked with engine OEM to identify and incorporate a more durable surface protection scheme (paint).

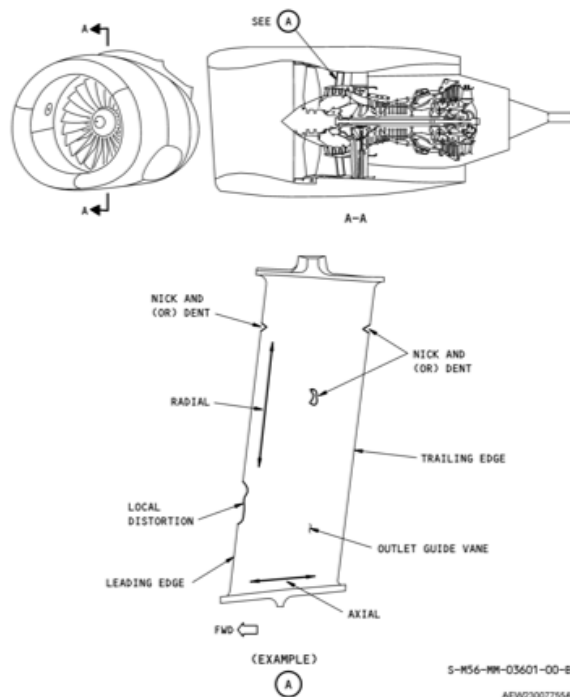
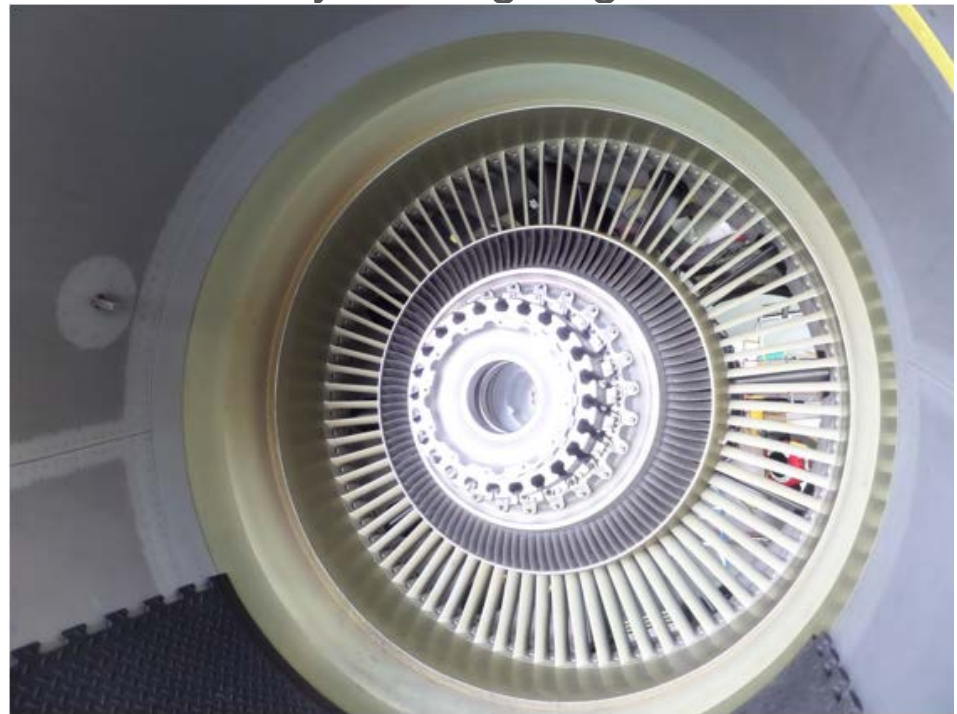
- Initial report of pitting corrosion on surface and leading edge of three OGVs, December 2015.
- Investigation identified seven OGVs replaced on aircraft to date, and up to 20 on aircraft A30-002 currently undergoing R8.

- Existing strategy is to remove and replace OGVs on identification of pitting corrosion.
- Alternative strategies under consideration:
 - Increase inspection intervals and repair OGVs.
 - Re-apply protective coating.
- Need to consider lifetime costs of repair vs replacement strategy when deciding which path to take.

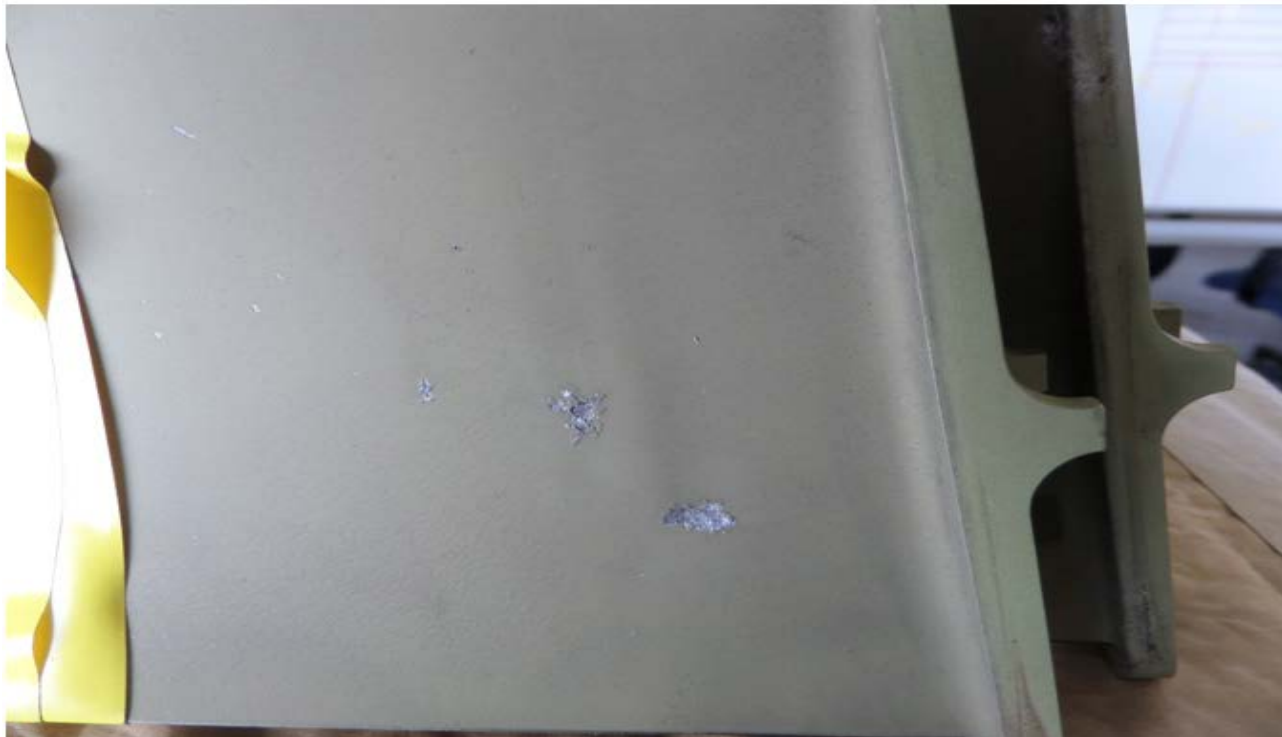
- Most occurrences of pitting corrosion have been on the concave surfaces with some instances on the convex side and leading edges.

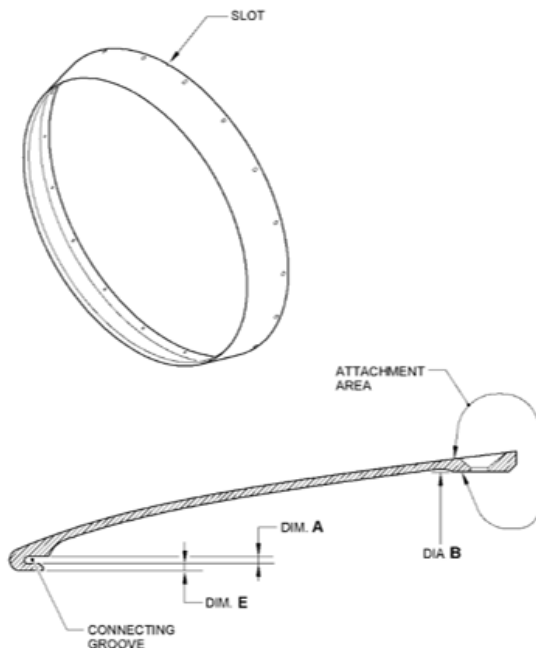
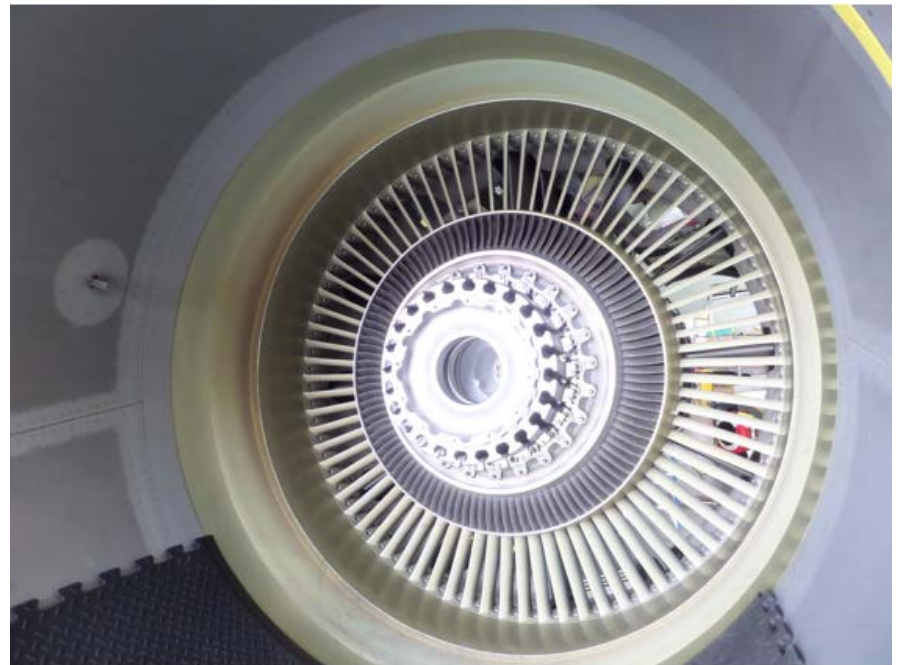
- Corrosion of the Splitter Fairing identified on both engines of A30-002 during R8, March 2017.
 - This is the first occurrence.
 - Corrosion on surface and around attachment screws.

- A30-002 Splitter Fairings:
 - Replacement Splitter Fairings will be sourced and installed during R8.
 - Removed Splitter Fairings sent to repair shop to quote on repair.
 - Repaired Splitter Fairings will then be used as serviceable spares.
- Establish an alternative for graphite grease lubricant.
- Due to recently identified corrosion issues (Splitter Fairing & OGV) a more holistic corrosion prevention program is being considered.
 - Are existing actions still effective? Are new actions required?
