MINISTERIAL SUBMISSION

Subject: Repair of HMAS Choules

BACKGROUND INFORMATION—HMAS CHOULES MAIN PROPULSION TRANSFORMERS

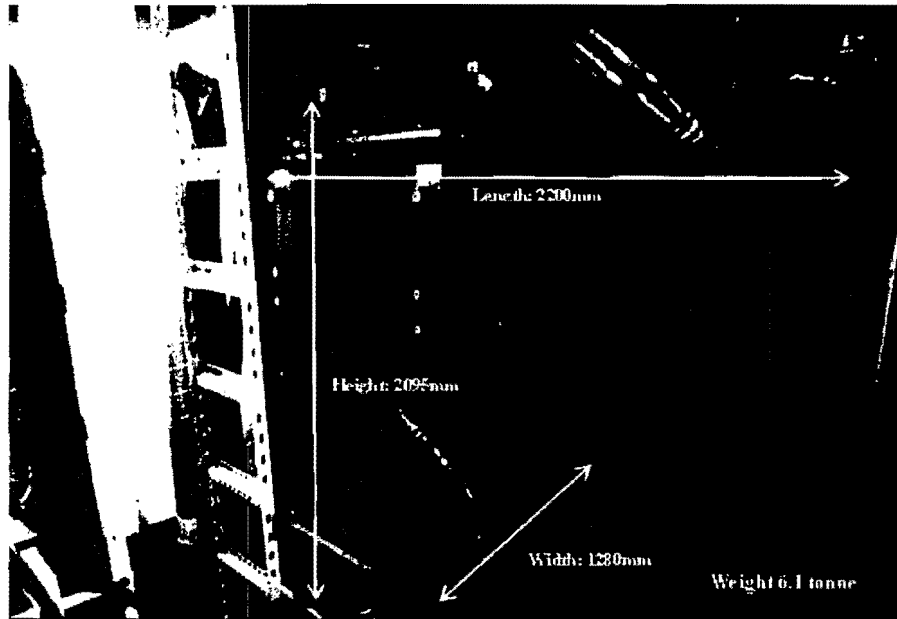
1. As you are aware, on 14 Jun 2012, HMAS *Choules* suffered a failure in one of the transformers on her starboard propulsion train. This reduced the ship's maximum speed to 6 knots and forced the ship to return to Sydney.

The failed transformer

2. With the support of the manufacturer Siemens and DSTO, Navy and DMO have examined options to repair the failed transformer in *Choules*. The primary repair method will be to replace the transformer unit with a new item. A second method of rebuilding of the damaged unit is uncertain, but will continue to be examined. Images of the transformer unit are attached in background information.

Given the design has two units operating in parallel to feed one propulsion motor, DMO is ordering two units in case the other unit in the pair needs replacing or as a spare. Removal and replacement of the unit requires an access panel to be cut in the ship, not an unusual occurrence for major repairs. Production work to install, trial and certify the new unit is estimated to be eight weeks. In total, the repair will take about six months, making the ship serviceable again in December 2012.
