19 Why did HMAS SYDNEY approach close and parallel to HSK KORMORAN?

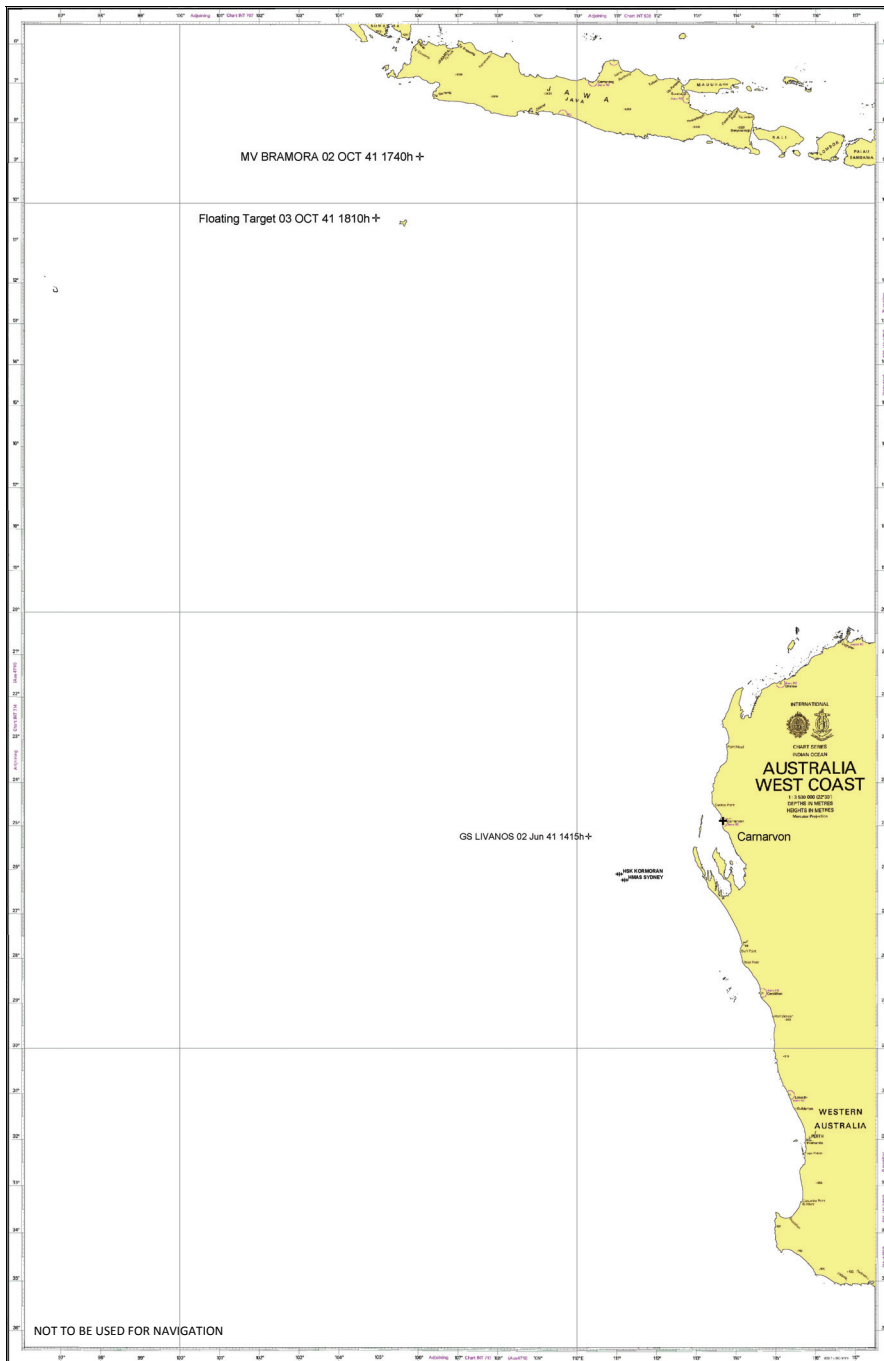
- 19.8 Those two factors—the absence of any ship on his plot and knowledge of the possibility of a raider in the area—render almost inexplicable CAPT Burnett's initial decision to assess the sighted ship as innocent. The decision did not depend on any guise or deceit on the part of KORMORAN: the ships were 20 miles apart. It was grounded entirely on the two factors just mentioned. It was, in my view, a basic error of judgment. Yet CAPT Burnett was a skilful and conservative commanding officer, and he was supported by a group of experienced officers. On three previous occasions he had gone to action stations in daylight on sighting an unidentified merchant vessel or unknown object. Figure 19.1 shows where that occurred.

Figure 19.1 The three locations where SYDNEY went to action stations in daylight⁷
