AVIATION ACCIDENT INVESTIGATION REPORT

EA-18G, A46-311, Uncontained Engine Failure, Nellis Air Force Base, Nevada, USA, 27 Jan 18

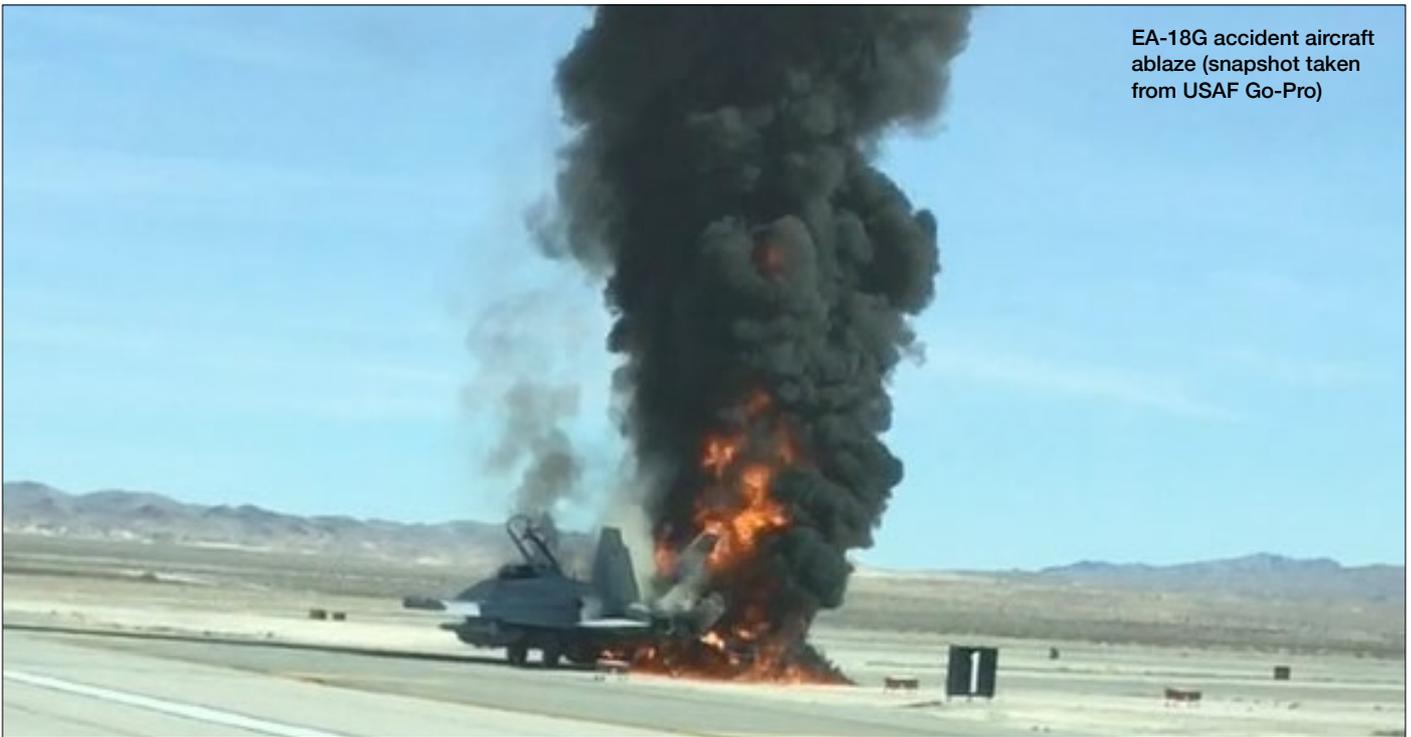
EA-18G accident aircraft
ablaze (snapshot taken
from USAF Go-Pro)
