MICROBIOLOGY  
FINAL REPORT

DEAKIN OFFICES

COOLING TOWER WATER

GEMS ID 100034 / GMS 2 1030358 - 109 Kent Street Deakin ACT 2600

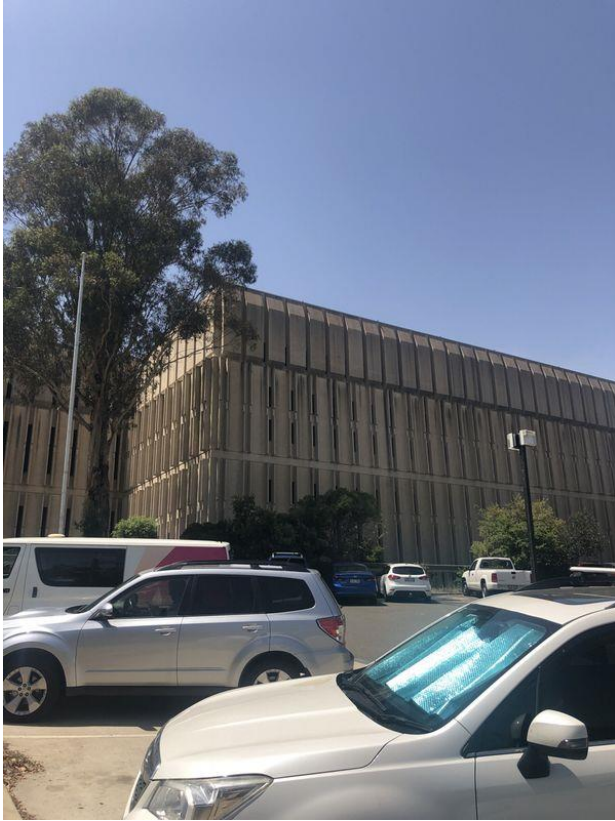
Appendix 1

| Question | Response | Details |
|---|---|---|
| 1.3 - Facade | Good | |
