# MICROBIOLOGY FINAL REPORT

## CERTIFICATE OF ANALYSIS

# Commercial Report

GEMS ID 100034 / GMS 2 1030358 - 109 Kent Street Deakin ACT 2600

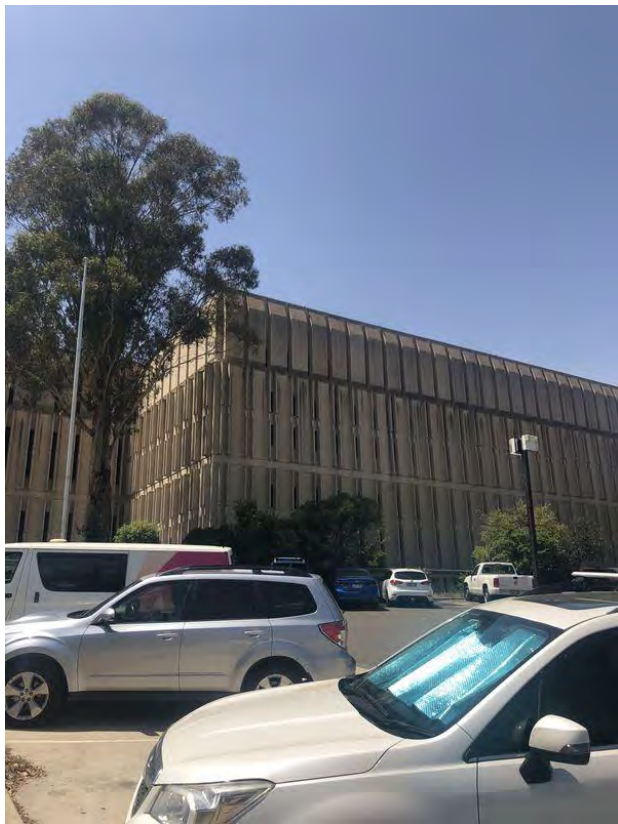
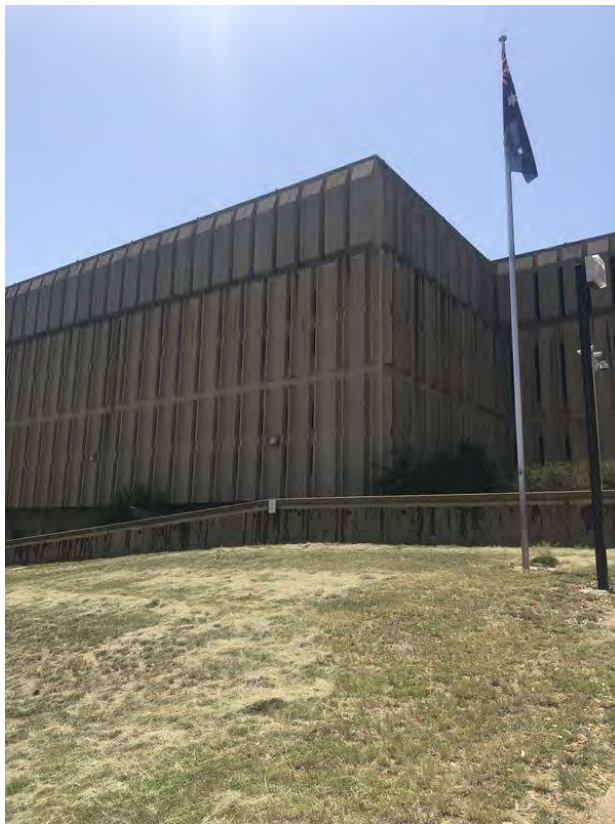
Appendix 1

| Question | Response | Details |
|---|---|---|
| 1.3 - Facade | Good | |

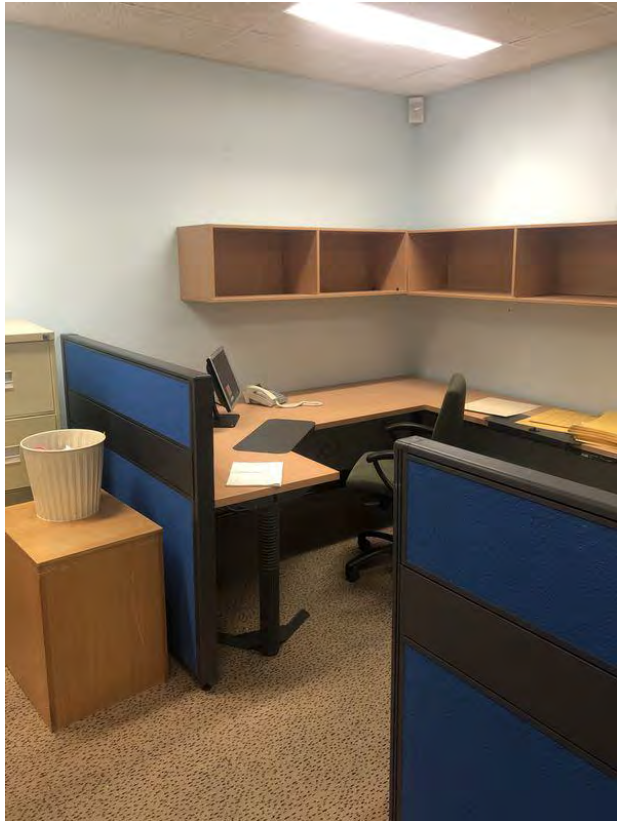
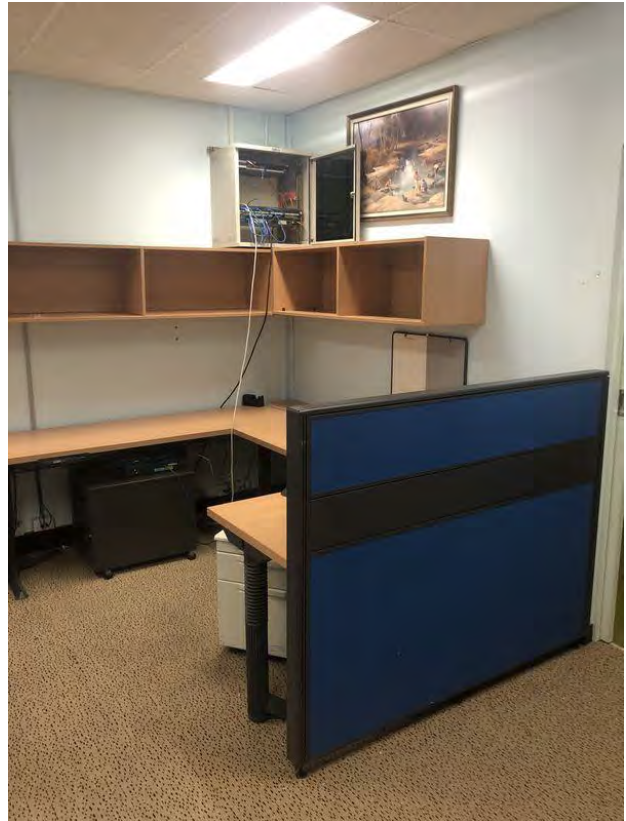
Appendix 3

| Question | Response | Details |
|---|---|---|
| Office Area - General Summary | Good | Photos of office areas were limited due to high security areas and photography restrictions. |

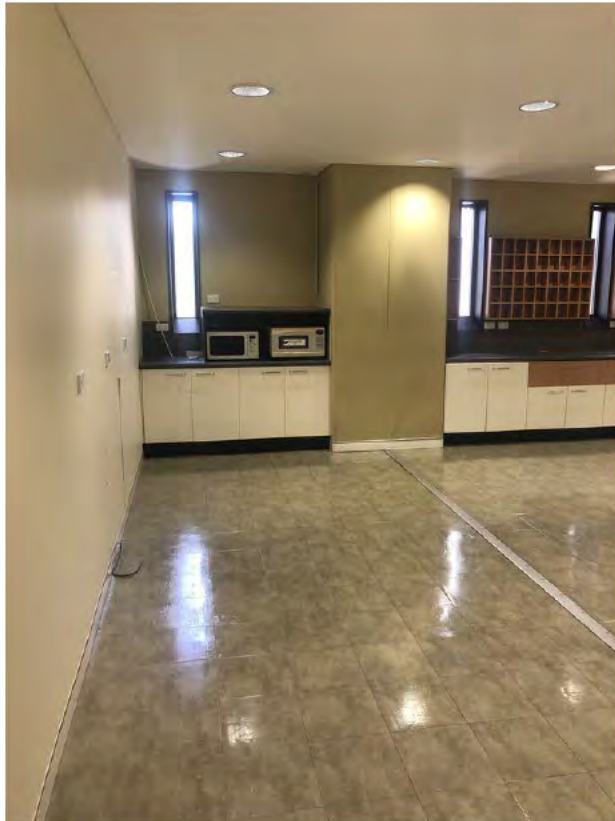
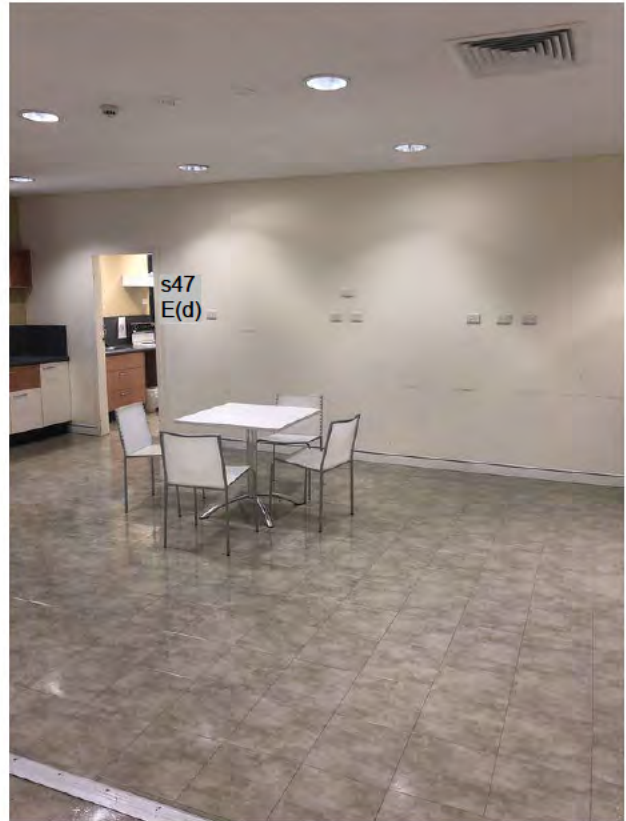
Appendix 15

| Question | Response | Details |
|---|---|---|
| Tea Room - General Summary | Good | |
