ROYAL AUSTRALIAN NAVY

Fleet Command- Maritime Safety Bureau

MARITIME SAFETY INVESTIGATION – HMAS *MARYBOROUGH* - OHSIR 03/17

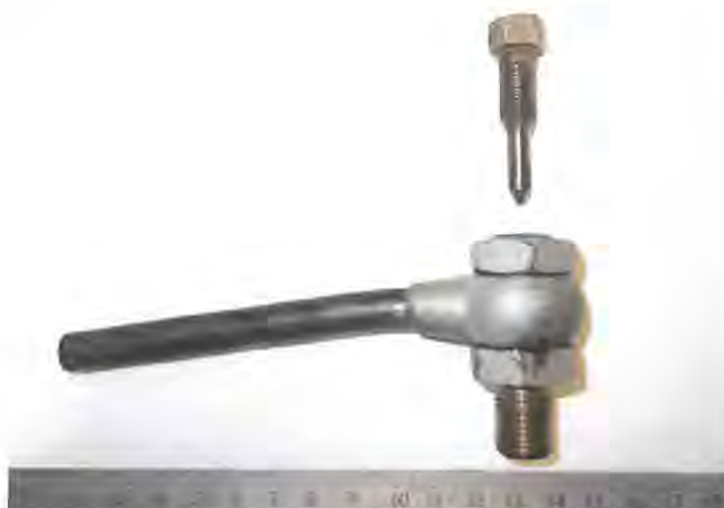
1. The following are results of examination of the fuel line vent positioned between the low pressure and high pressure fuel pump of engine number 1 (starboard main engine) of HMAS Maryborough as a result of the reported fuel fire on this engine on 25 May 2017 at approximately 2337 hours. The complete assembly is seen below in Figure 1. A request by Mr Ewan Farquharson was made to examine the vent assembly components (Ref A) and secondly approximate the volume of fuel likely to have flowed from the opened vent.

Figure 1 Fuel vent assembly HMAS Maryborough - engine number 1

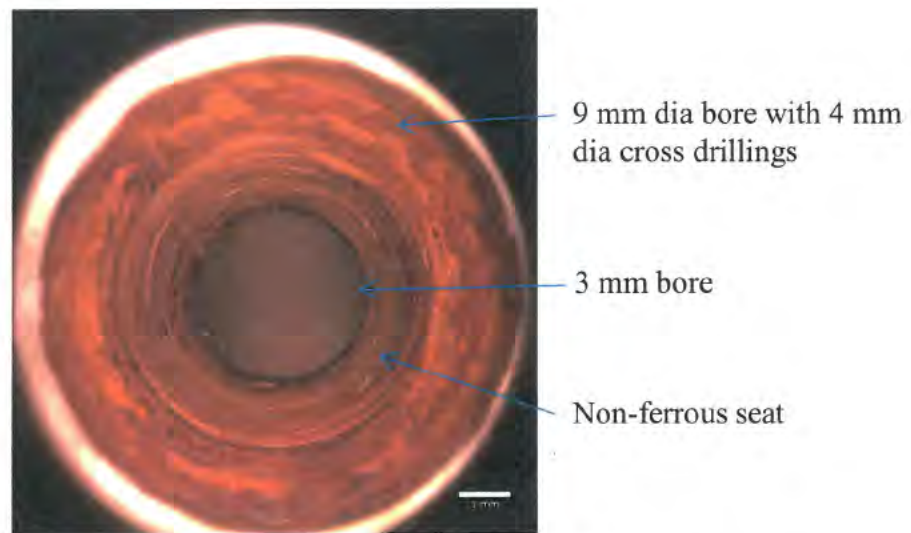
2. Optical microscope examination of the vent sealing surfaces shows both the non-ferrous seat (Figure 2) and steel spindle (Figure 3) to be in serviceable condition. Some minor non-critical corrosion is apparent on the spindle above its sealing surface. From Figure 1 it can also be ascertained that the hexagonal flats are in good condition.

Figure 2 View of non-ferrous seat as seen from above (image courtesy of Mr Stephan Toman AD – AFE)

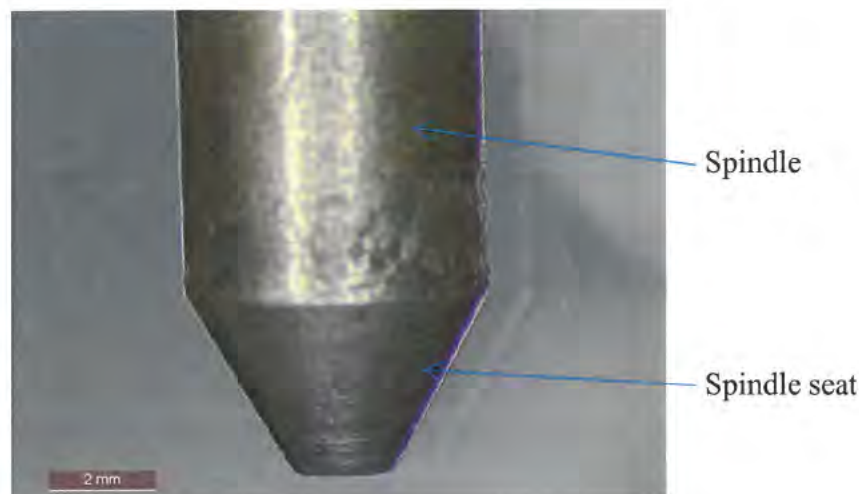
Figure 3 Steel spindle seat and minor corrosion above sealing surface

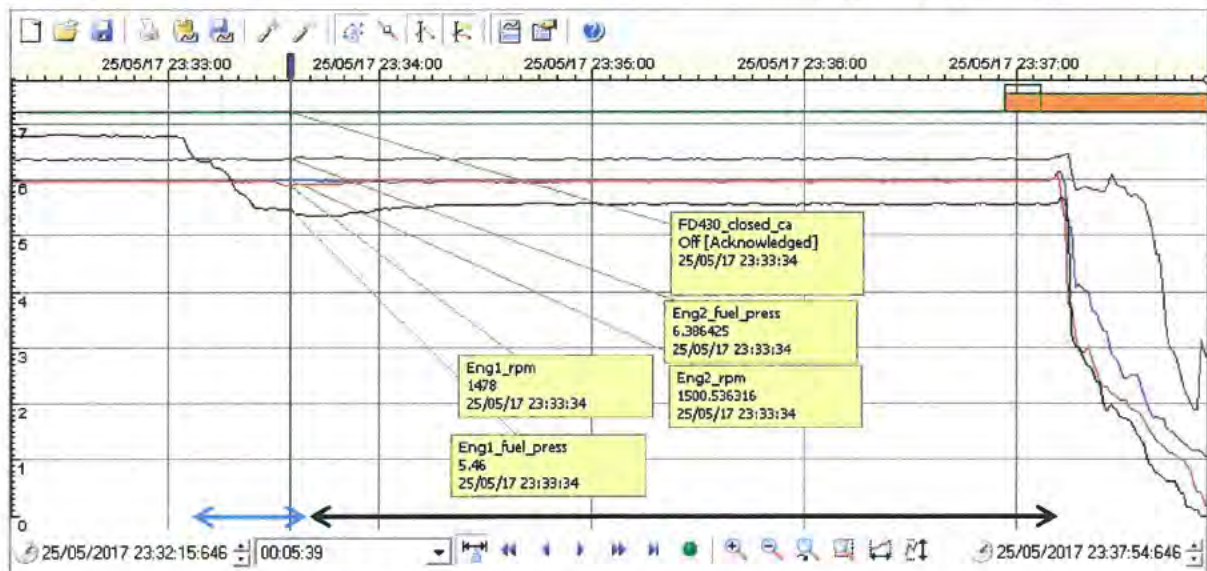
$$\begin{array}{r} 23:37:13 \\ - 23:33:05 \\ \hline 00:04:08 \text{ or } 248 \text{ seconds} \end{array}$$

Which represents the amount of time fuel was available to exit the opening/opened fuel vent.

Figure A1 Marinelink record of HMAS Maryborough main engine RPM and fuel pressure at the time of engine shutdown on 27-May 2017

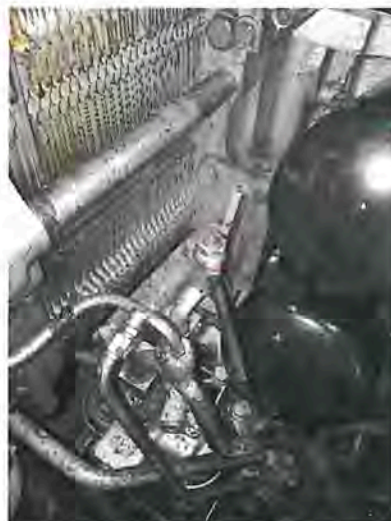
3. As mentioned previously in the entire material, the loss of control was the detachment of the bleed off screw from the assembly, as shown in Figure 1. Figure 2 presents a schematic of this assembly and its associated pipework. The nominal condition for this assembly can be seen at Figure 3, which was present in Engine 2 during the investigation.
4. With the detachment of the bleed screw, marine diesel was being discharged near the forward inward side of engine one of the bilge and deck plates, as well as a mist cloud forming between the two engines. A mist cloud sized to support a deflagration event was able to develop due to the engine being at approximately 1500 rpm (with only one turbo charger running) which leads to almost static air conditions within the main engine room.

Figure 1: Bleed off assembly for engine 1 missing its bleed screw, within the red circle. Additionally, note the colour of the vent line, which indicates that a fire likely occurred within and around it.

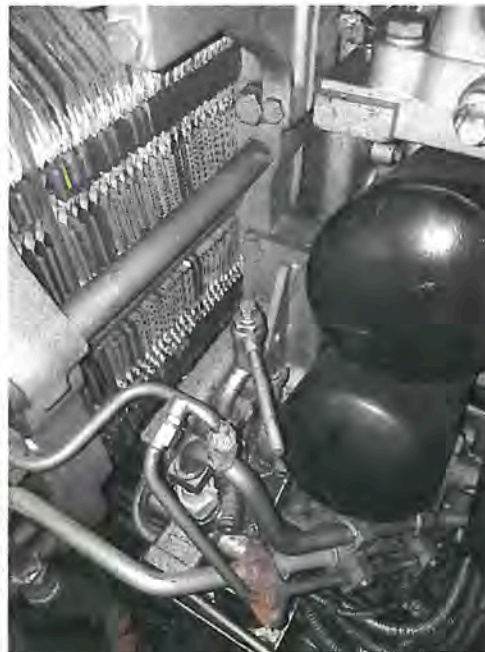
Figure 3: Bleed off assembly for Engine 2, showing the nominal condition.

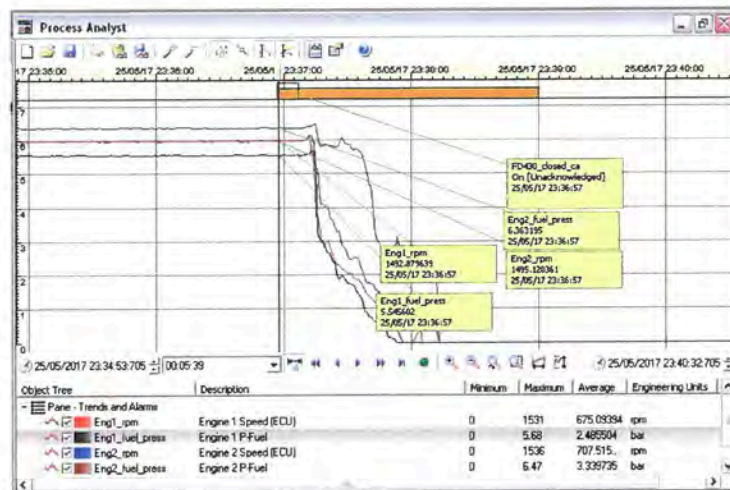
6. One potential ignition of the oily mist cloud could be that some of the oily mist cloud ingressed into the engine(s) turbo charger. This would have lead to an over rich combustion, which increases the engines rpm and may also generate a backfire which could ignite the oily mist cloud. Figure 4 presents the closing of the mid forward engine room damper and for each engine low fuel pressure reading plus the rpm for each engine. As can be seen in Figure 4, the rpm were steady around the time of the damper close, although there is a small spike just before engine shut down. This rules out a backfire as a possible ignition source.

Figure 4: Marinelink display of mid forward engine room damper close and for each engine the rpm and low fuel pressure reading.

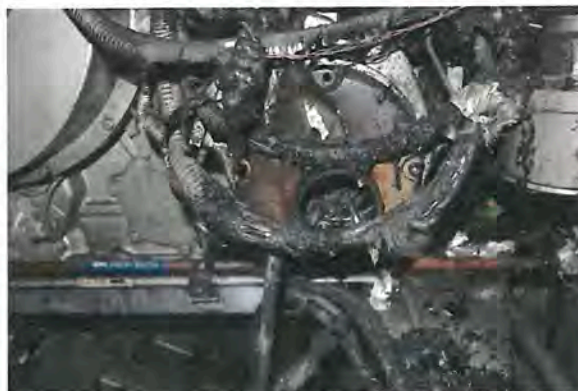
7. It is plausible and supported by evidence that liquid and mist diesel entered engine one alternator. As the alternator was in use and is not a brushless configuration it could have ignited the diesel, which would have travelled rapidly to the oily mist cloud via the vapour which is expected to have existed between the alternator and the main oily mist cloud. Figure 5 shows the alternator in its standard position post fire. This position is below the bleed off assembly and as can be observed from Figure 5 that combustion has occurred below and within the alternator. Figure 6 shows the alternator removed from the engine and there are clear signs of fuel ingress and combustion.

Figure 5: Alternator fitted to engine one, impacted by combustion

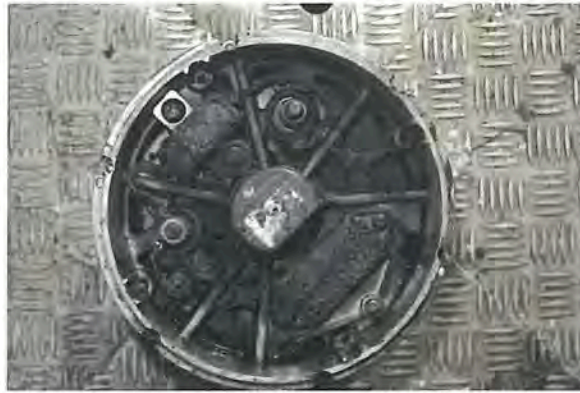
Figure 6: Removed alternator with signs of fuel ingress and combustion

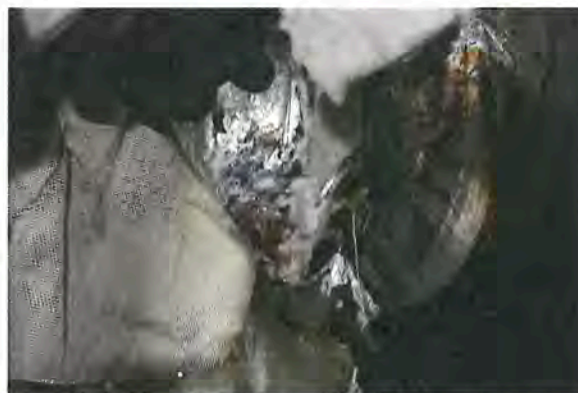
8. From the inspection of the site, it was observed that much of the lagging at the forward part of the engine room has absorbed significant marine diesel. Figure 7 shows part of this exhaust lagging above the forward part of engine one. There are signs of flash burn marks on the outer layer of the lagging. Samples have been sent to DSTG for analysis.

Figure 7: Exhaust lagging above the forward end of engine one, where an inner and outer lagging samples were collected and sent to DSTG

13. Noting the above, it is considered that the lagging issue within HMAS Maryborough main engine room was the most likely ignition source for the oily mist deflagration, although this cannot be proven unequivocally. Even still it is considered that this lagging issue was a contributing factor to the overall incident.

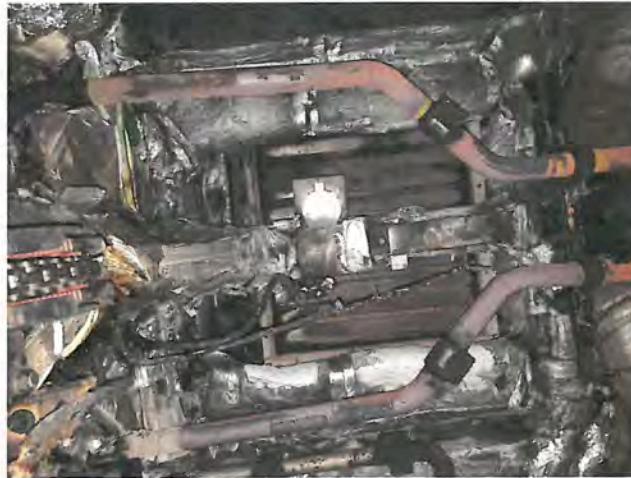
14. By Marinelink timing, at 23:36:57 the Mid (forward) damper in the engine room closed, shown in Figure 8. It appears that the control mechanism to this fire damper was blown off, but there is also clear evidence of thermal damage. This implies a deflagration event roughly positioned under this point.

Figure 8: Mid Damper of the Main Engine Room in closed state

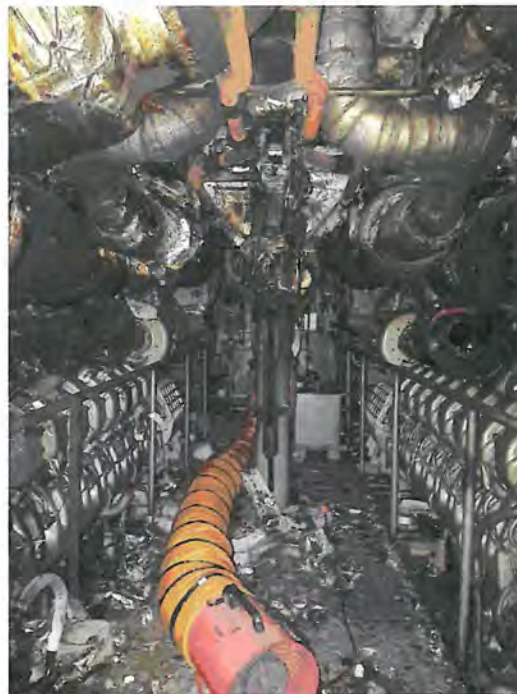
15. Further evidence to support a deflagration event is shown in Figures 9 to 12. Specifically, the level of lagging damage and its scattering around the engine room as can be seen. This lagging damage ranges from outer layer blown off, to the entire lagging torn away. Additionally, the light fitting in between the two engines is hanging by its wires with no real signs of combustion. This suggests it was knocked out of its fitting before combustion had taken hold. All of this implies an over pressure (air) event and within the scope of the event and evidence that fuel air deflagration is the most likely course.

Figure 9: Between both engines looking aftwards. Significant damage to the lagging as well as the deck covered is bits of lagging. Near the king post the light fitting is being held up by its wires.

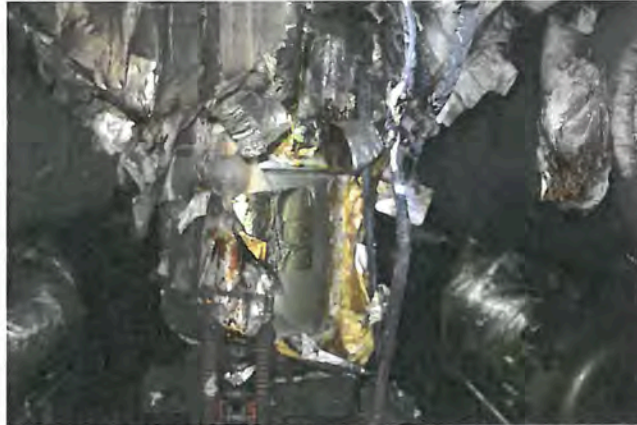
Figure 10: Damage lagging on the top of the king post.

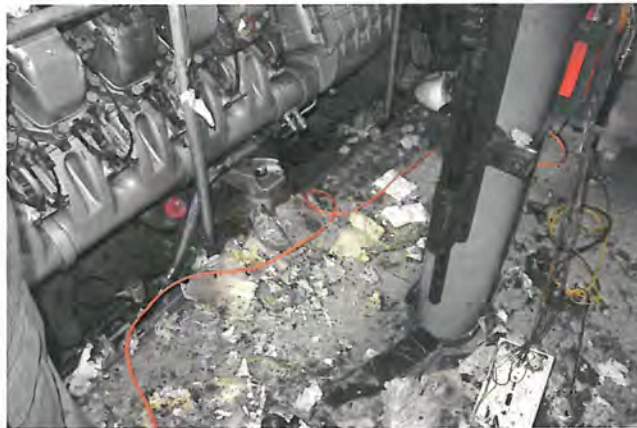
Figure 11: Deck plate around the king post, where the light fitting and lagging can be observed.

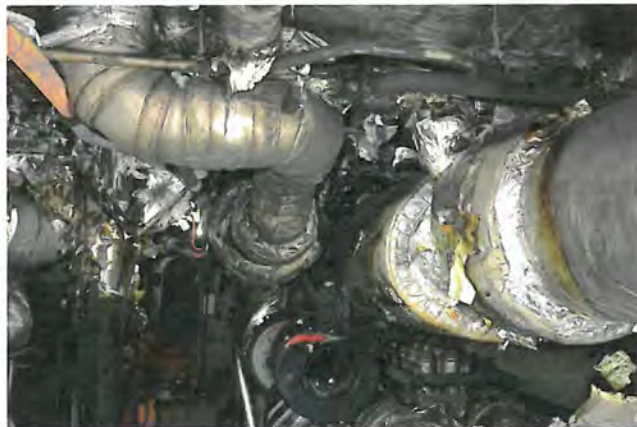
Figure 12: Above engine 2 looking aftwards. Much of the lagging has been torn up as well as pieces of lagging on the engine. The yellow brownish marks on the exhaust lagging are signs of where marine diesel has absorbed into the lagging.

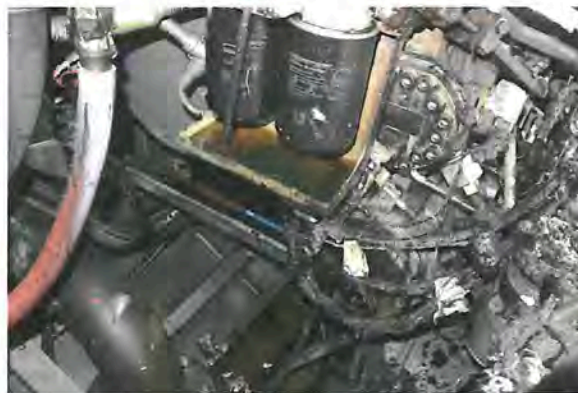
16. The pools of marine diesel, mostly on the deck plates and in the bilge, would have combusted due to the fuel air deflagration. Figure 13 shows the small pools of marine diesel that developed. These various pools combusting lead to the following:

Figure 13: Pool of diesel below two filters of engine one.

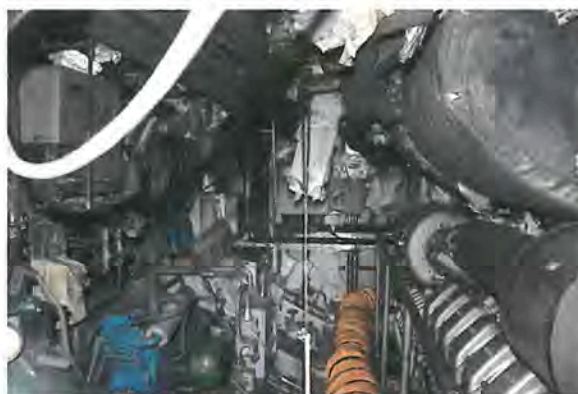
17. Beyond the deflagration and combustion damage at forward and between the two engines, the remaining main engine room shows damage up high from smoke and heat, with limited deflagration damage, and no signs of combustion. As an example Figure 14 shows the port deck plates pass engine two.

Figure 14: Looking forward on the outer side of engine two. There are signs of components been blown off as well as smoke and thermal damage up near the deckhead. There is no event of combustion in this area of the engine room.

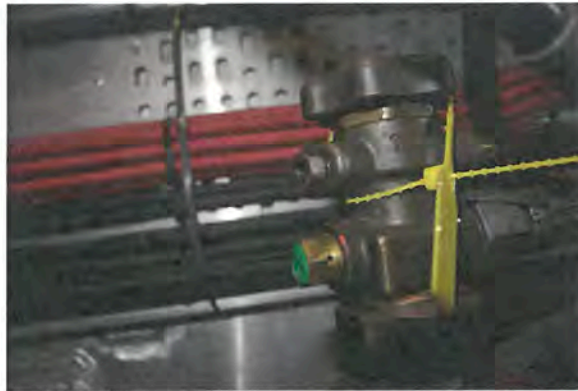
Figure 15: The fourth CO2 bottle activation value with the pivotal hose missing.

39. The hose detachment with respect to the first CO2 discharge was investigated. At Reference 6 the PBSPO tasked SERCO to undertake a 60M replacement of all synthetic rubber flexible hoses on the CO2 which were over 10 years old. The work instruction which was undertaken, as shown at Reference 6, was a 12 M Flexible Hose – Survey / Inspect. This highlighted that many of the CO2 flexible hoses were over ten years old and need to be replaced. With discussions with the crew, there understanding was that it was acceptable as ABR 5225 permits 12 years service life and therefore no risk. This is incorrect, in that ABR 5225 states a maximum of 12 years service life but in accordance with OEM requirements, which for this CO2 system is 10 years². The pivot hose that goes from cylinder 3 to 4 has an id of 333-

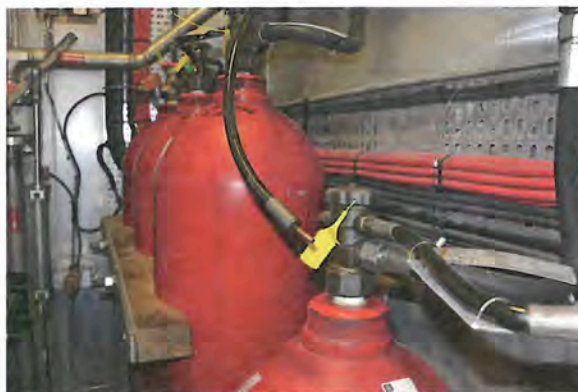
Figure 16: The pivotal hose detached from the fourth CO2 bottle.

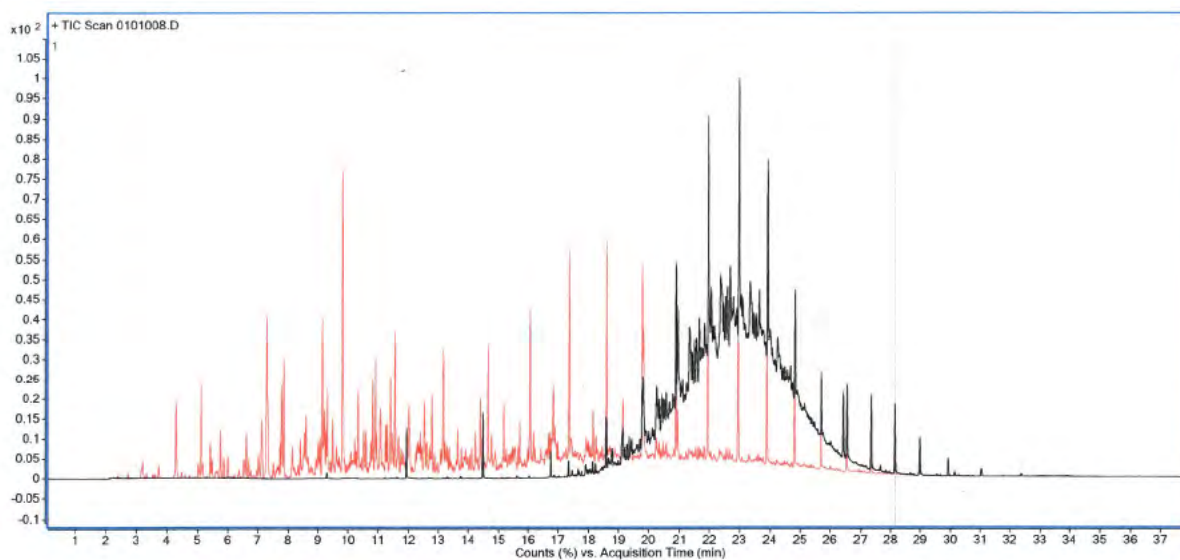
Figure 1. Gas Chromatogram over lay of diesel fuel (red) versus sample 1 SPME extract. Note alignment of major n-alkanes

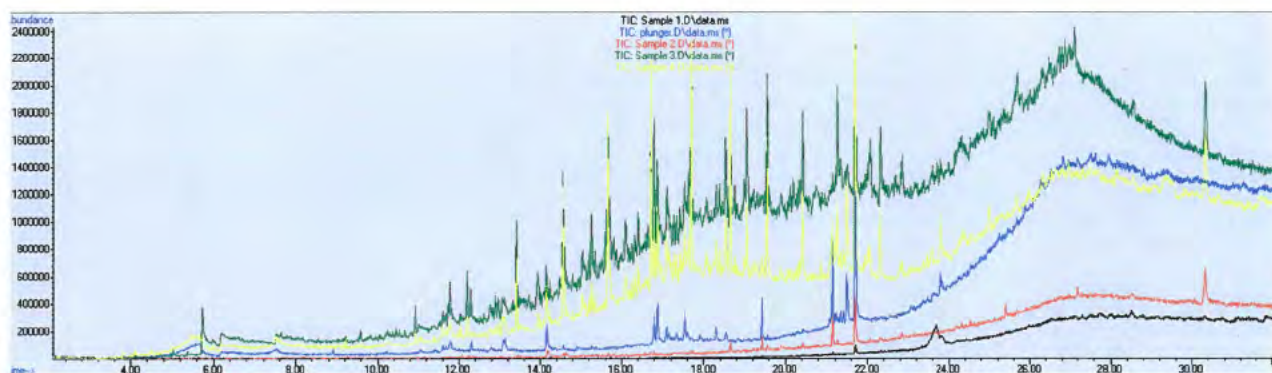
Figure 2. Gas Chromatogram overlay of solvent extract of samples, note;

- Sample 1 and 2 have no obvious fuel trace.
- Sample 3 and 4 have obvious fuel trace.
