Ageing Aircraft Sustainment

Optimising Aircraft Availability

Stress Corrosion Cracking
Wing Panel Rib H-Clips
AP-3C Orion

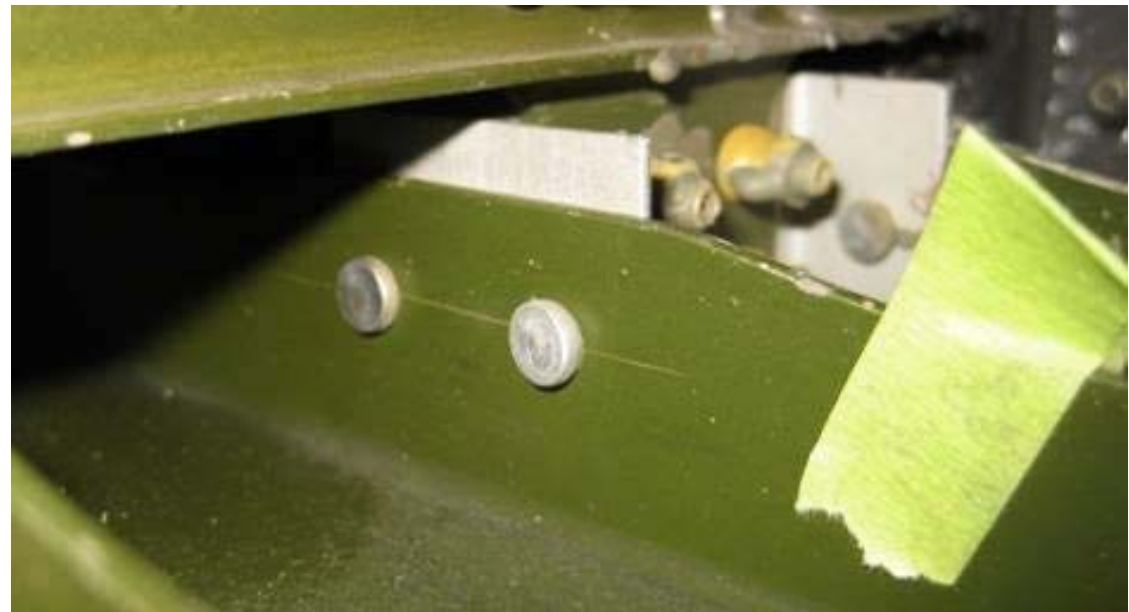
- Crack confirmed with surface scan
- NDT performed a visual sweep of the tank area
- Detected and confirmed a further 7 cracks

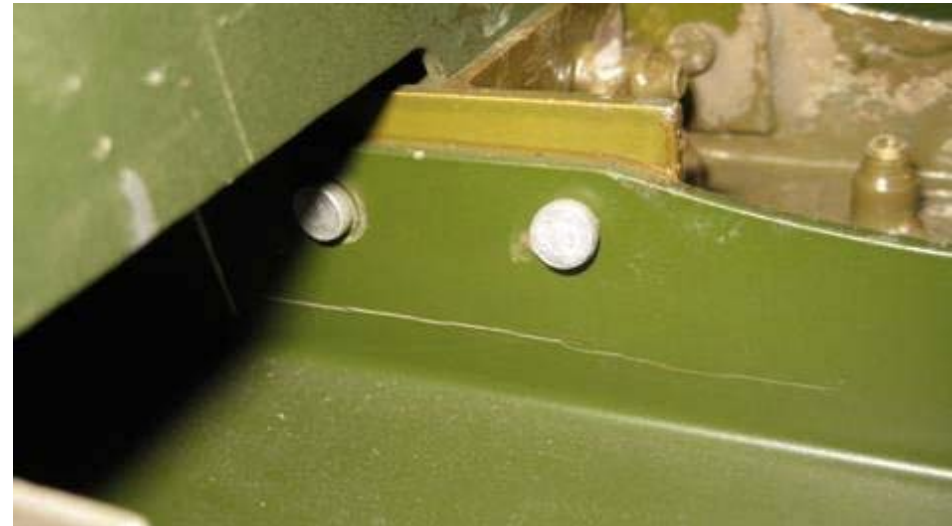
- SMM and SDE directed a complete re-examination of both aircraft at the facility
 - Training delivered to mechanical workforce
 - Additional cracking detected
 - Increase in the number of ‘suspect cracking’ which all had to be confirmed by NDT – 10% (or less) were actually cracks
- Over conservatism due to cracks being missed on other aircraft

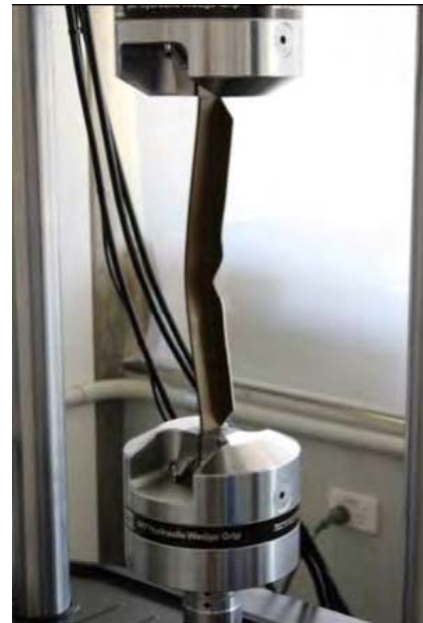
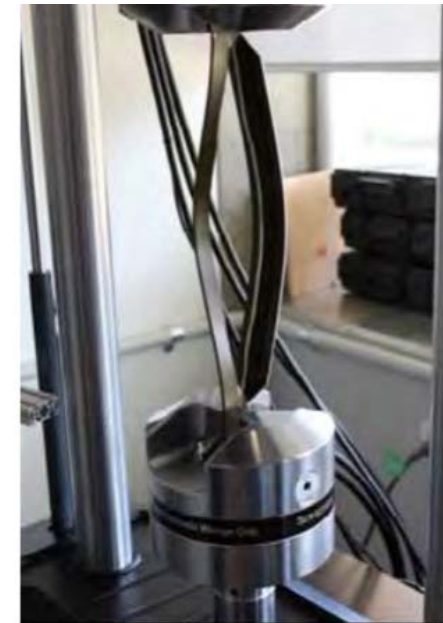
- Initial compressive strength testing conducted to assist in validation of design behind the STI – single riser test only
 - Laboratory EDM slots in the riser
 - Results from FE model and test were in good alignment

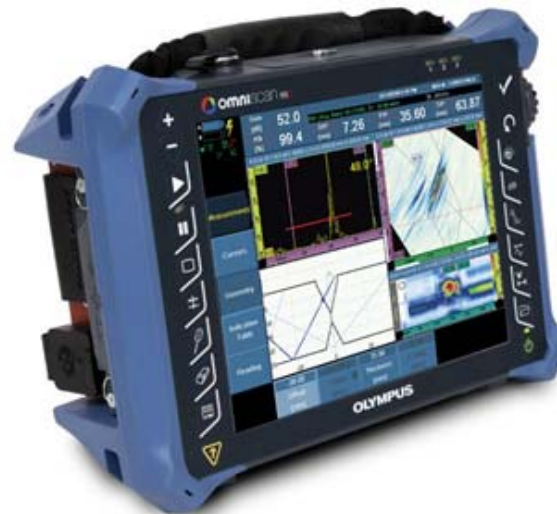
- Phased Array Ultrasonic inspection was identified as having significant potential
 - Successful on-aircraft trials have been conducted
 - Final approved NDT procedure yet to be released
 - Significant cost of equipment purchase is offset by the increased availability of aircraft once incorporated
