Defence Aviation Safety Authority

ADF Wear Debris Analysis

Introduction of ChipCHECK

17 October 2018

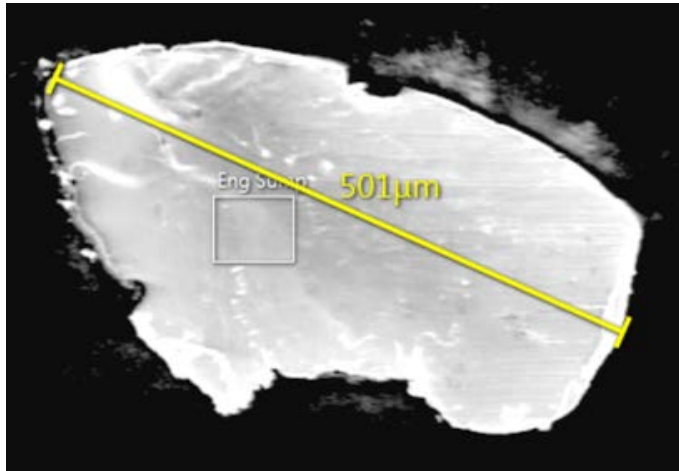
Bearing fatigue

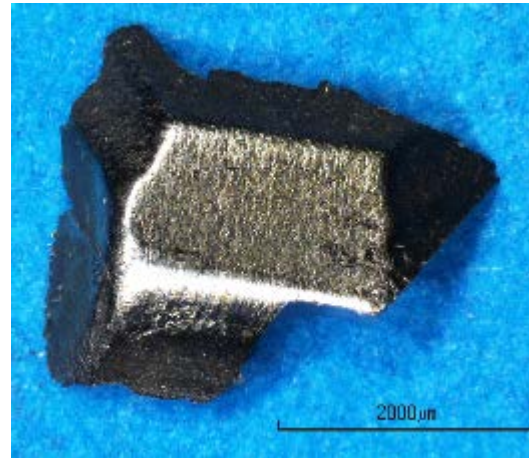
Gears/splines

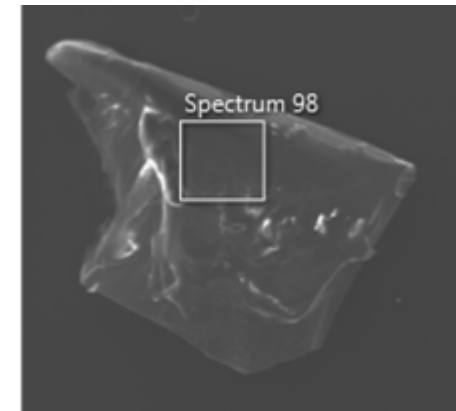
Other Contaminants

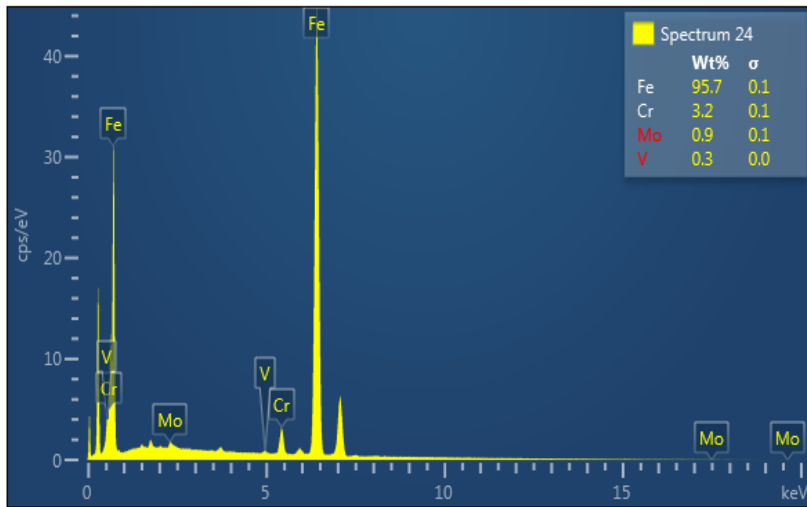
Gear Steel

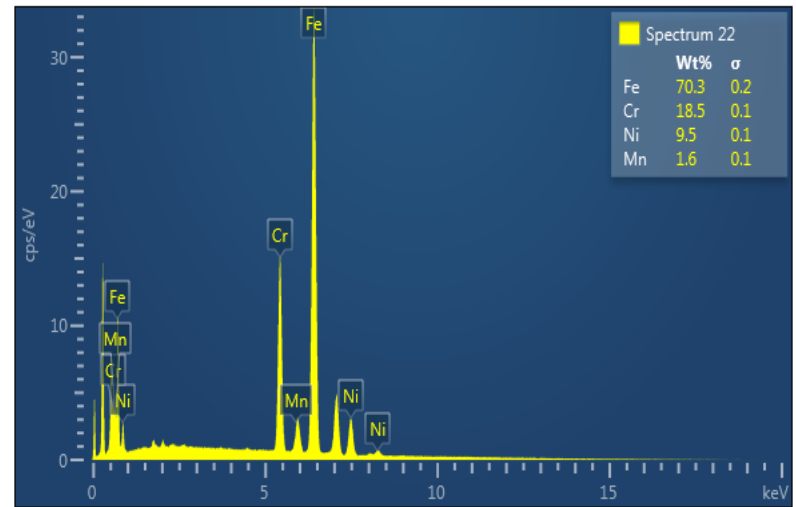
Stainless Steel

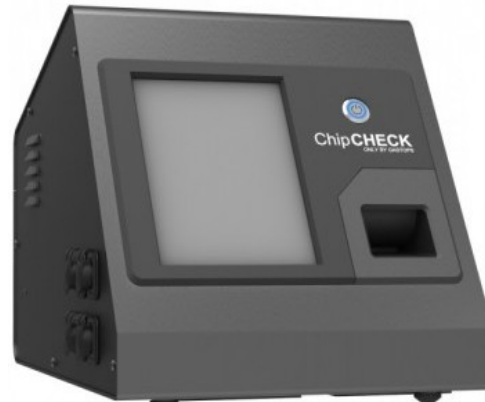
- The ChipCHECK instrument is specifically designed for in-field composition analysis of aviation propulsion machinery wear debris

- Manufactured by GasTOPs Ltd and is commercial off-the-shelf
- Uses Laser Induced Breakdown Spectroscopy (LIBS) to determine elemental composition of wear debris

- Dimensions
 - 360mm x 360mm x 470mm deep
 - Weighs 18Kg
- Requires 100-240V AC, 50-60Hz, power source
- The Instrument consists of:
 - User interface screen
 - Sample access panel
 - Power button
 - Isolating switch
 - USB and HDMI connections

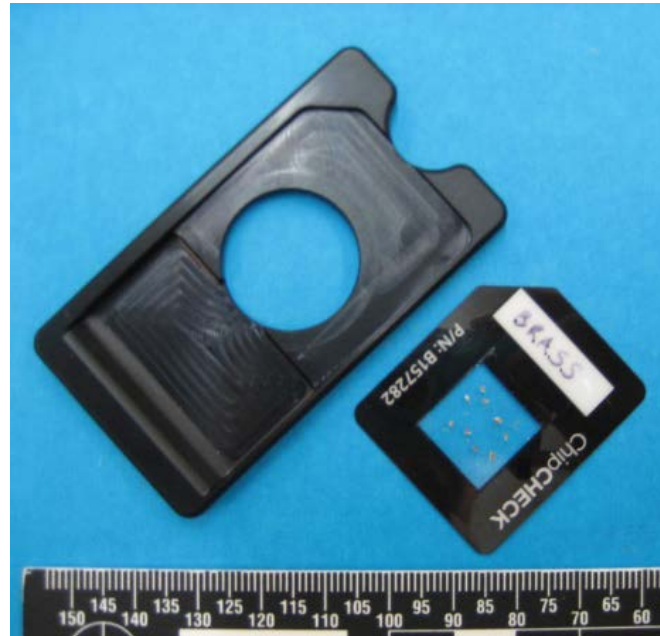
- Debris are collected, washed and placed on an adhesive patch then into a sample tray. The sample tray is loaded into the instrument.

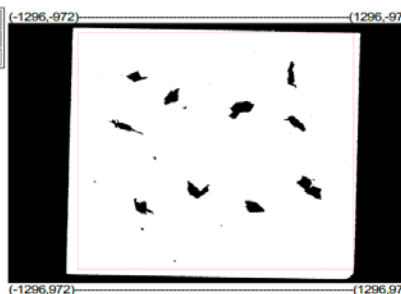
Patch Image (2592 x 1944)

Alloy	No. Particles	Particle Area (um ²)		
		Min	Max	Total
Brass	13	9,010	713,684	4,538,620

Particle ID	Area Size (um ²)	Centroid XY	Alloy Match
1	713,684	(X=-586,Y=-260)	Brass
2	672,995	(X=175,Y=-323)	Brass
3	502,741	(X=-99,Y=275)	Brass
4	445,137	(X=251,Y=403)	Brass
5	404,971	(X=-461,Y=402)	Brass
6	402,414	(X=-263,Y=-419)	Brass
7	374,222	(X=531,Y=-219)	Brass
8	347,484	(X=491,Y=-585)	Brass
9	340,857	(X=-575,Y=-196)	Brass
10	295,053	(X=507,Y=-572)	Brass
11	16,915	(X=-183,Y=-338)	Brass
12	13,137	(X=-374,Y=39)	Brass
