**RAAF Base Darwin**

Supplementary Detailed Site Investigation -  
Per- and Poly-fluoroalkyl Substances (PFAS)  
Executive Summary

2 November 2018

754-MELEN199421-R10-ES

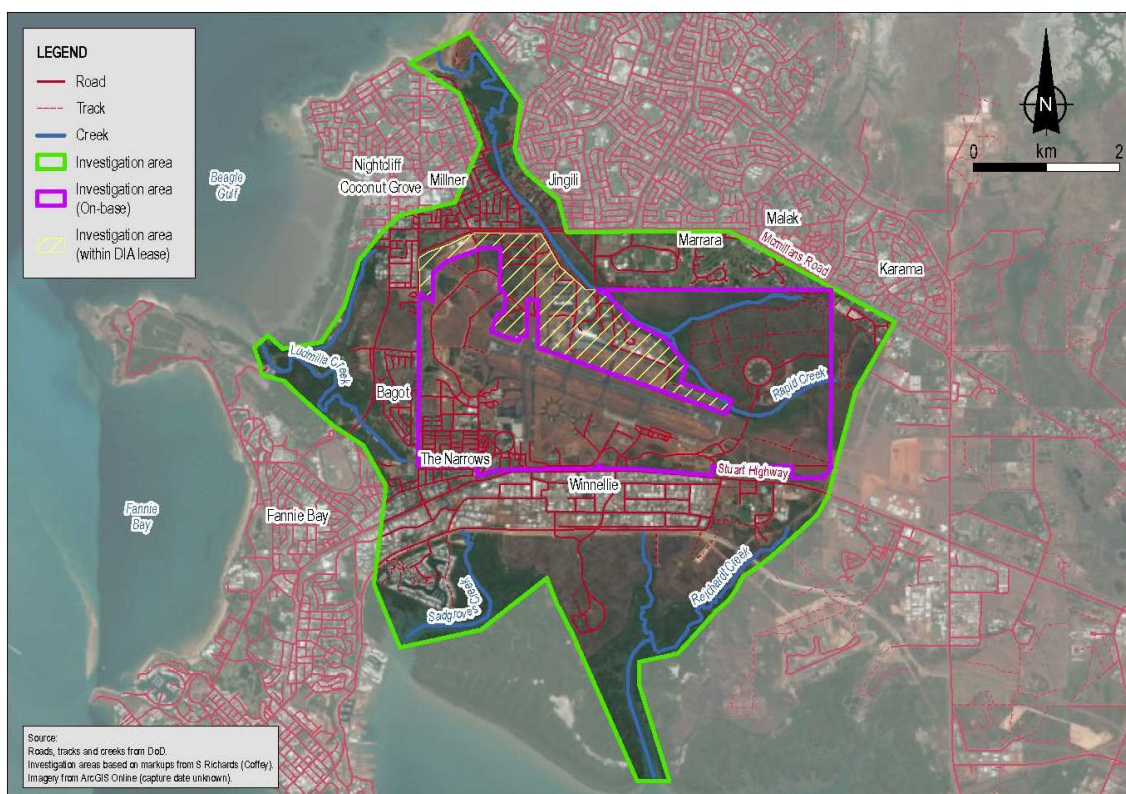
Figure A –Investigation Area

An Investigation Area was defined to reflect the extent of potential PFAS impact to focus the investigation, based on suspected release sites and contaminant migration pathways. The Investigation Area is shown in Figure A.
