R50 – 7 PNEUMATIC TYRED MARCO ROLLER

P56H014

Correct as at 01 Jan 2010

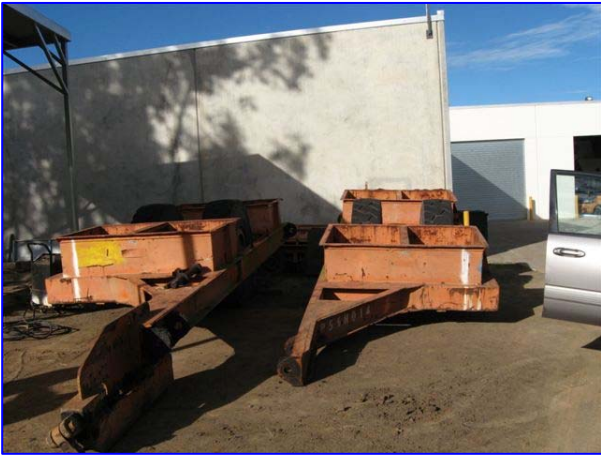
Front View

| 3. | Body Condition | Painted orange and is generally in an average condition, extensive surface rust with paint flaking off and requires sandblasting and repainting. Structural integrity visually appears fit for purpose | |

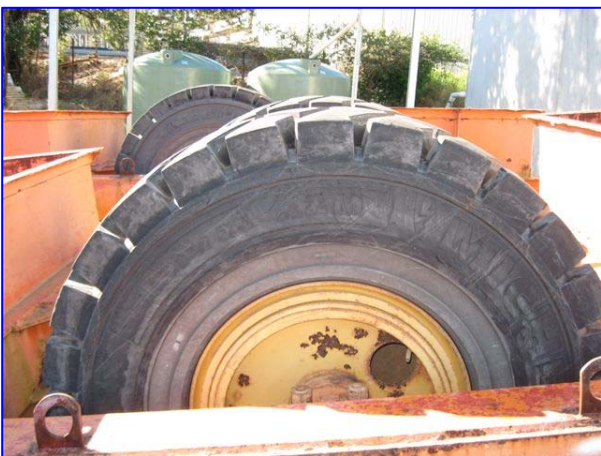
| 4. | Tyre Condition | Pneumatic Tyres. Tyres appear to be in good condition.

Wheel bearings may need to be inspected in a workshop, however, they appear to be maintained and greased. | |

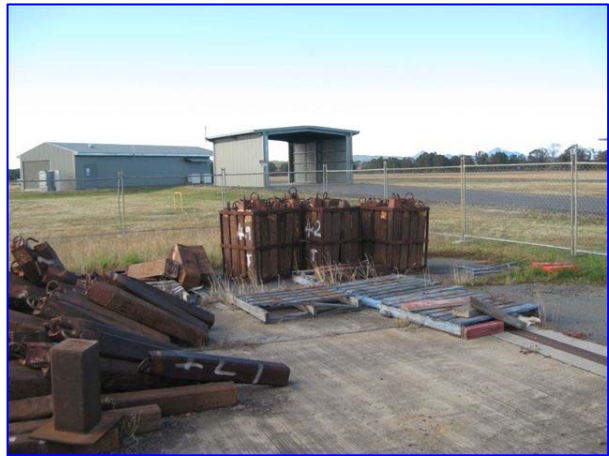
| 5. | Ballast Weights | Weights are individual and uncaged, some handles are bent and damaged. Require individual inspection and assessment prior to loading | |
