SUBM.001.0120

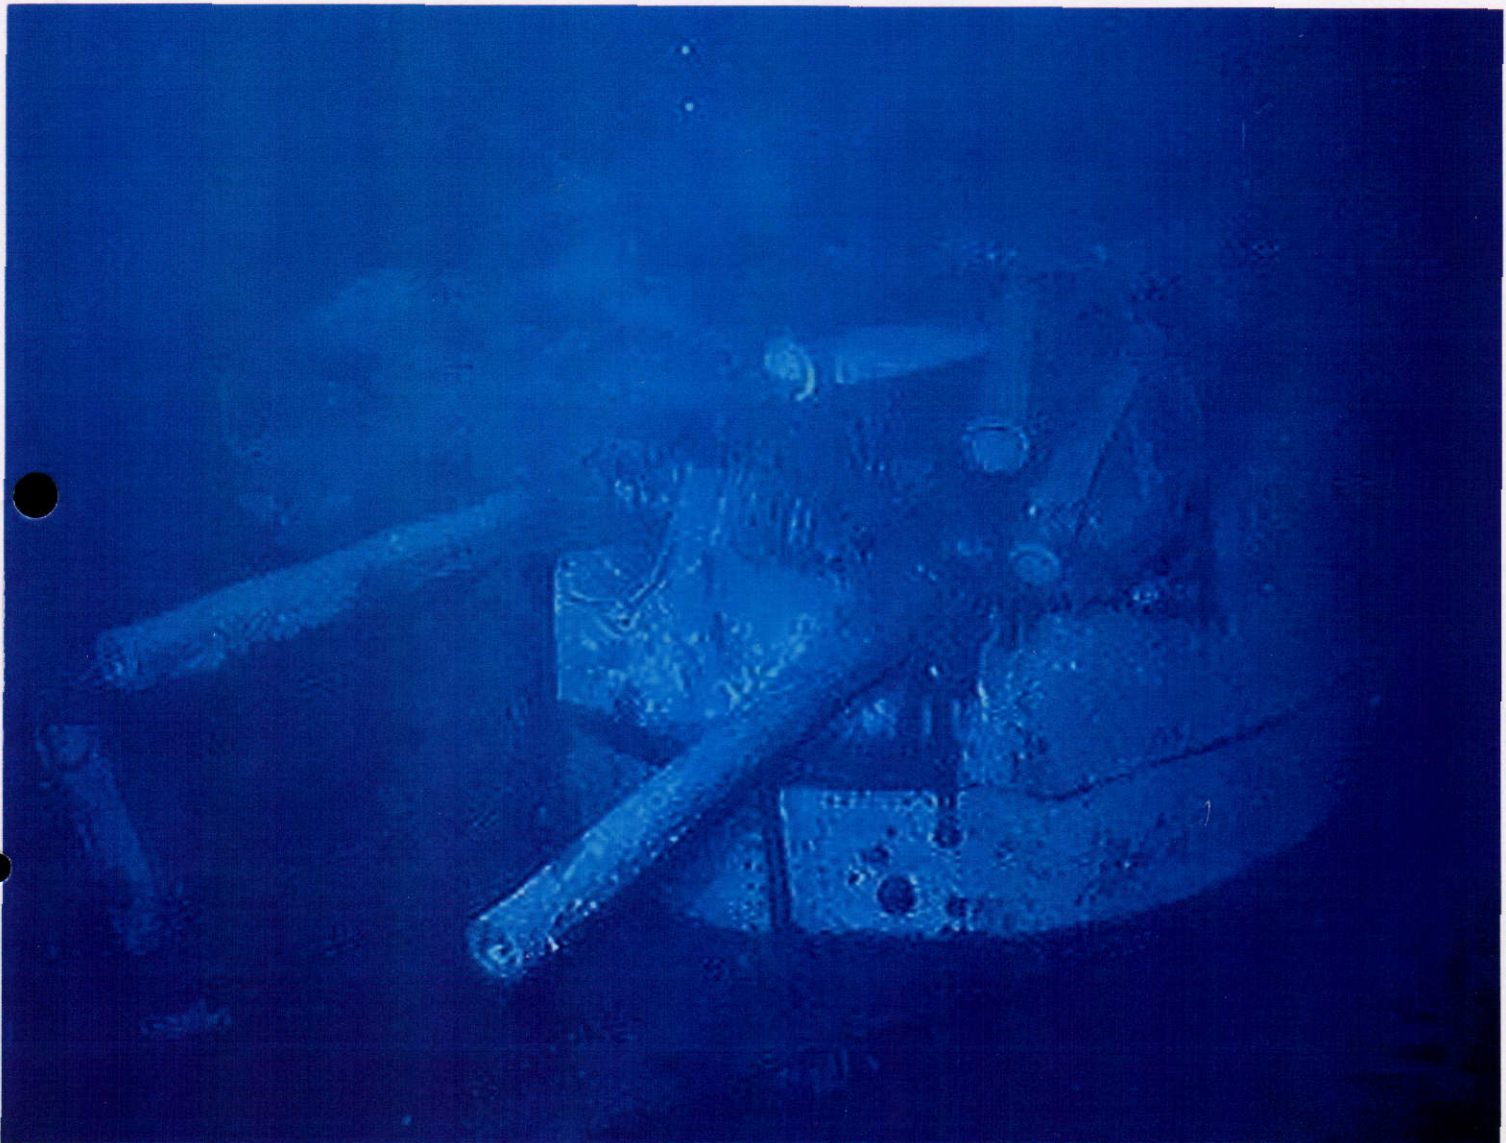
The following photograph of 'Y' turret is also of great interest in that it does not appear to be a MK XXIII turret. It shows no damage to the front of the turret and yet it has no Safety Depression Gear below each barrel, nor does it show any signs of any ever having been there. On some British ships this Safety Depression Gear was only on 'A' and 'B' turrets, but the three Australian Modified Leander cruisers had it on all turrets. There are any number of photographs available that show this quite clearly.

The turret also appears to have a fishing net draped over it and the tubes on top of it are not rounds from the 4" guns, but seem to be pipes. The left hand one has something going into the end of the pipe, either net or silt. The turret also appears to be the wrong shape as well. It appears too narrow and round rather than wider and flatter. (See comparison photographs).
