SUBM.001.0125

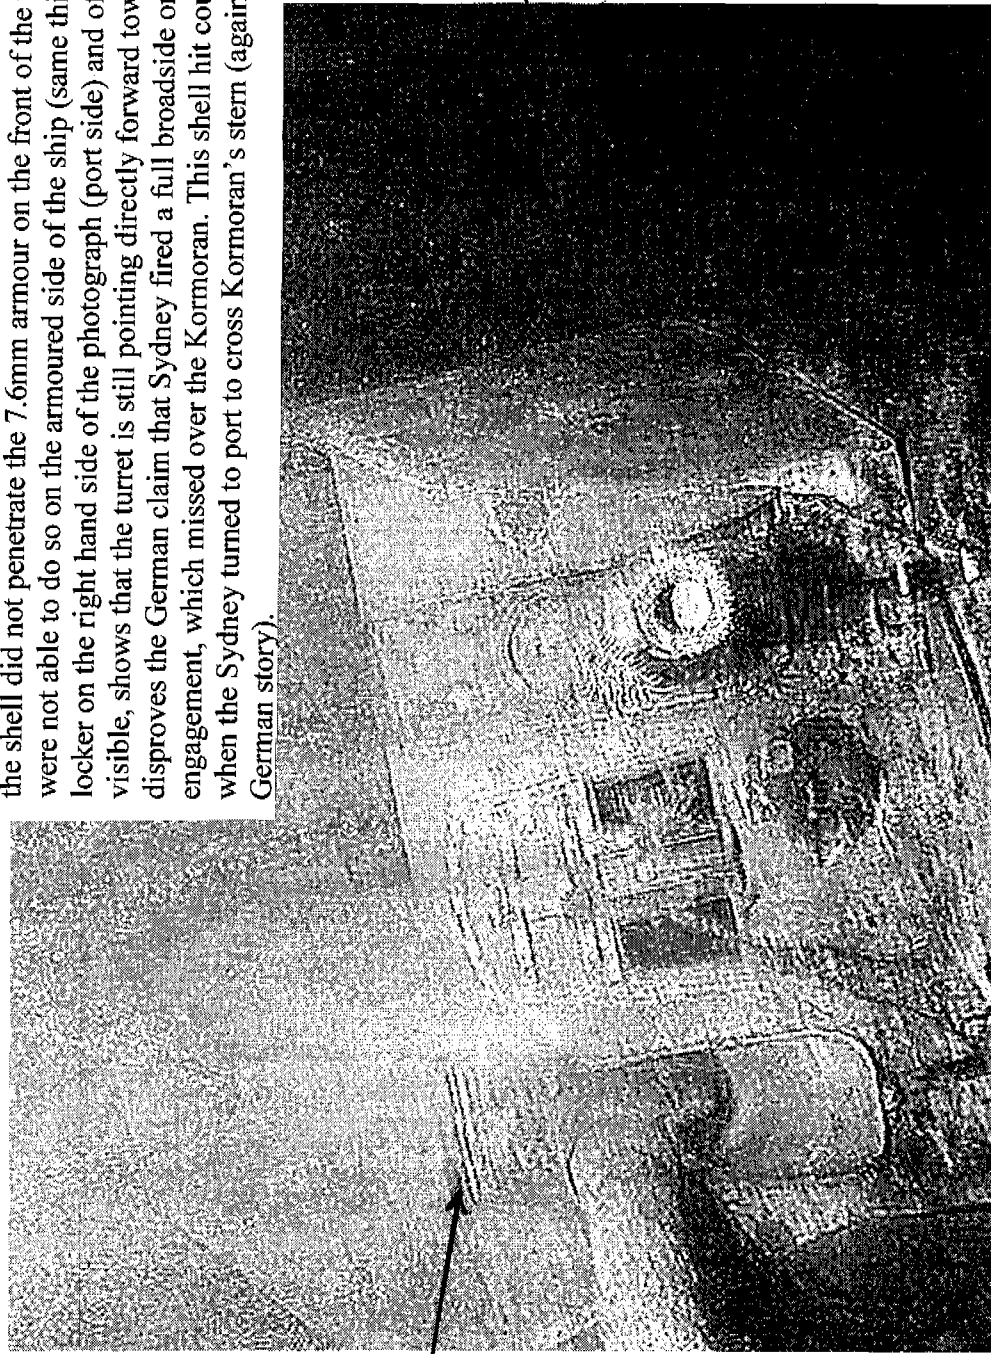
'B' turret in the photographs shows a direct hit in the middle of the turret, but it is clear the shell did not penetrate the 7.6mm armour on the front of the turret, just as the shells were not able to do so on the armoured side of the ship (same thickness armour). The locker on the right hand side of the photograph (port side) and of the turret, which is just visible, shows that the turret is still pointing directly forward toward the bow. This disproves the German claim that Sydney fired a full broadside on opening the engagement, which missed over the Kormoran. This shell hit could only have taken place when the Sydney turned to port to cross Kormoran's stern (again only according to the German story).

Square top on gun port at top - this gun could only elevate to about 50° not 60° that Sydney could do.

Locker on deck shows turret facing forward. The turret never fired to port as the Germans all Claimed.
