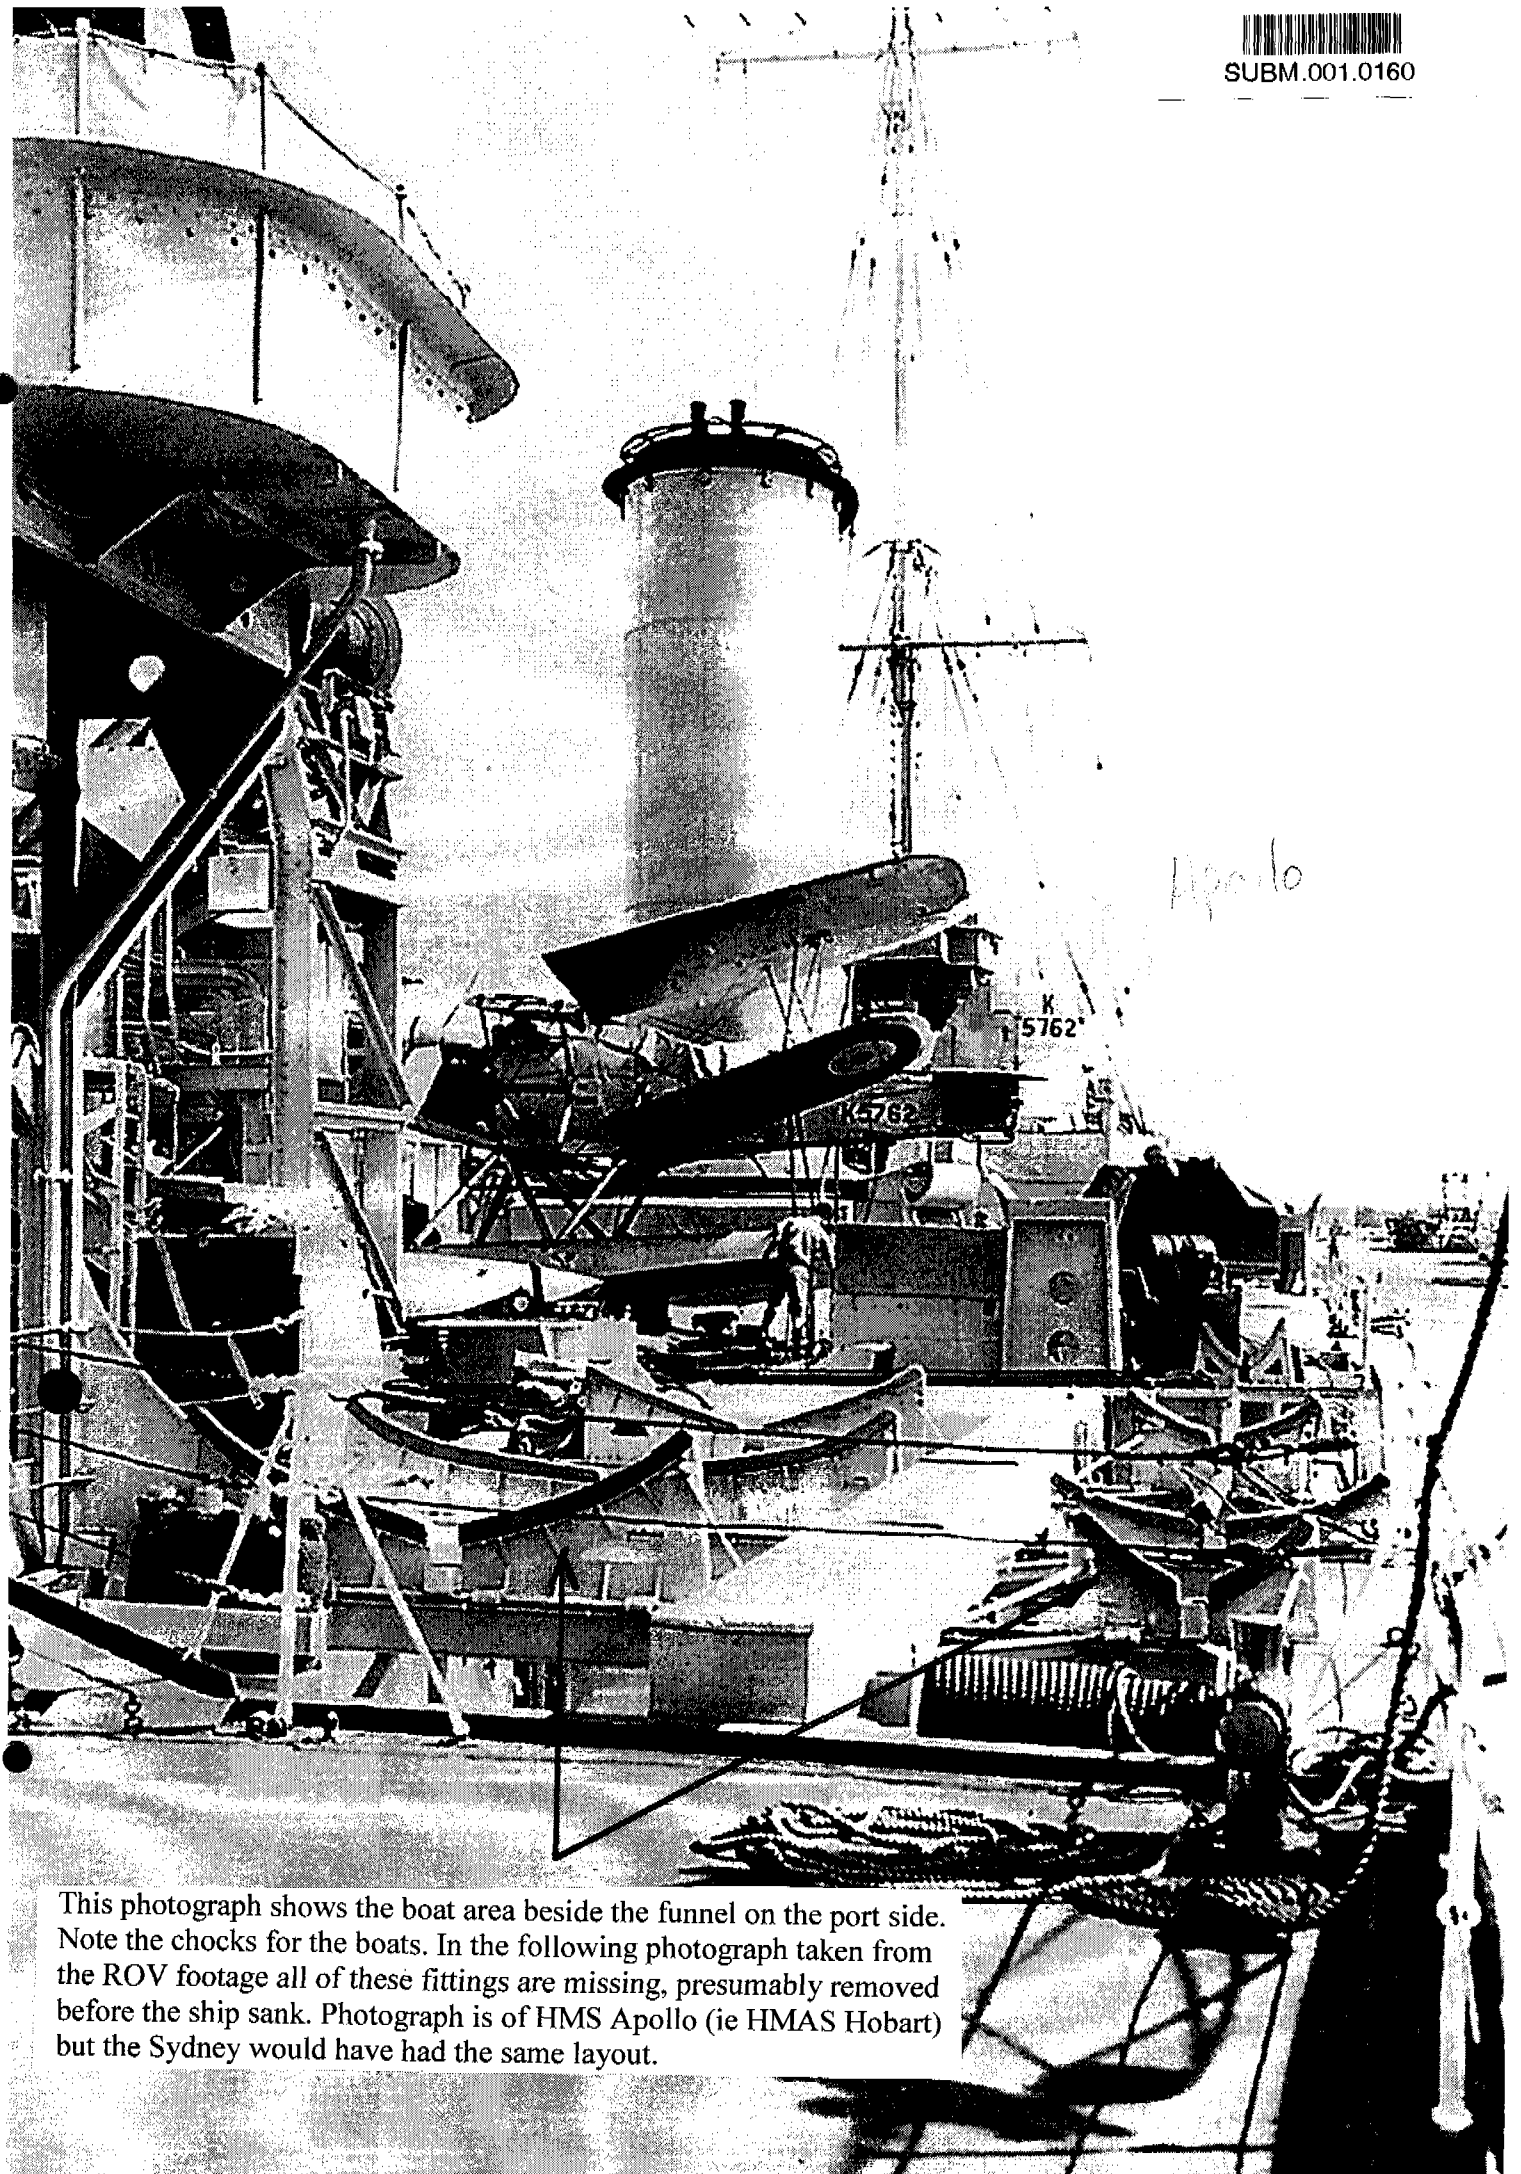
This photograph shows the boat area beside the funnel on the port side. Note the chocks for the boats. In the following photograph taken from the ROV footage all of these fittings are missing, presumably removed before the ship sank. Photograph is of HMS Apollo (ie HMAS Hobart) but the Sydney would have had the same layout.
