## Randwick Barracks

Preliminary Site Investigation

IH107200-500-NP-RPT-0002 | FINAL

Defence Housing Australia

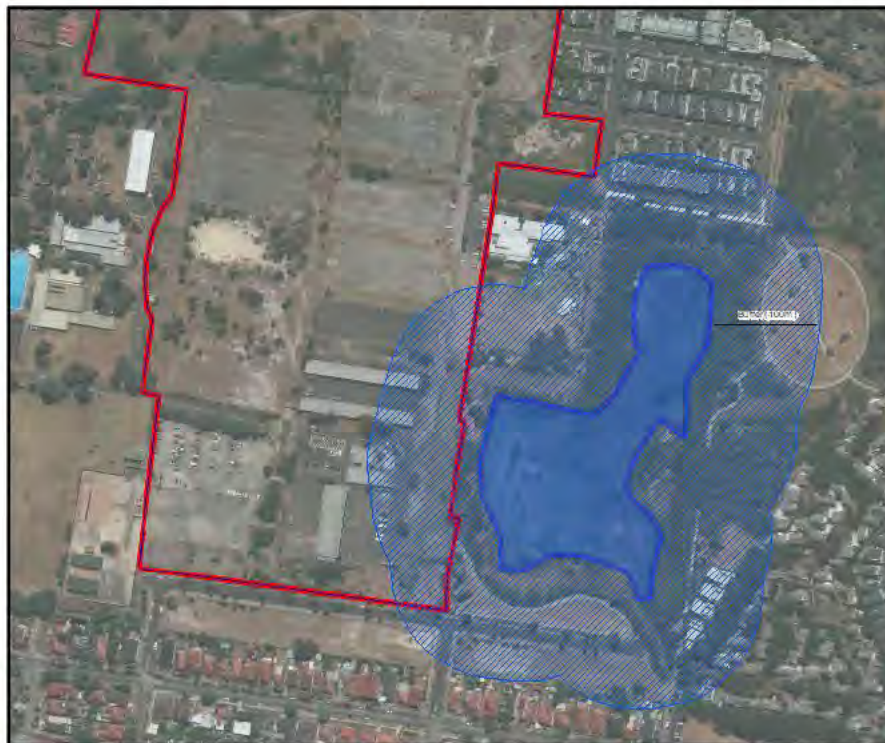
Figure 4.1: Randwick Environmental Park; Coastal Wetlands area (solid blue), and proximity to coastal wetlands area (hashed blue). Site boundary indicated in red.

Following a review of the Coastal Wetlands and Littoral Rainforests Area Map (2018) (the following Figure 4.1) it is identified that eastern portions (IP-F and IP-I) of the Site fall within land identified as 'Proximity Area for Coastal Wetlands'. With reference to the State Environmental Planning Policy (2018):

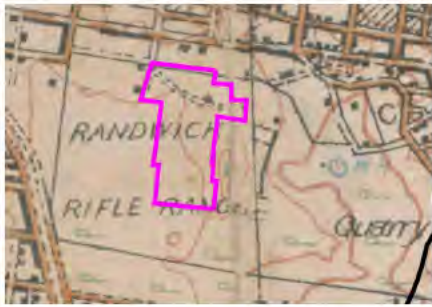
Historical map indicating the presence of Randwick Rifle Range on site, and a quarry located to the east of the Site.	Australia 1:63360, Australian Section Imperial General Staff (presented within the Lotsearch report)
1936

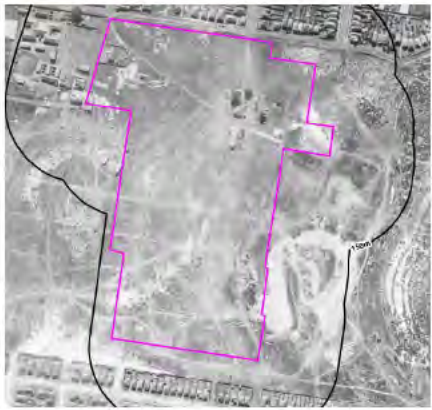
Historical aerial photograph showing the presence of the Rifle Range on Site. It is not clear from this aerial whether it is still in use, however previous reports indicate it was not in use at this time.	Aerial Imagery, Department of Finance (Present within the Lotsearch report).
1955

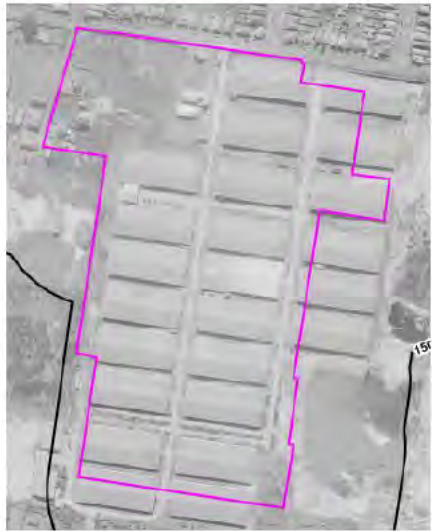
Historical aerial photograph showing the redevelopment of the Site as the Naval Stores Depot. This is consistent with the site's appearance from this date onwards until 1991 (with the exception of some minor changes). Structures in the north-west of the Site later to become associated with a community centre.	Aerial Imagery, Department of Finance, Services and Innovation (Presented within the Lotsearch report)

The Randwick Naval Stores Depot was constructed in 1943 and used for various Defence functions until 1967. Aerial images from 1943 show the Naval Stores, which consisted of 26 main stores and other buildings which stored a range of materials including machinery and dry goods. A small Transport Store building (identified as former Building 9FSB) was constructed adjacent to the retention basin on the eastern boundary of the Site between 1965-1970, which was used for administration and storage of miscellaneous (non-hazardous) items. The stores and buildings are reported to have been constructed using timber and asbestos cement cladding on concrete slabs (HLA, 2003). Store 14 was reported to have been used as a weapons equipment store and later as a hazardous material store which stored solvent, poisons, corrosives and general hazardous goods. The building is reported to have remained mostly vacant since 1998, with the exception of short-term use (CH2MHill, 2004).

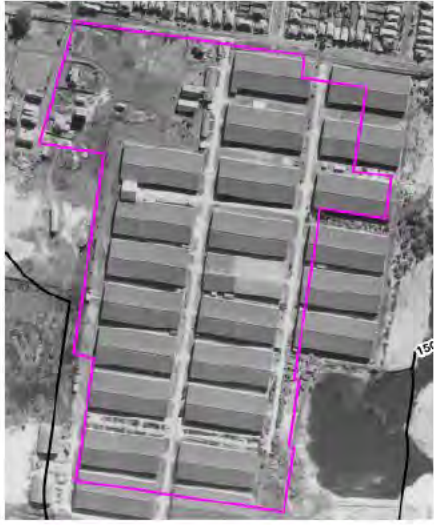
Historical aerial consistent with the previous aerial photograph.	Aerial Imagery, Department of Finance, Services and Innovation (Presented within the Lotsearch report)
1965

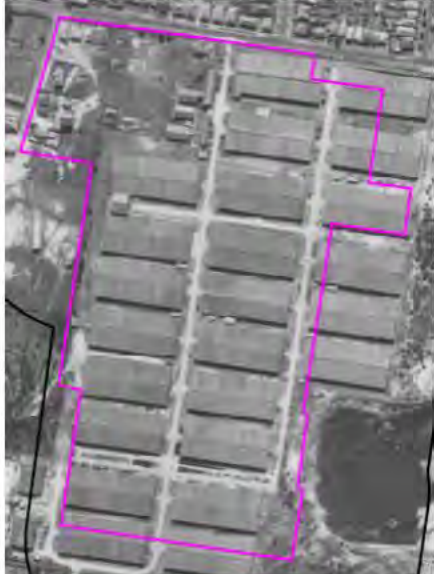
Historical aerial consistent with the previous aerial photograph, with the exception of some minor development in the north-western portions of the site.	Aerial Imagery, Department of Finance, Services and Innovation (Presented within the Lotsearch report)
1970

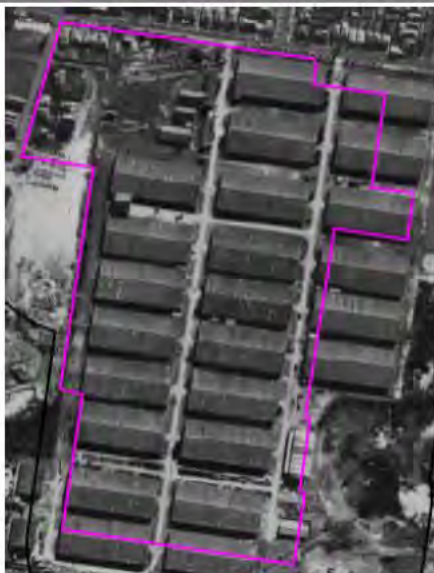
Historical aerial consistent with the previous aerial photograph. Minor changes to the now Randwick Environmental Park are apparent to the east of the site.	Aerial Imagery, Department of Finance, Services and Innovation (Presented within the Lotsearch report)

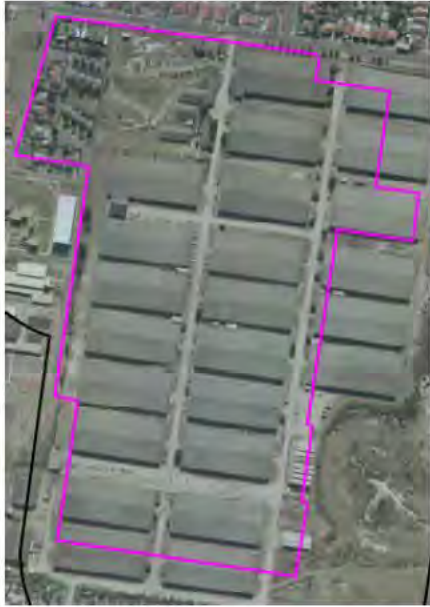
Historical aerial consistent with the previous aerial photograph. Residential development now present in the north-western portions of the site.	Aerial Imagery, Department of Finance, Services and Innovation (Presented within the Lotsearch report)
1991

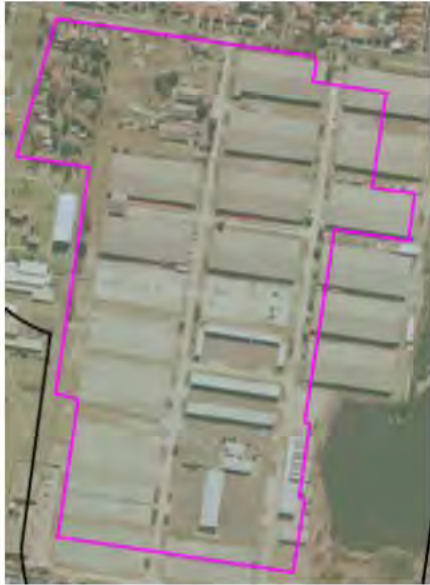
Historical aerial photograph showing the demolition of storage facilities/warehouses and redevelopment of the southern portion of the Site.	Aerial Imagery, Department of Finance, Services and Innovation (Presented within the Lotsearch report)
2007

CMPS&F (1995) reported that Stores 1 and 2 were removed between 1986 and 1991, although the aerial photograph from 1991 suggests that instead Stores 3, 5 and 7 were demolished between 1986 and 1991 and replaced by infrastructure associated with the Army Transport Compound (refer to Figure 3, Appendix A). Egis (1999) reports that the Army Transport Squadron took over the southern portion of the Site in 1984 for minor general repairs and vehicle maintenance.

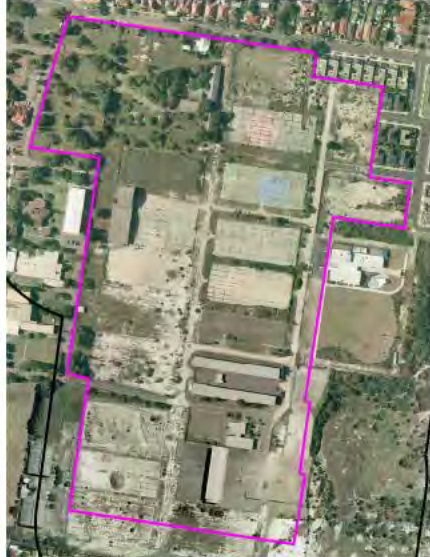
Historical aerial showing further demolition in the northern portions of the site. Demolition of housing associate with the site on the north-west boundary and some minor demolition of the community centre in the north-west of the site.	Aerial Imagery, Aerometrex Pty Ltd (Presented within the Lotsearch report)

Demolition of the Naval Stores occurred progressively between 1986 and 2009. Demolition is understood to have caused widespread scattering of asbestos cladding fragments across the Site.

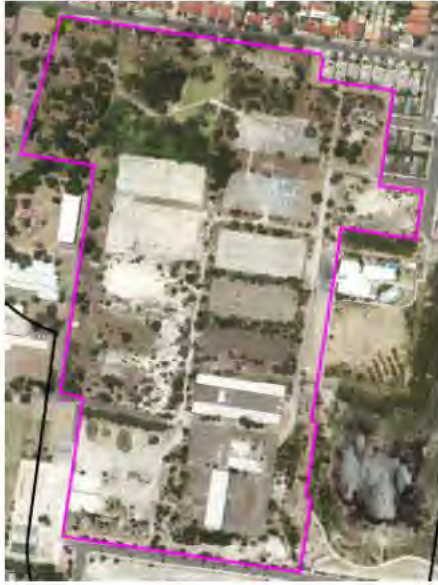
Complete demolition of the community centre in the north-west of the site.	Aerial Imagery, Aerometrex Pty Ltd (Presented within the Lotsearch report)

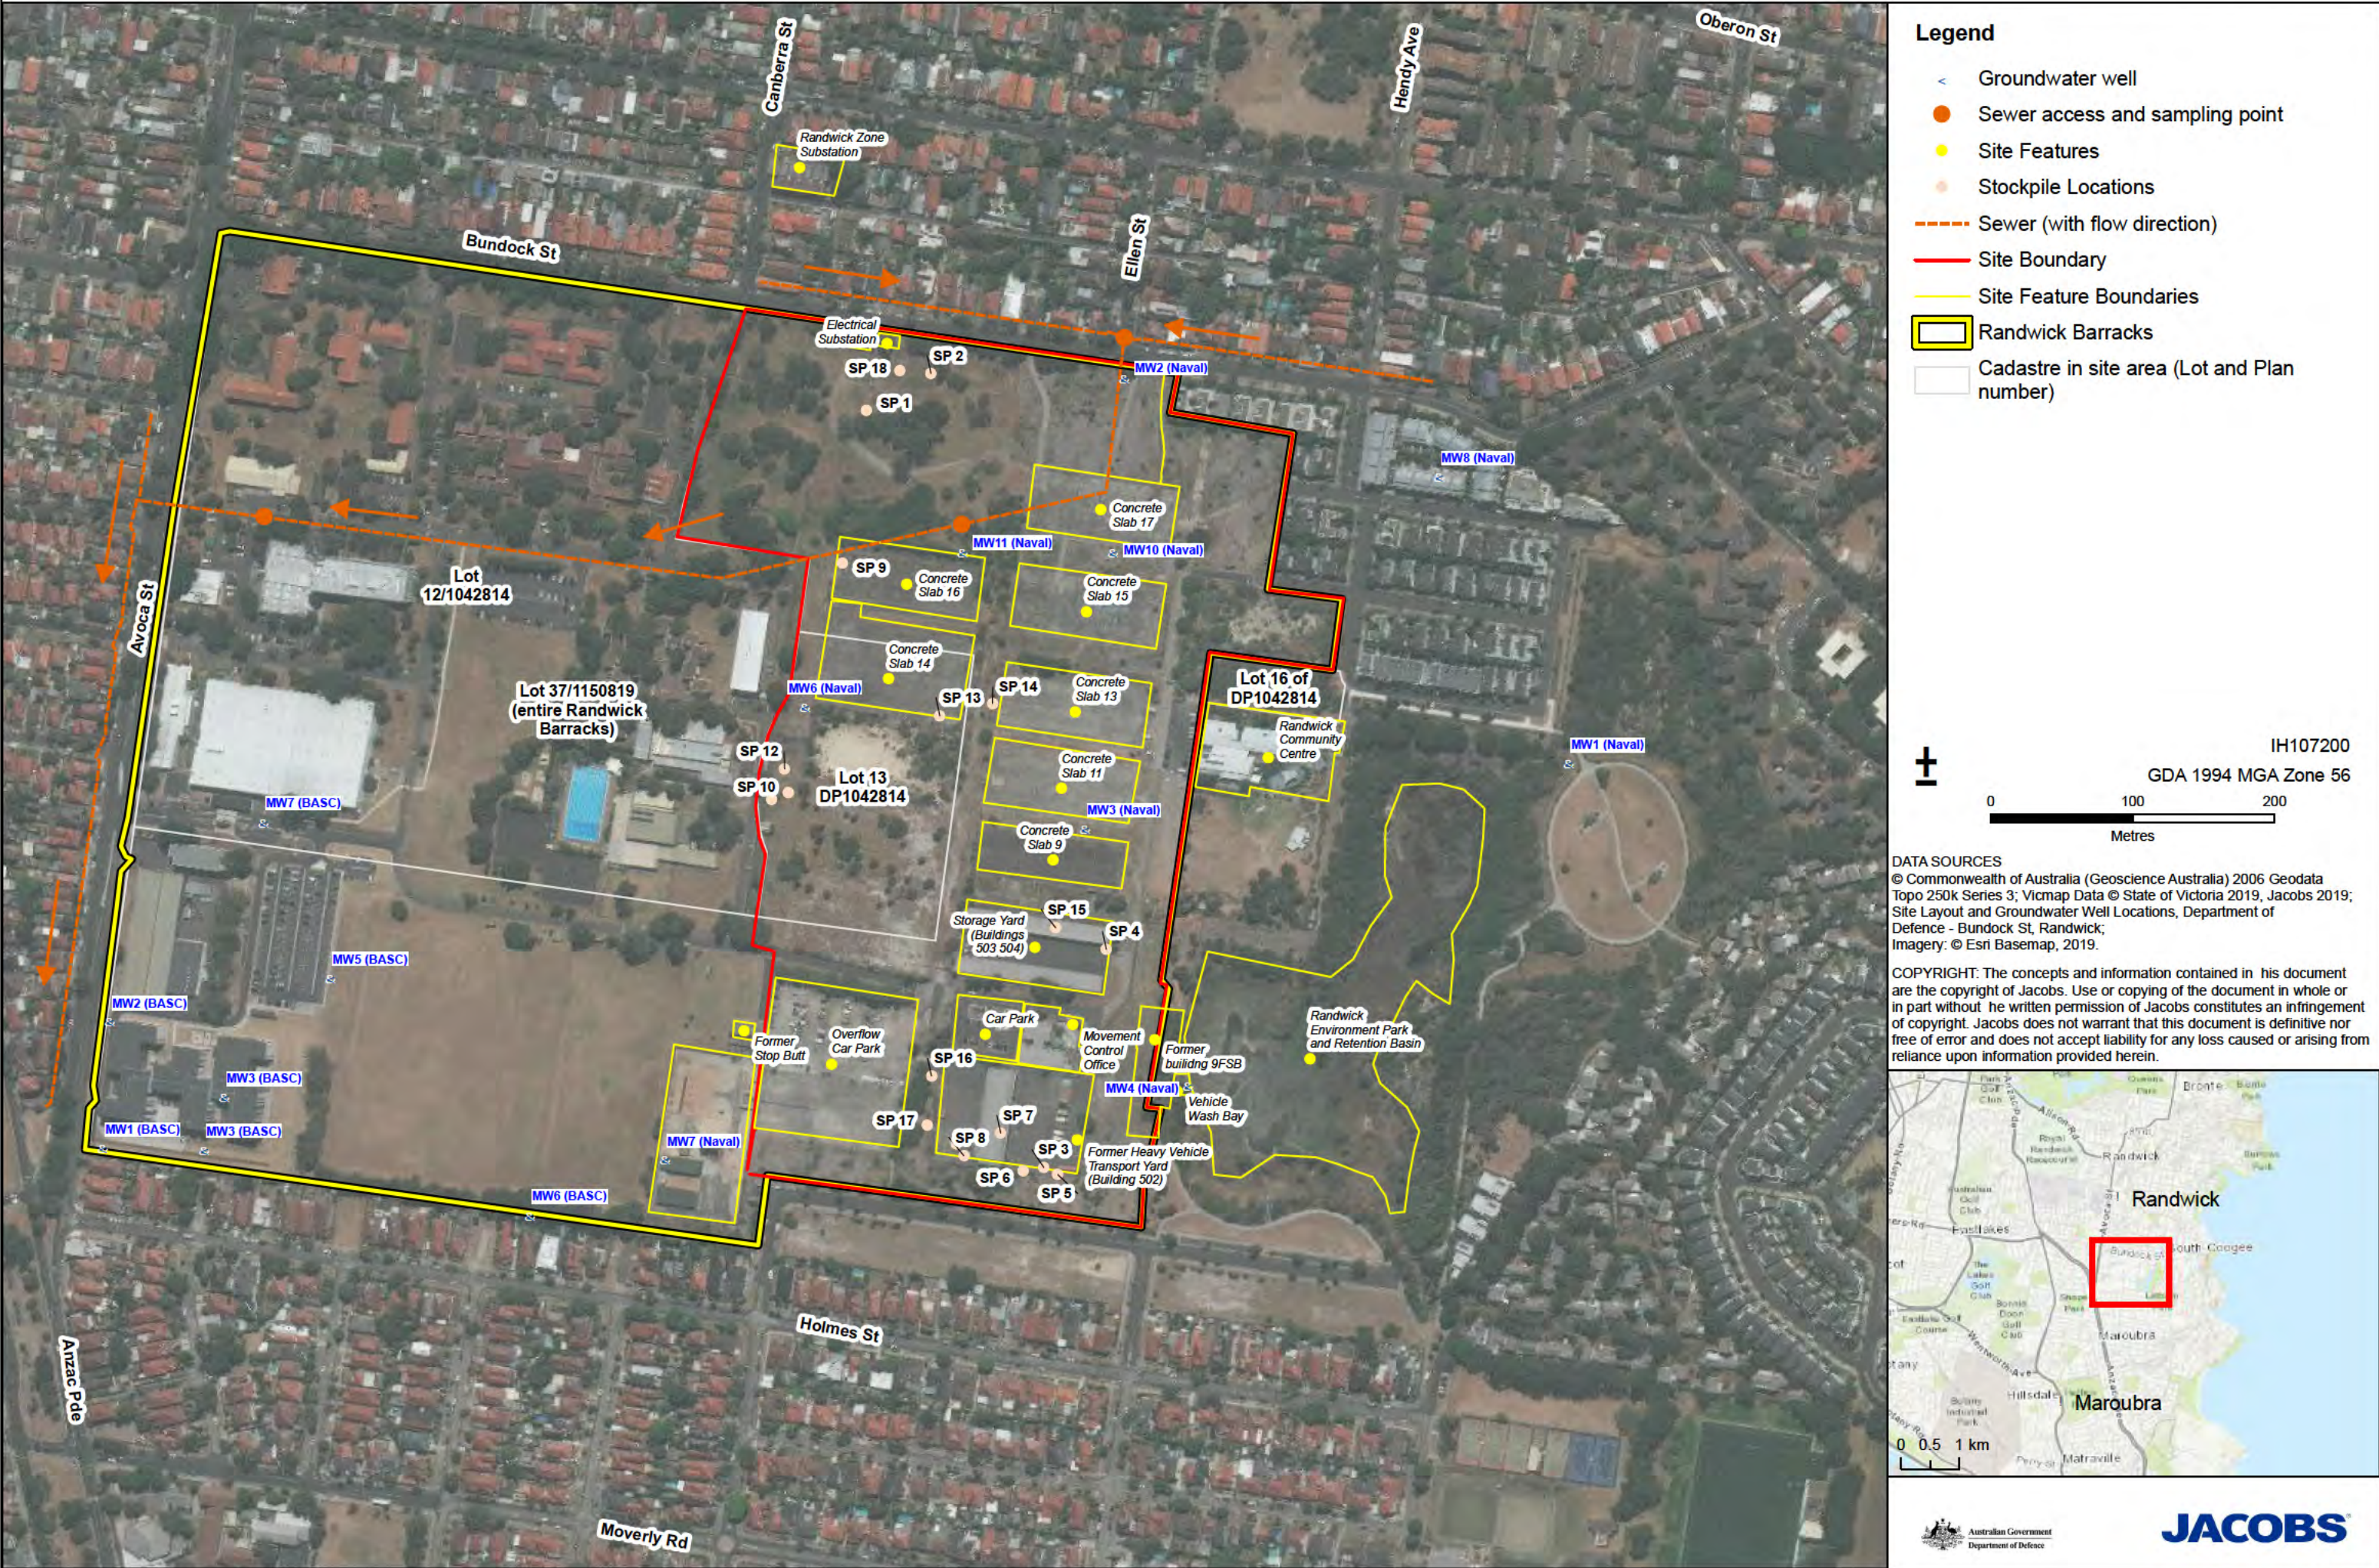
Figure 2: Site Features

Site Features / Structures	<p>Northern Portion of Site</p> <ul style="list-style-type: none"> <li>• An electrical substation backs onto Bundock Street in the north western portion of the Site. Two stockpiles were noted directly south (soil) and east (soil and some vegetation) of the substation building.</li> <li>• A rock lined drain was observed running north-south from the northern Site boundary to concrete slab 17.</li> <li>• Remnants of the former residential areas were observed (i.e. light poles, sections of road).</li> </ul> <p>Central Portion of Site</p> <ul style="list-style-type: none"> <li>• The dominant Site features observed were six concrete slabs (former Naval Store Depot footprints) covering the majority of the central portion of the Site.</li> <li>• Two shipping containers (contents unknown) were present on the south-eastern corner of concrete slab 9.</li> <li>• Evidence of removed concrete slabs (former Naval Stores 8, 10, and 12 (see Appendix A, Figure 3), including concrete guttering and edging and associated infrastructure (hydrants and boosters) were observed.</li> <li>• An excavation (approximately 40m X 100 m X 2.0 m deep) was observed at the location of former Naval Store 12.</li> <li>• A small excavation (approximately 0.2 m deep) observed at the western end of and between concrete slabs 9 and 11.</li> </ul> <p>Southern Portion of Site</p> <p>Site features observed within the precinct include the Storage Yard, Movement Control Office and carpark, overflow carpark and Former Heavy Vehicle Transport Yard (currently used as a site office and storage area for contractors undertaking electrical works).</p> <p>The Storage Yard was observed to contain the following:</p>	Appendix A, Figures 2 and 3

Spoil and stockpiles	<p>A total of 19 stockpiles were observed across the Site. Observations of each stockpile are detailed below:</p> <p>Soil / Fill Stockpiles</p> <p>SP1 - Stockpile of sandy fill/soils (approximately 27m x 2m x 1 m) south of the electrical substation. The fill materials appear to have been derived from recent works undertaken at the sub-station.</p>	Appendix A, Figure 2

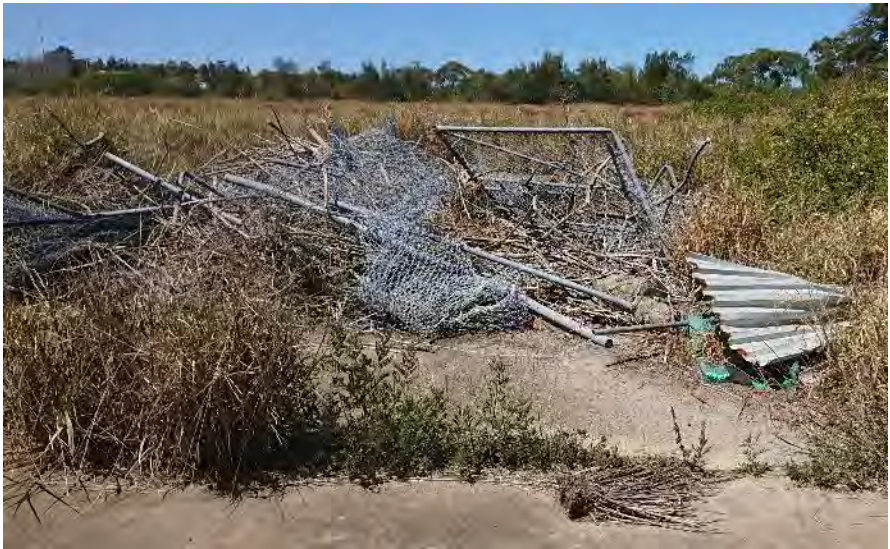
Photo No.	7

Date:	14/11/19	
Direction photo taken:	South	
Description: Stockpile of fencing, irrigation pipe and potential ACM pipe (SP9) observed on the western edge of concrete slab 16.

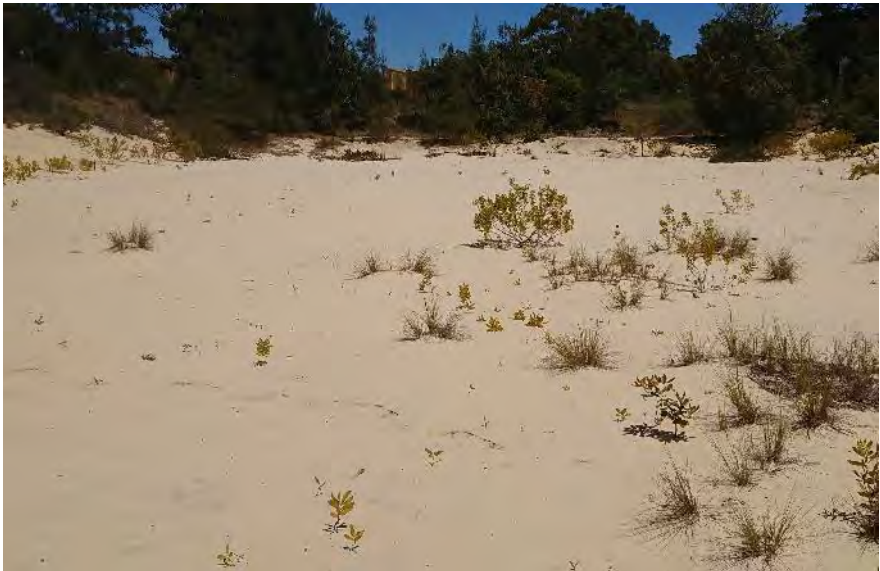
Photo No.	8

Date:	14/11/19	
Direction photo taken:	West	
Description: Excavated area north of concrete slab 16 on the western portion of the Site.

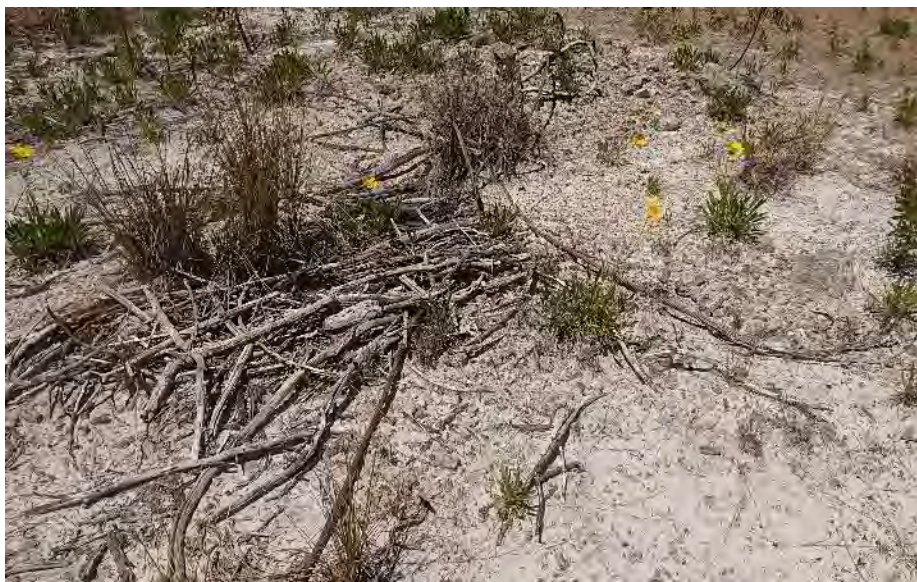
Photo No.	9

Date:	14/11/19	
Direction photo taken:	South	
Description: Sections of steel cable and concrete rubble observed on the western portion of the Site.

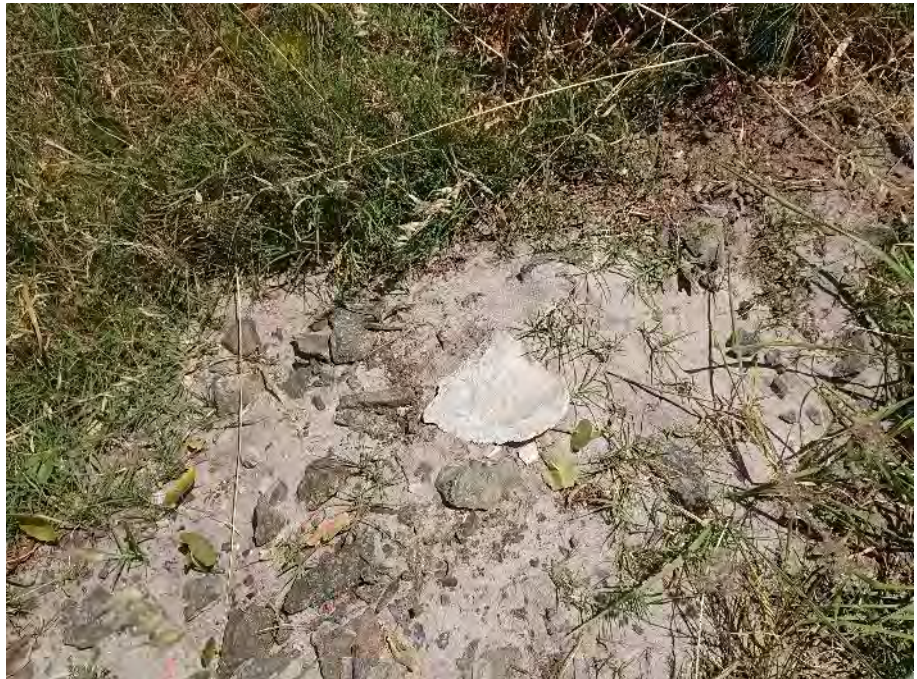
Photo No.	12

Date:	14/11/19	
Direction photo taken:	-	
<p>Description:</p> <p>Fragment of potential ACM observed in material from the excavation between concrete slabs 1 and 2.</p>

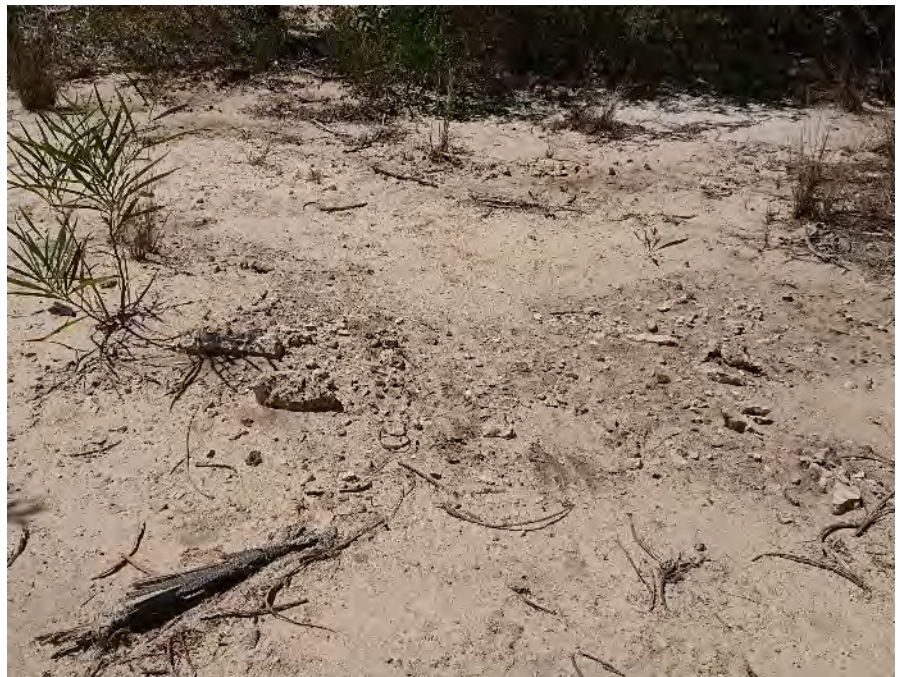
Photo No.	13

Date:	14/11/19	
Direction photo taken:	-	
<p>Description:</p> <p>Concrete rubble observed across the surface of the western portion of the Site.</p>

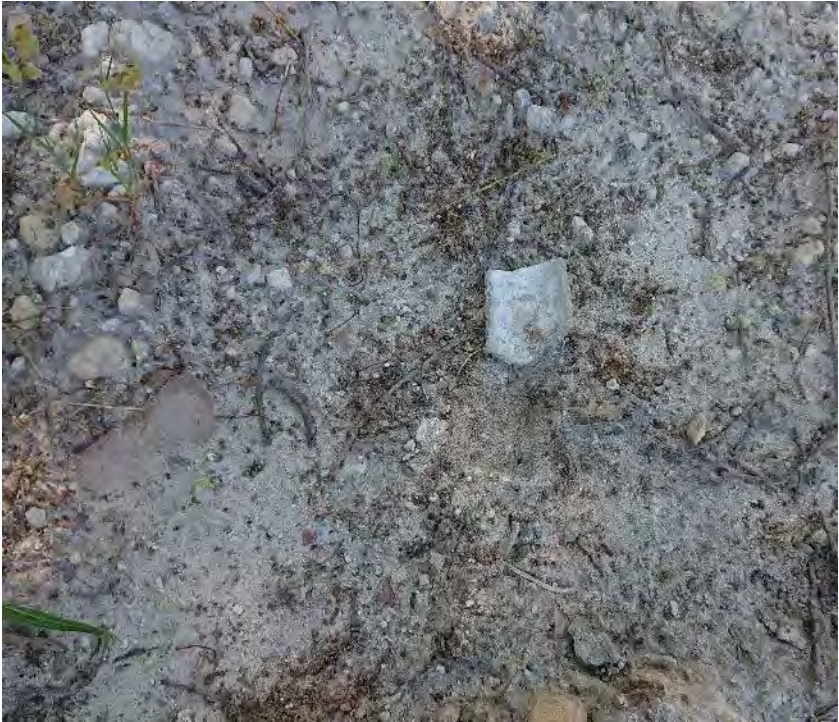
Photo No.	20

Date:	14/11/19	
Direction photo taken:	-	
Description: ACM fragment observed on the surface of the north western portion of the Site.		
Photo No.	21

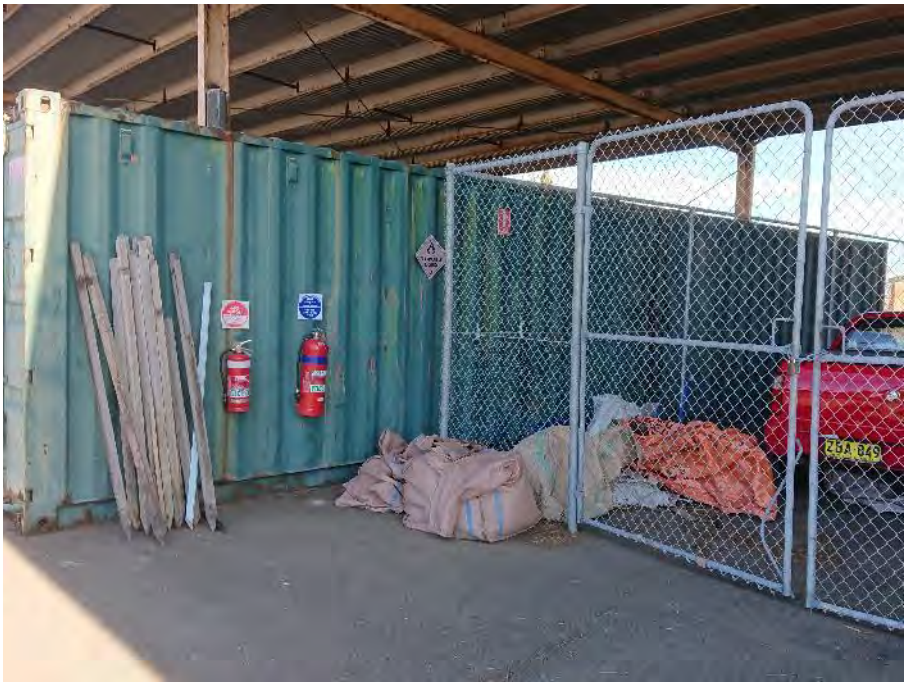
Date:	14/11/19	
Direction photo taken:	South East	
Description: Flammable liquid store located in the storage yard on the southern portion of the Site.

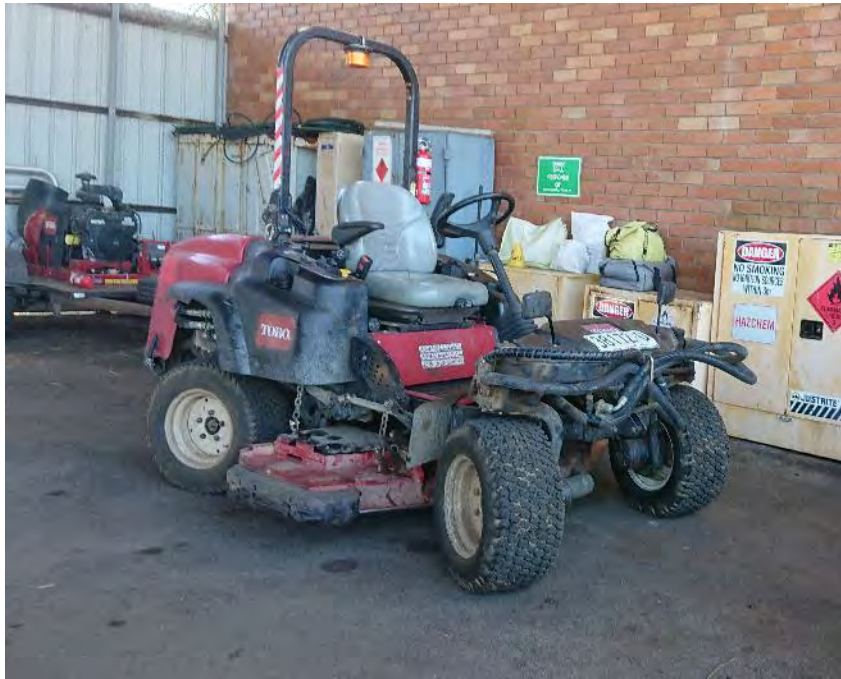
Photo No.	22

Date:	14/11/19	
Direction photo taken:	South West	
Description: Minor surface staining around mower in the storage yard on the southern portion of the Site, flammable liquid storage cabinets can be seen in the background.

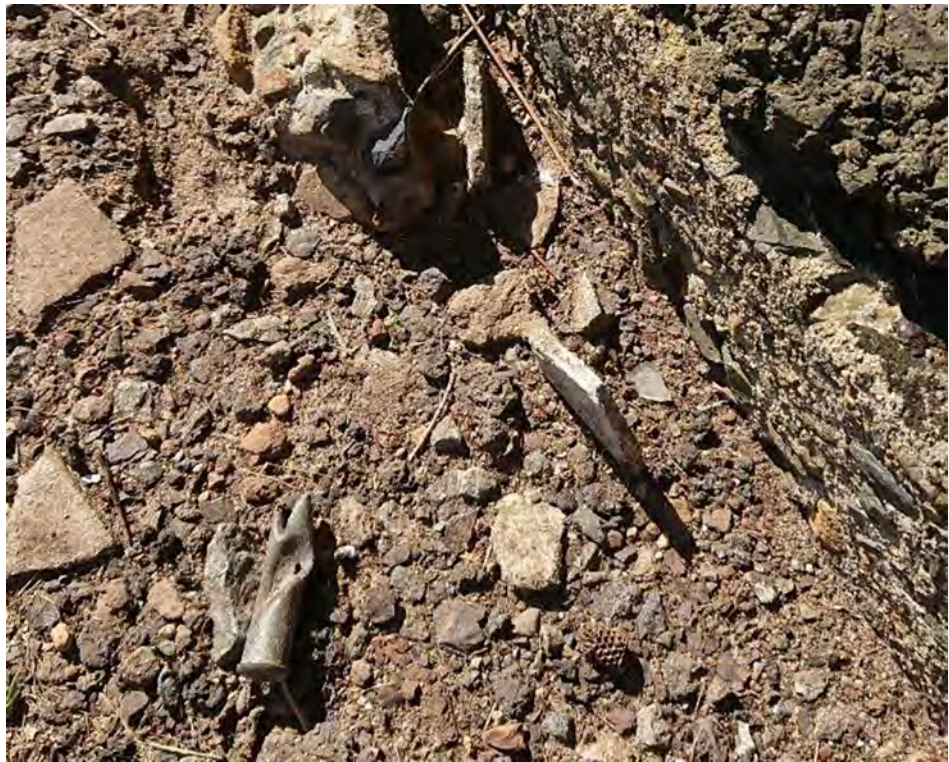
Photo No.	23

Date:	14/11/19	
Direction photo taken:	-	
Description: Spent shell casing and fragments of ACM observed adjacent to and directly south of the storage yard

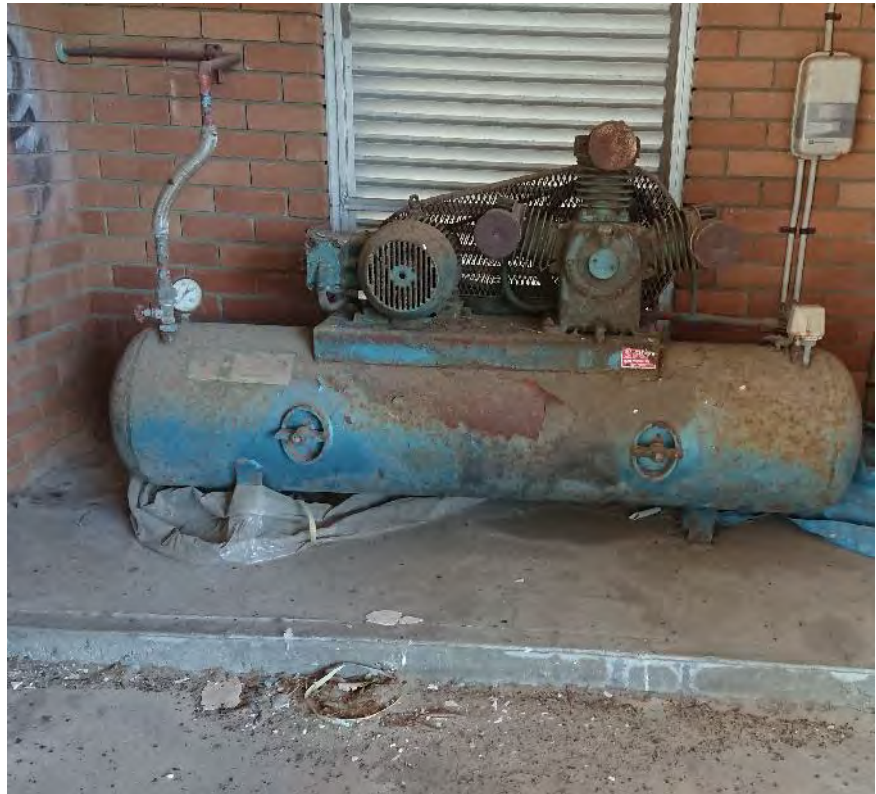
Photo No.	24

Date:	14/11/19	
Direction photo taken:	North	
Description: Staining observed under compressor at the former transport compound.

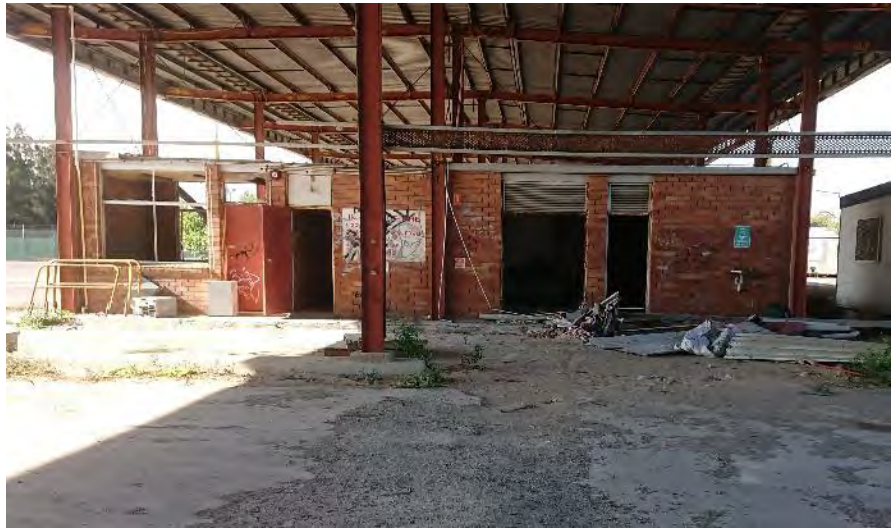
Photo No.	25

Date:	14/11/19	
Direction photo taken:	North	
Description: Former vehicle wash bay and brick building in former transport compound.

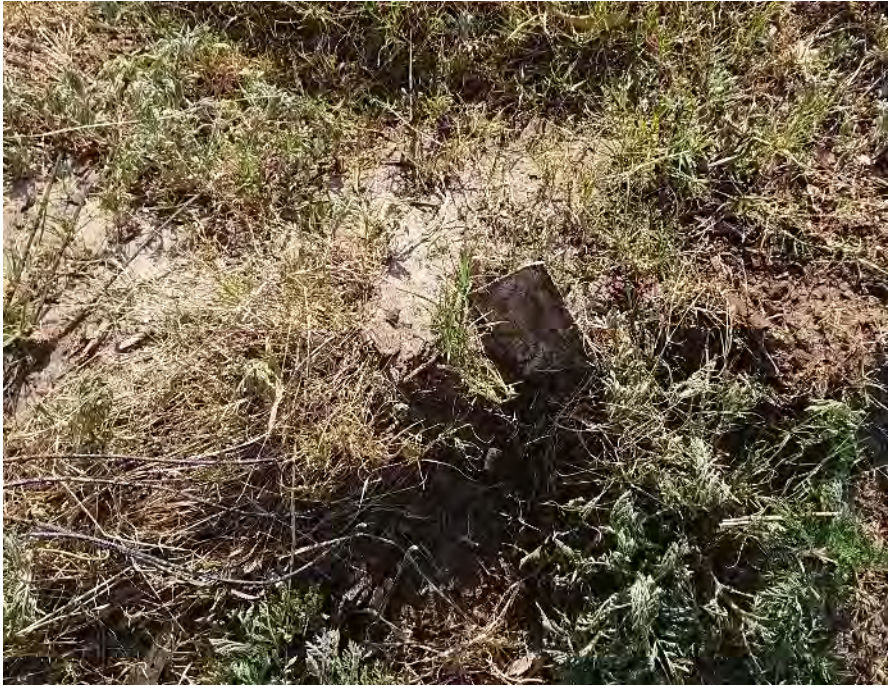
Photo No.	26

Date:	14/11/19	
Direction photo taken:	-	
Description: ACM fragment observed on the surface of the southern portion of the Site south of the former transport compound.		
Photo No.	27

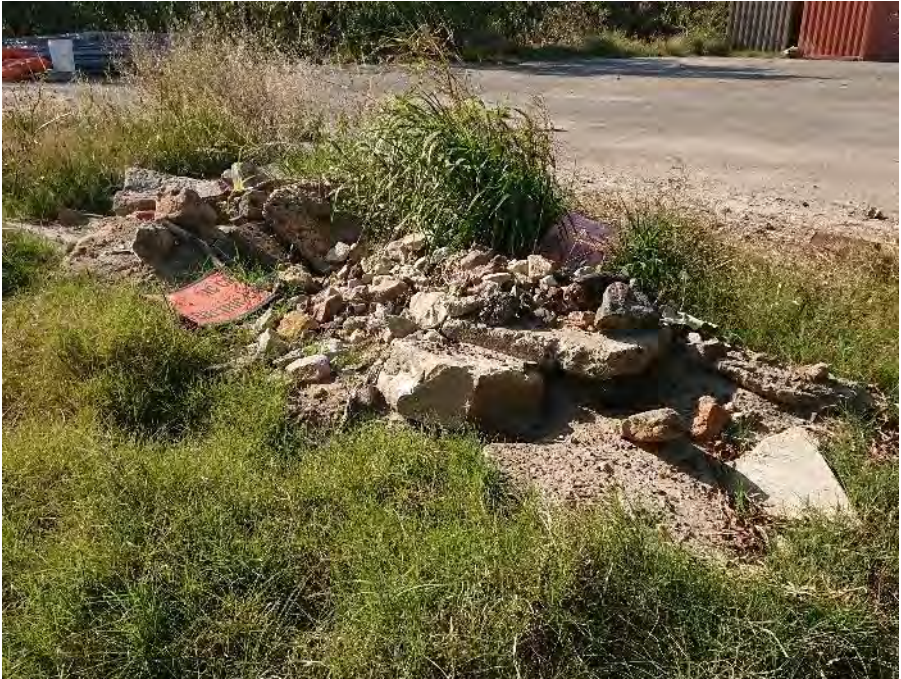
Date:	14/11/19	
Direction photo taken:	North west	
Description: Stockpile of construction rubble observed on the surface of the southern portion of the Site south of the former transport compound.

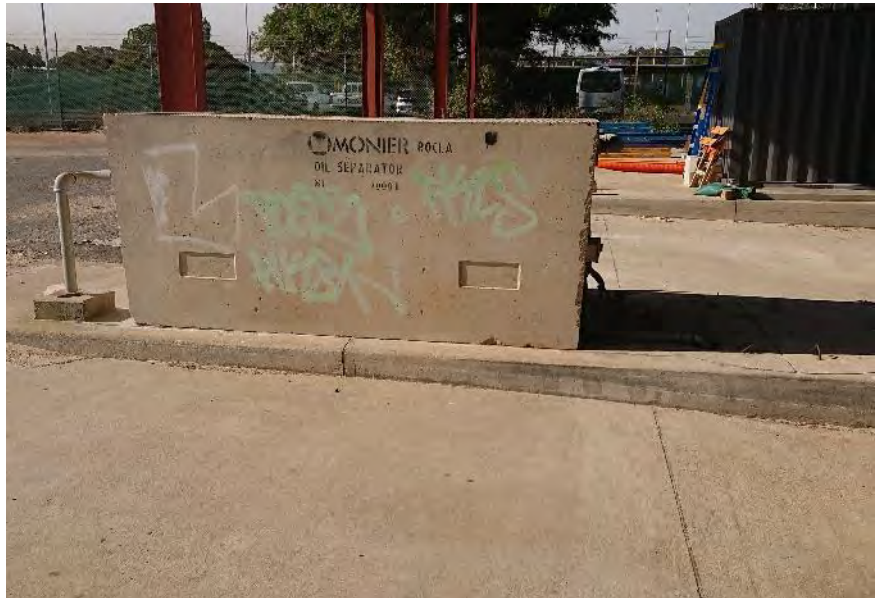
Photo No.	28

Date:	14/11/19	
Direction photo taken:	North	
Description: Oil water separator and collection pit observed adjacent to vehicle inspection ramp and two vehicle inspection pits in the former transport compound on the southern portion of the Site..
