Victoria Barracks Brisbane

Heritage Asset Action Plan

11 November 2022

Project No.: 0634873

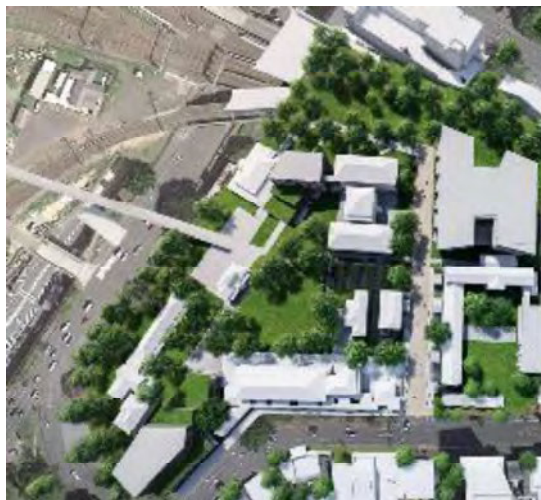
Figure 3.3 VBB Master plan (Conrad Gargett, 2015)

Around the time of Draft Strategy development, Conrad Gargett was engaged to prepare design an architectural concept plan as part of a broader Urban Renewal Master plan for VBB.⁵ New approaches to the existing buildings and site were developed and tested following workshops with Council and heritage and urban/cultural landscape analysis. The Master plan 'aimed to tell the unique story of the site through a visitor centre, museum, artefacts and heritage walking trail while retaining and enhancing the Defence presence on site.'

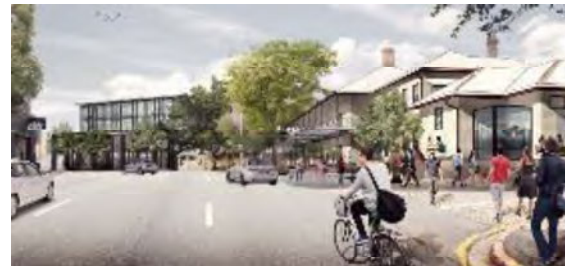
Figure 3.4 VBB Master Plan Render – Petrie Terrace visualisation (Conrad Gargett, 2015)

New uses for heritage buildings were identified, based existing form, scale, internal layout and original function. Proposals for new buildings highlighted the requirement to be sensitive to siting and to respect existing heritage buildings while enabling a commercially viable redevelopment. Overall, the Master plan aimed to create a new, permeable mixed use precinct improving the amenity of City West through hotel accommodation, functions, retail, community functions and quality public realm.

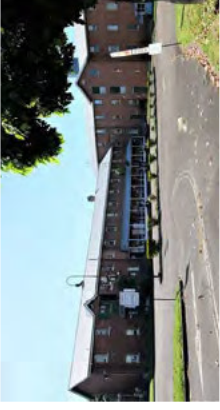
A1a Administration (Former Tailor's Workshop/Armoury)

A1a is a long block with a corrugated iron gable roof, originally built as a 2-storey tailor's workshop and residence armoury, store fronting Blackall Street during the Queensland Defence Force (1885-1901) period. External walls are original face brick. A single entrance off Blackall Street leads to a split level original stairs. Chimney on east side of the traverse entrance and fireplace (now boarded) serviced what were the original tailors' quarters and workshops. Timber verandah leads to VBB Recreation Room in A1b. Verandah is comprised of timber decking and simple post and rail balustrading, punctuated by four sets of short concrete steps to the expansive central courtyard.

- Rectify failing mortar and loose face bricks
- Blocked drainage—check outlet
- Gaps between sills and window frames
- Repair and repaint windows
- Rectify Spalling sills
- Rust treatment to downpipes

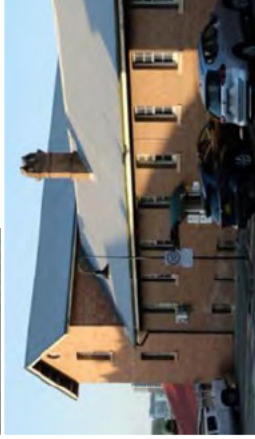
- Setting—Blackall Street streetscape frontage and courtyard shared with A1b and A1c
- Building form, including visual evidence of construction phases in masonry
- Roof form and pitch, including chimney and gable to south-west elevation
- Hoist pulley mechanisms at gable and associated opening
- Unpainted exterior brick walls
- Fenestration arrangement, form, and all associated original or early fabric (double hung sash timber windows, stone sills, header brick course, remnant bars)
- Staircases—location and fabric
- Interior doors with transoms
- Original ceilings including timber boarded ceiling linings and corncicing
- Wrought-iron structural system
- Fireplaces
- Chubb safe (First Floor)
- All original hardware

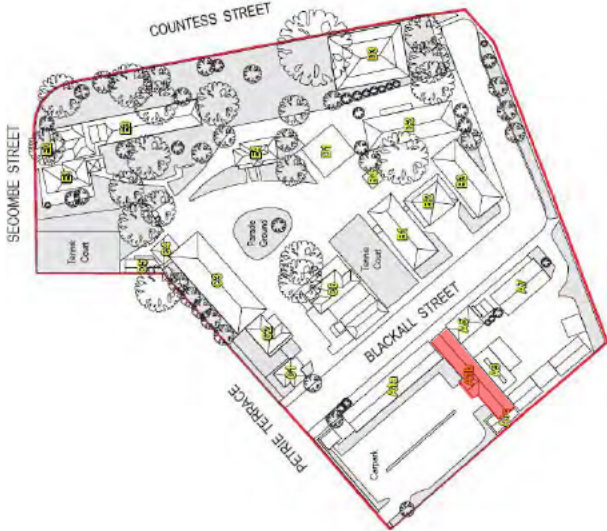
Building condition and integrity are good. External weathering and areas of inappropriate repairs to brickwork and mortar noted. Reversible internal planning changes have occurred but original/early room configuration are legible. Changes include wall partitions, false ceilings, toilet and tearoom fit-outs, etc.

- Rectify spalling sills
- Safeguard and restore timber cradle (hoist component)
- Failing mortar and loose face bricks (poor prior repair jobs)
- Corrosion to downpipes and check outlet areas (drain blockages)

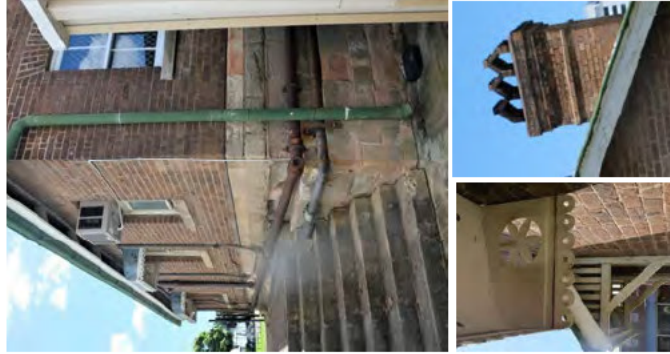
Building A1c is in good condition with fair integrity. Interior alterations for repurposing the building has occurred several times and the space is currently used as a tea room and office. Reversible internal planning changes have occurred and changes include wall partitioning and false ceilings. The original blacksmiths forge has been concealed by plasterboard.

- Setting—courtyard shared with A1a and A1b significant sight lines from Petrie Terrace
- Single storey building form
- Stone base
- Unpainted brickwork
- Chimney with protruding banding and decorative brickwork
- Gable roof form and pitch
- Fenestration and door placement
- Timber sash windows and stone sills
- Remnant forge fabric
- Metal bullnose window hoods and single timber strutted door awning
- Timber boarded ceiling lining

- Remove or relocate select redundant pipes that are causing damage to base stone course
- Remove or relocate connecting downpipe from A1b
- Check damp proof course
- Rectify spalling sills
- Repair and repaint timber windows
- Check corrosion to metal window hoods and repaint
- Remove A/C units from windows and install replica glazing

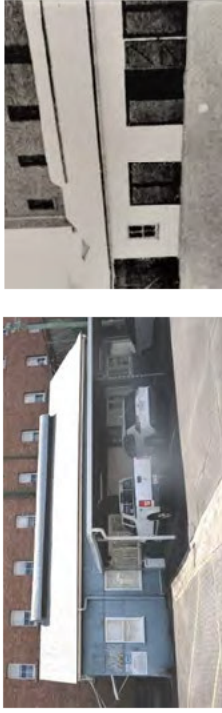
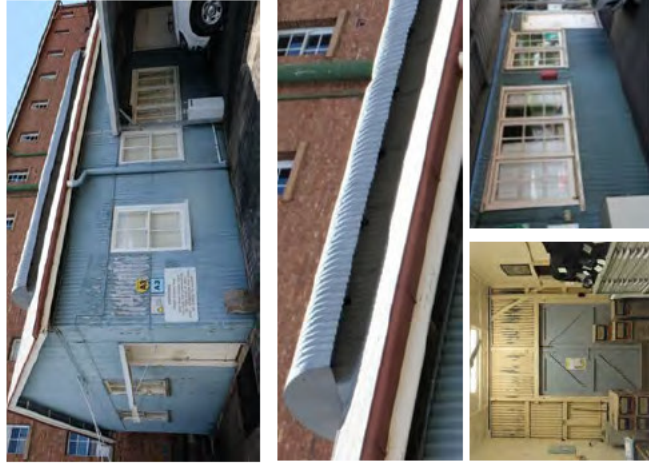
A3 — Q Store (Artillery Gunpark)

The condition and integrity of Building A3 is fair. Alterations have been made to the building's façade and only one original entrance remains (other doors have been replaced by windows). Side and rear fenestration may be original. Wall re-sheeting has occurred (probably several times during its 100+ year lifespan). Carport detracts from the building's appearance. Original timber tongue and groove wall panelling and early room configuration remains intact.

- Building form and roof form/pitch
- Corrugated metal sheeted walls
- Timber sash windows and sills
- Original double door entrance
- Tongue and groove walls to interior and timber lined ceiling (original layout)

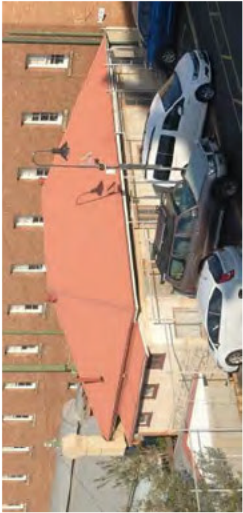
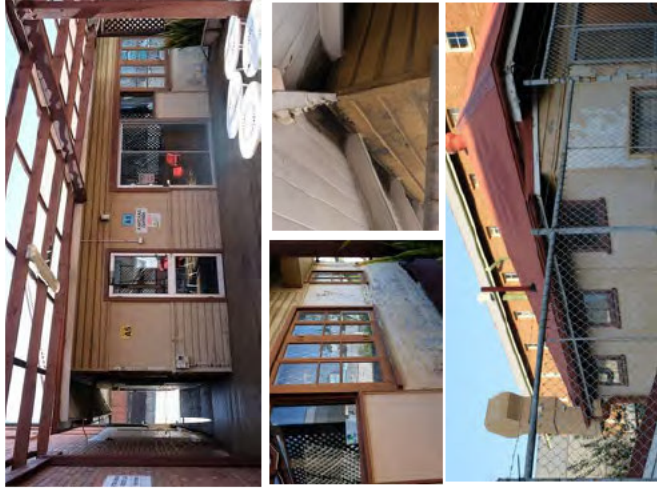
Building A5 is a single-storey timber-framed building supported on concrete stumps and clad with chamferboard and fibre cement panels. It has a hipped corrugated Colorbond roof and has been used as a canteen since its erection in 1940. It is adjacent to Blackall Street, however is situated lower than the street and 'tucked behind' Building A1b. It does not present an obvious building frontage that might contribute positively to the Blackall Street streetscape aesthetic, as the dominant visual element is the roof. The building's surrounds are further obscured by an unsympathetic external timber deck that

The condition and integrity of Building A5 is fair.

- Exterior finishes—repaint flaking corrugated sheeted walls
- Recondition and repaint timber sash window frames
- General exterior clean
- Remove or upgrade unsightly timber screening and deck
- Consideration should be given to reversing unsympathetic alterations

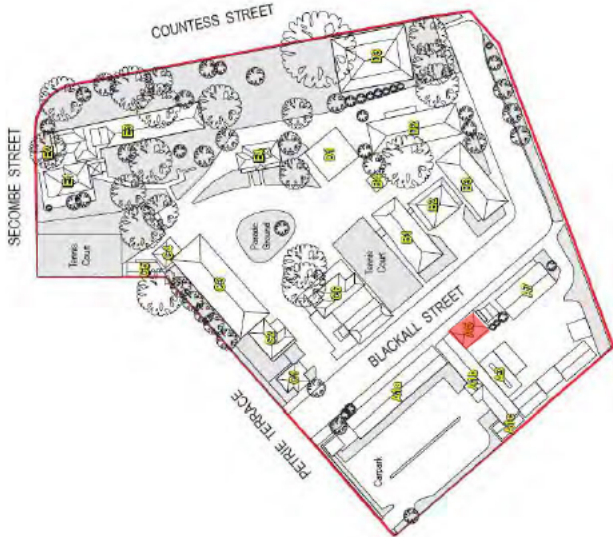
Fencing to Blackall Street and the elevated deck obscures the building's setting. The building has been substantially and unsympathetically altered internally. Some early/original tongue and groove panelled walls/partitions exist within the kitchen section. Aluminium sliding doors to deck and single pane window to south elevation detract from original fenestration pattern. Finishes to exterior paint also detract from appearance.

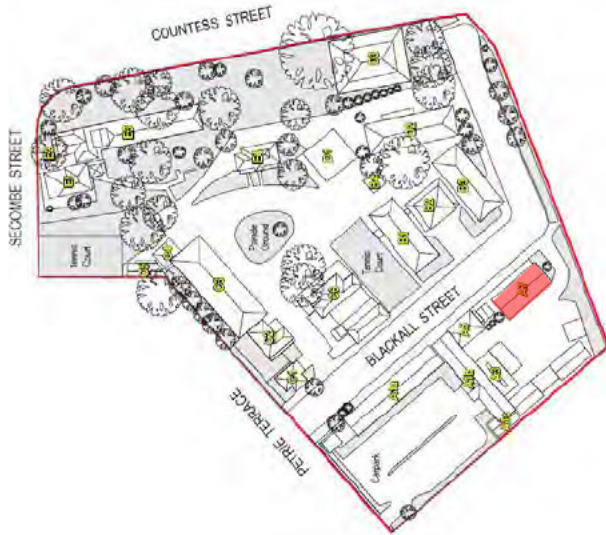
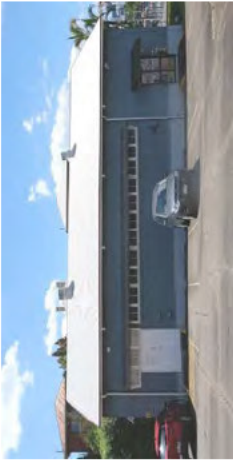
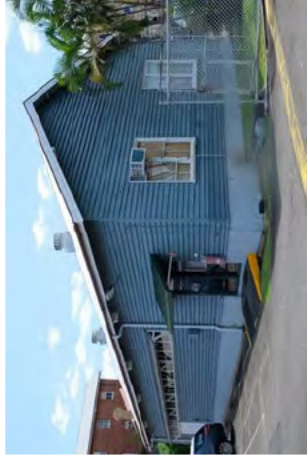
Building A7 is a rectangular single-storey timber-framed building originally used as a workshop and now used as stores. The building is clad in weatherboard, painted light blue with a corrugated iron gable roof. A linear bank of windows at height with timber strut and slatted window awning to south elevation. The linear window bank (8 x 2 double bank) to the north elevation have been painted over. The building has two access doorways to the south elevation - aluminium sliding doors at the east end, and double timber door beneath the windows at the west end. Downpipes are white or painted PCV.

Building A7 is reasonably intact and in good condition.

- Building form and gable roof
- Weatherboarding
- Fenestration patterning, particularly linear and bank rows of glazing
- Tongue and groove walls to interior and timber lined ceiling (original layout)

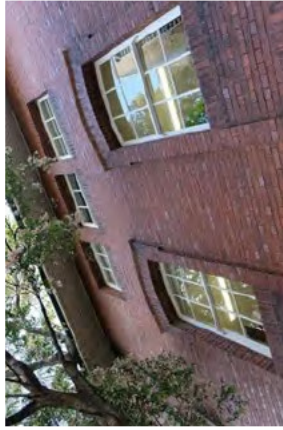
Building B1 has a high level of built integrity and is in good condition. The original floor plan of both sections remains largely intact and most original windows, doors and timber moldings survive. Numerous reversible internal planning changes have occurred and original/early room configuration are legible. Changes include superficial partitions, false ceilings, toilet and tearoom fit-outs etc. False ceilings block original window headers.

- Setting—Blackall Street streetscape frontage and one of three 'B Group' key buildings
- Building form including materiality and decorative unpainted brickwork
- Roof form and pitch
- Fenestration arrangement, form, and all associated fabric (double hung sash timber windows, bullnose or stone sills, header brick course, window hoods to 1901 section)
- Plan configuration including interior doors with fanlights
- Staircases—location and fabric
- Original ceilings—timber boarded ceiling linings and cornicing, and pressed metal

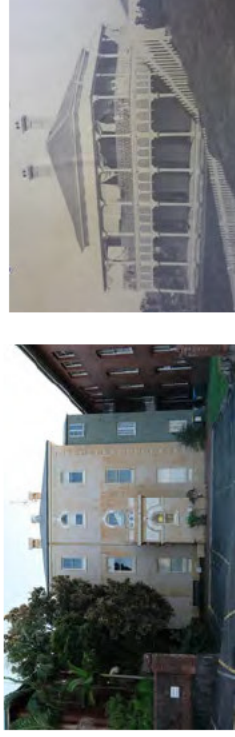
Building B2, which fronts Blackall Street, is a three-storeyed load-bearing brick building rendered with course lines resembling stonework, corner quoining and semi-circular hood moulds to the west facade. The short-ridged corrugated iron roof forms a shallow pyramid, with a dominant pair of chimneys. The main facade features an ornate entry portico to the central bay with corbelled eaves and a decorative parapet enclosed porch. At each level is a central arched window, with a rectangular window either side. A weatherboard addition to the south extends all three levels.

Fair condition. While the style of the original residence was maintained, its elegant proportions were lost following third storey extension. However, B2 has a high level of built integrity and is in fair condition. The original floor plan and most original fabric and joinery remains largely intact. **Tolerance for Change Low**—Building form/materiality and decorative plasterwork, and fenestration and opening pattern, all original and early fabric, location of stairs, plan configuration including all doors/fanlights, **High**—Infill form and material of any more recently upgraded spaces/fit-outs.

- Severe deterioration of internal wall and ceiling finishes—repaint (and repair as required) walls and pressed metal ceiling
- Recondition and repaint all timber elements as needed, particularly windows, verandah posts and balustrades, weatherboards
- General cleaning and vermin control
- Check damp proof course and drainage
- Patch /repair downpipe corrosion (replace brackets)

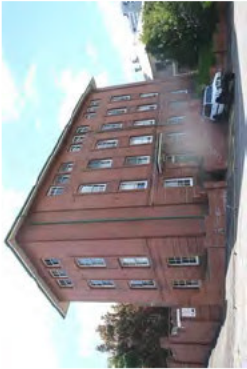
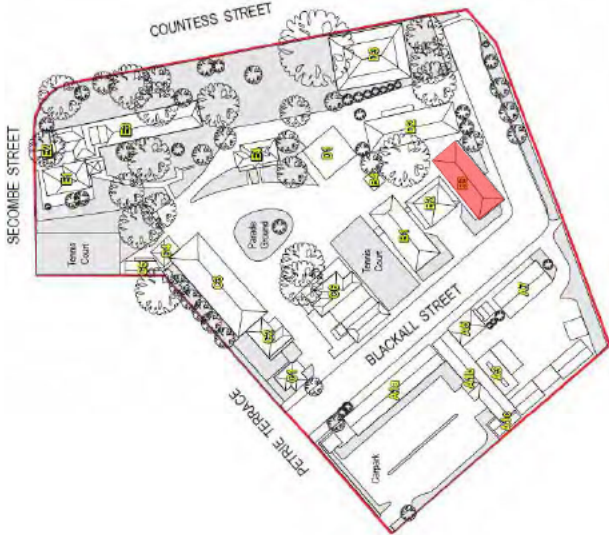
Original plan configuration of Building B3 is intact, and retention of original fabric, although many of the moulded timber skirtings have been removed and suspended plasterboard ceilings introduced which impinge on the integrity of the room spaces by obscuring part of the full height window assemblies. Consider reversing and rectifying as part of future refurbishment plans.

The facade at ground level is rusticated by protruding panels of brickwork. Windows are large twelve-paned sashes on three floors, with shallow arched heads over those on the third level. Protruding brickwork frames the second and third level windows and forms the sills throughout. Fourth level windows are smaller six-paned sashes. Building corners are accentuated by a change in plane of brickwork. Closely spaced timber boarding lines the eaves soffit of the long hipped corrugated iron roof.

- Severe deterioration of internal wall finishes—re-paint (and repair as required) walls
- General cleaning and vermin control
- Consider raising or removal of false ceiling during next refurbishment to expose full windows assemblies

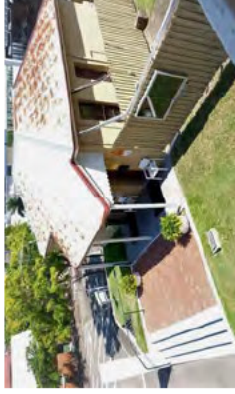
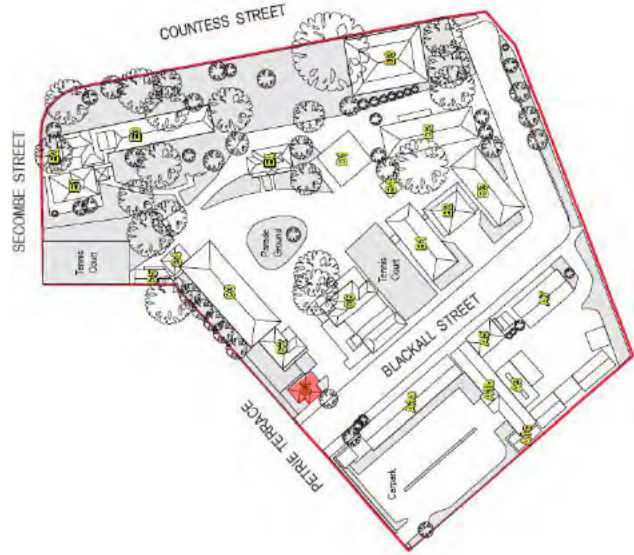
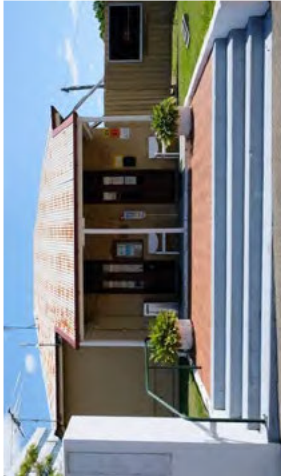
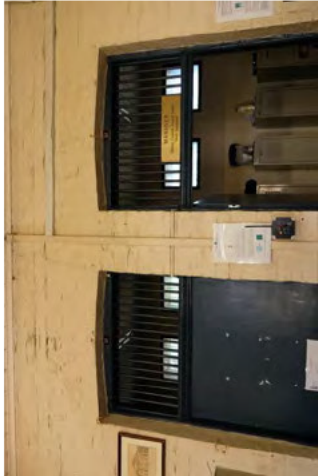
Building C1 is in good condition and integrity. The original floor plan remains largely intact and evidence of the buildings use as a lock-up survives. Numerous reversible internal planning changes have occurred and original/early room configuration are legible. Changes include superficial partitions, toilet and tearoom fit-outs.

The original plan form remains largely intact and clearly demonstrates its early use. Cells survive although the original cell doors are missing. The original face brickwork has been painted and the original timber floor replaced with concrete

- Building and roof form/pitch
- Exterior high level windows to former cells (not original, but location similar)
- Brick walls
- Stone base
- Existing wall vents
- Casement window with fanlight is original (double hung sash windows replacements)
- French doors to main façade
- Early boarded timber lined ceilings
- Internal plan configuration
- 1885 cell door openings with bars

- Building is in good condition and no priority repair or maintenance works are identified
- Consideration should be given to removal of redundant conduit and pipes to both interior and exterior, and patch and repair wall as required.

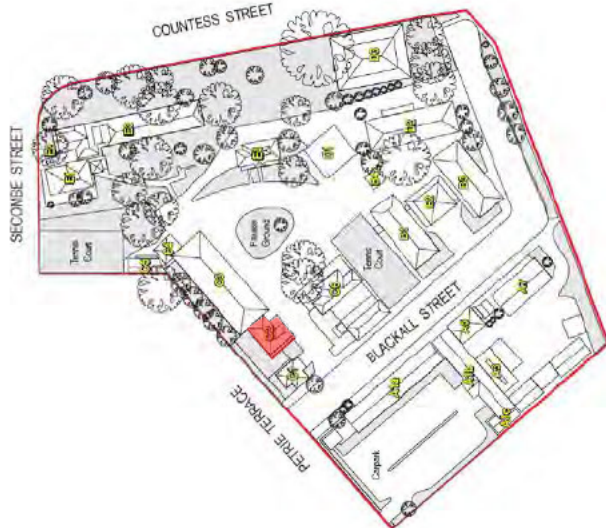
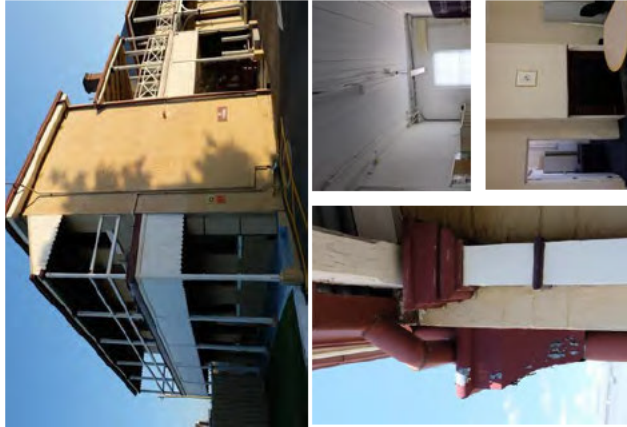
The original face brickwork has been painted and much of the interior finishes have been removed. The levels are divided into several smaller rooms, now used as offices and formerly as residential accommodation. False ceilings have been installed to ground floor level. Fireplaces present to both levels, although these are boarded over.

Overall good condition. Legibility of layout has been compromised through extension and partitioning. The series of additions have obscured original form and understanding of the evolution of this building.

- Rotting timbers to upper level balustrade at bridge to C3 (posts and rails) to be replaced/repared
- Repaint deteriorating finishes to rain head
- Investigate rising damp at ground floor west corner.
- Timber windows peeling internally and requires reconditioning and repainting
- Redundant services should be removed.

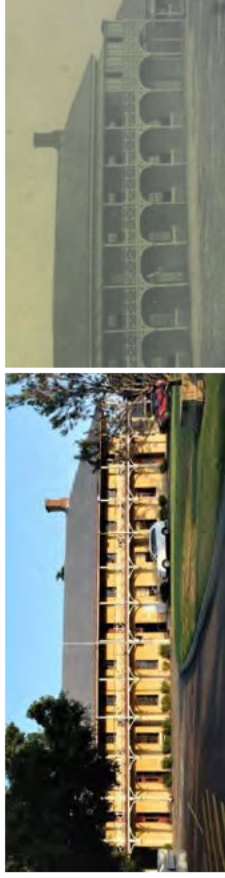
C3 Barracks / Administration

Building C3 is a long, double-storeyed, painted brick barracks building with a hipped roof of corrugated iron which extends over open wide verandahs on all four sides. Originally built as dormitory-style accommodation for ordinary ranks (100 troops), end rooms for commanding officers and all rank dining room (refer photo above, circa 1870). Rising above the roof are a pair of chimneys stands, one on each end of the ridge. The building incorporates mid-span internal timber columns. The building ceased being used as a barracks early this century and is currently used as office accommodation. In 1907, the original slate main roof and curved corrugated iron verandah roof was replaced with the current arrangement of hipped corrugated iron. The original main roof eaves and verandah wall plates survive to demonstrate this previous roof form.

Building C3 is in good condition and integrity. **Tolerance for Change Low**—External form and all Significant Contributory Elements; **High**—Infill fabric associated with refurbished spaces/fit-outs.

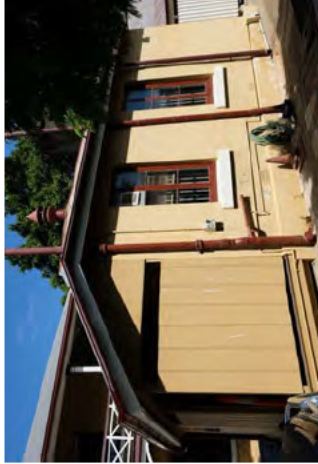
Timbers have been affected by termite activity and their structural integrity is unknown. The building otherwise appears to be in good condition.

- Patch before replacement of termite affected timbers. Replacement should seek to use same or similar timber species

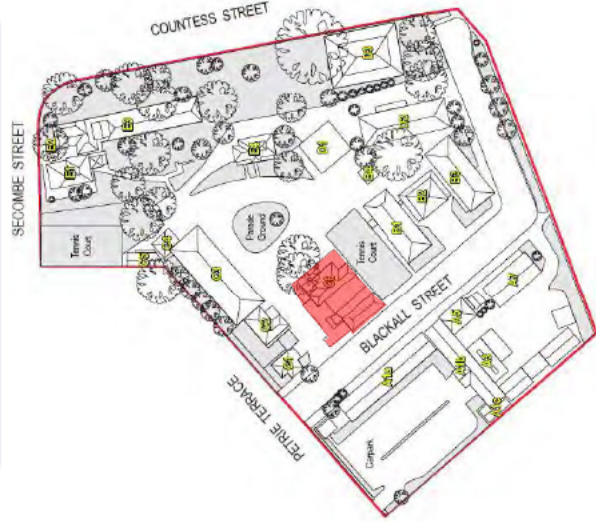
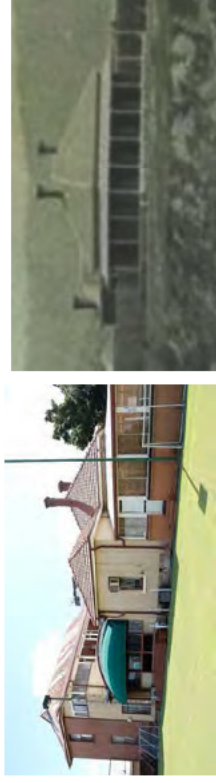
The series of additions have obscured original form and understanding of the evolution of this building. Infill to the front verandah, unsympathetic kitchen addition and ancillary structures to the parade ground access way and the mid-century link all detract from the building aesthetic value and historic form. Early door and window joinery remains throughout 1912 extension, original fabric remains to the 1864 build, albeit obscured. The upper level rooms have been modified as accommodation (circa 1990s). **Tolerance for Change Low**—External form; External form and all Significant Contributory Elements; **High**—infill verandahs, kitchen extension and Infill fabric associated with refurbished spaces/fit-outs.

- Investigate options in brick courtyard relating to brick paving uplift (trip hazards), subsurface impacts to the building, and water ingress/drainage.
- Investigate integrity of first floor verandah, repair balustrade rails and posts

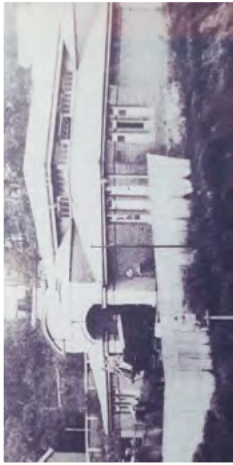
Constructed in 1875 as police stables, this large, single-storeyed, rectangular painted brick building occupies lowest corner of the VBB close to Countess Street. The main entrance came off Countess Street until the street was lowered in 1914. The building is symmetrical about two porticos central to the Countess and Blackall Street elevations. The Blackall Street doorway is exceptionally tall to enable the police to mount in the courtyard area and ride out of the building. The entrance from Blackall Street has been modified with a sunken ramp and set of steps, and the external brickwork has been painted. A flagstone floor extends through the entrance and likely to be intact in part of the building beneath the current timber floor.

The original stables layout remains legible, and much of the original fabric survives albeit often covered over by later fit-out. The current fit-out, particularly on the western side, is unsympathetic to the building. Some minor cracking noted to north-east and south-east corners.

- Rectify retaining wall and steps at Blackall Street entrance
- Cracked brickwork noted to internal rooms
- Check waterproofing along windows
- Investigate erosion control and stair/call collapse to rear (Countess Street lawn)

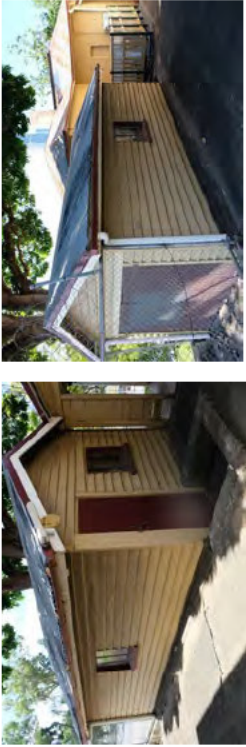
External condition is fair, although some loosening of roof sheeting noted.

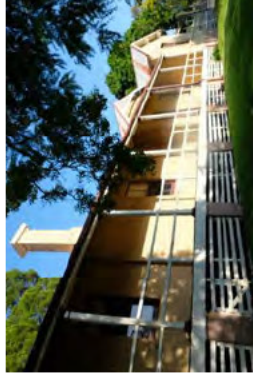
doors are of particularly heavy timber construction (some metal-lined). Recent toilet installations to the western verandah are unsympathetic. The cottage form (Building E3b) is hip-roofed, with a gable front projecting across the verandah space. Abutting this gable at the Secombe Street end, the verandah roof is set down separate from the main roof (all corrugated iron sheeting) E3b is complete with chimney and in English bond brickwork, stands on stone foundations. On the gable, bands of brickwork protrude across the face at window head and sill line. A pair of four-paned sashes is placed together central to the gable front. Elaborate timber brackets support the gable eaves. Elsewhere windows are twelve-paned sashes with a four-paned panel above. The later gable section has main brick walls in stretcher bond and sheeted in weatherboards and decorated with a battened pediment. Opening to the Countess Street verandah are a pair of French doors and a four-paned sash window. Vertical pivoting windows appear to have provided security as well as ventilation. A deep wear groove in the hearth indicates previous existence of a heavy fireplace grate and small floor level.

Good condition with high level of original and early fabric remaining. **Tolerance for Change Low**—External form and all Significant Contributory Elements; **High**—Infill fabric associated with refurbished spaces/fit-outs.

- Investigate and rectify cracked brickwork noted externally and internally
- Loose/timber rot to verandah rails and posts
- Missing and broken slats to sub-floor verandah
- Rectify flaking and crazing paint to walls
