Site Audit Report 0503-2503 Singleton Military Area, NSW

Site audit statement no. 0503-2503

Title	Site Audit Report 0503-2503, Singleton Military Area, NSW	
Report no.	JBS&G 66617-164286	Date 30 April 2025

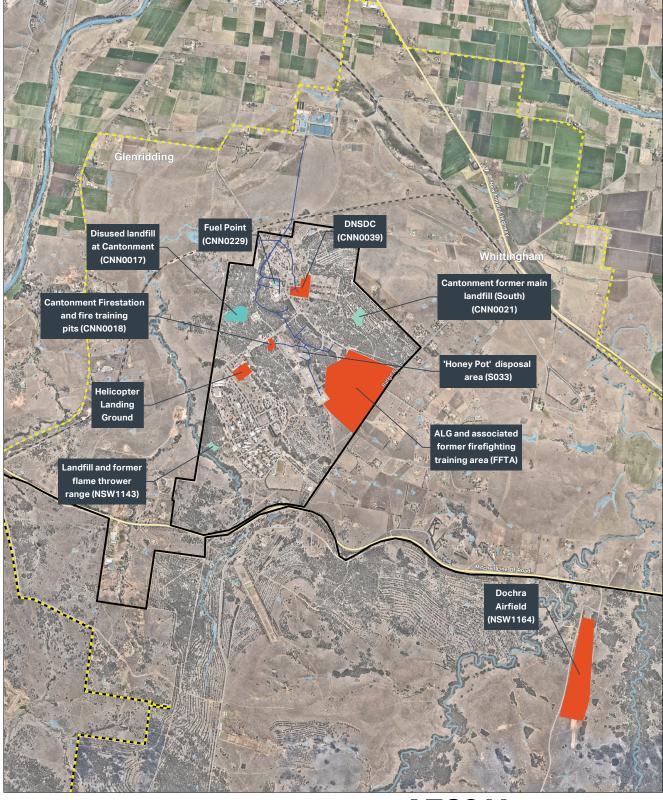
FIGURE 2: PMAP Source Areas

The SMA comprised of mostly open country with timber lined creek and scattered forests. The Broken Back Ranges rise steeply to the south of the base within the Pokolbin State Forest. The southernmost portion of the SMA extends to the south of Cessnock Road with the norther portion of the base (The Cantonment) extending to the north of Mitchell Line of Road (The Golden Highway). The SMA is divided into two areas, the Cantonment (Lone Pine Barracks) is the location of the on base accommodation, maintenance and training facilities, vehicle maintenance, storage and distribution of fuels, equipment wash-down and firefighting training with the Singleton Training Area (STA) the former location of active ranges for weapons firing, vehicle training and explosives testing. The STA occupies the majority (approximately 90%) of the SMA. The location of the main base features listed above are shown on **Figure 2**, **Appendix C**.
