### RAAF Base Wagga Remediation Update

## RAAF Base Wagga Ongoing Monitoring Results – April 2024 to February 2025

# RAAF Base Wagga Program Timeline

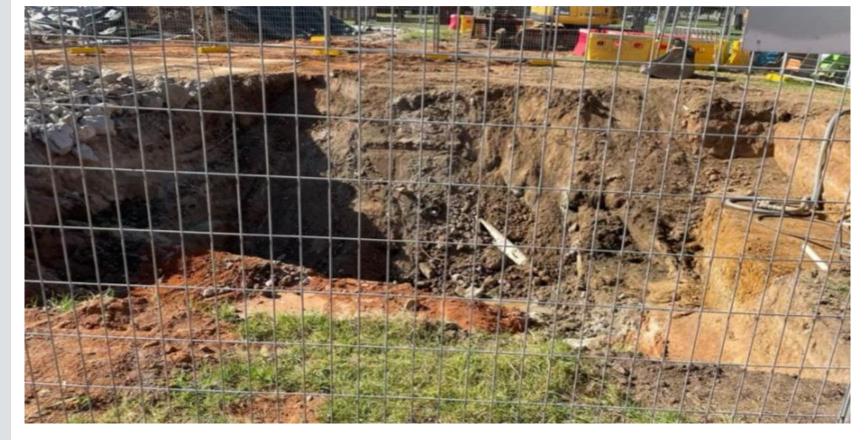
Removal of wastewater collection tanks

- In 2025, Defence completed remediation of the Fire Extinguisher Training Pad (FTP), the Former Fire Station and the Fire Station wash bay.
- The objective of the remediation was to reduce PFAS discharges in stormwater and sewer from the base, stormwater discharges to the Gumly Gumly Wetland and sewage discharges from the base to the Forest Hill Sewage Treatment Plant.
- Soil and other PFAS
   contaminated materials
   were removed and
   transported off-site to
   licensed facilities for
   treatment and disposal.
- A legacy underground diesel storage tank was also removed.

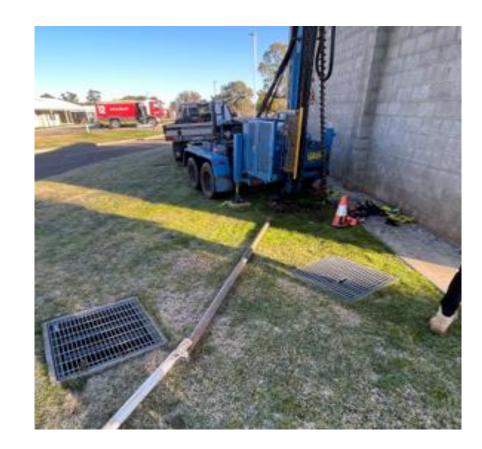
Decommissioning monitoring wells

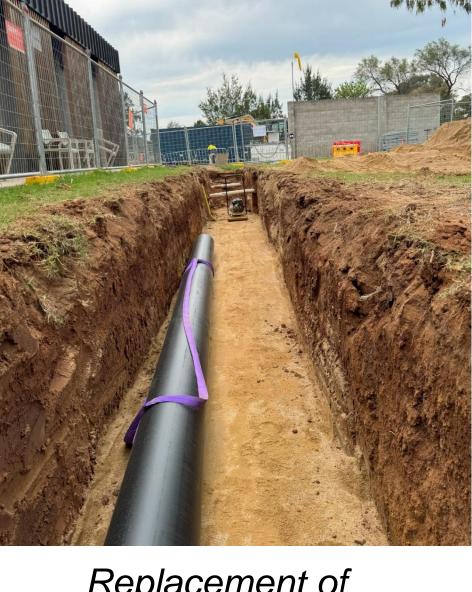
Replacement of stormwater pipes

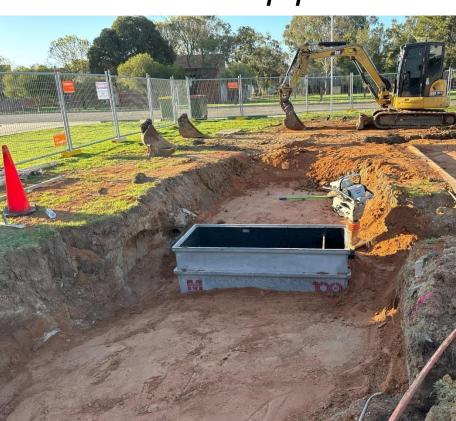
Replacement of oil/water separator

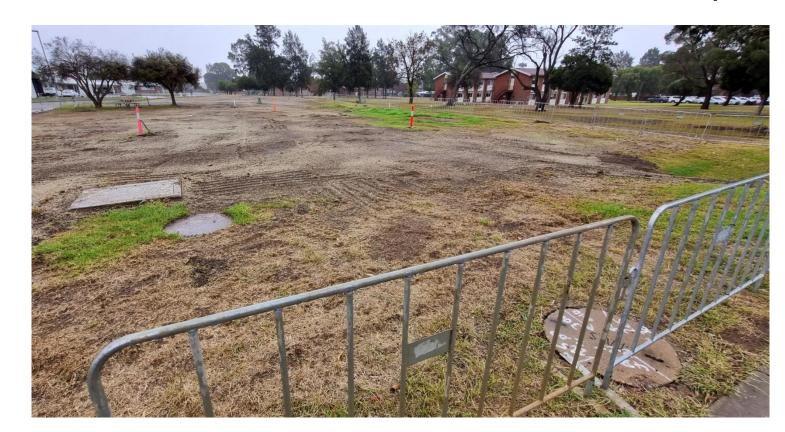
Completion of remediation works

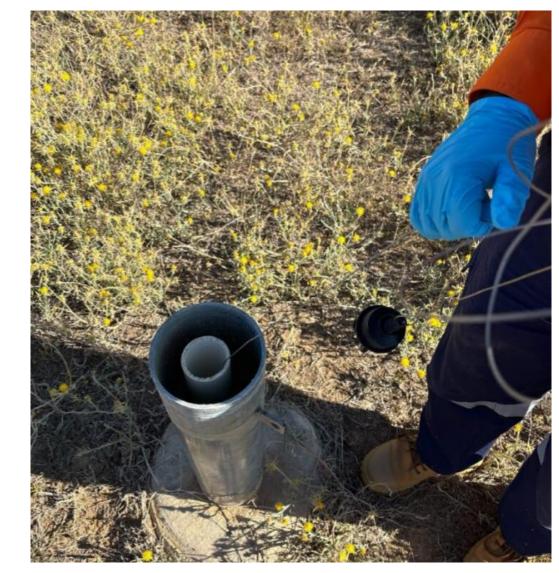
Groundwater sampling

Groundwater sampling RAAF Base Wagga

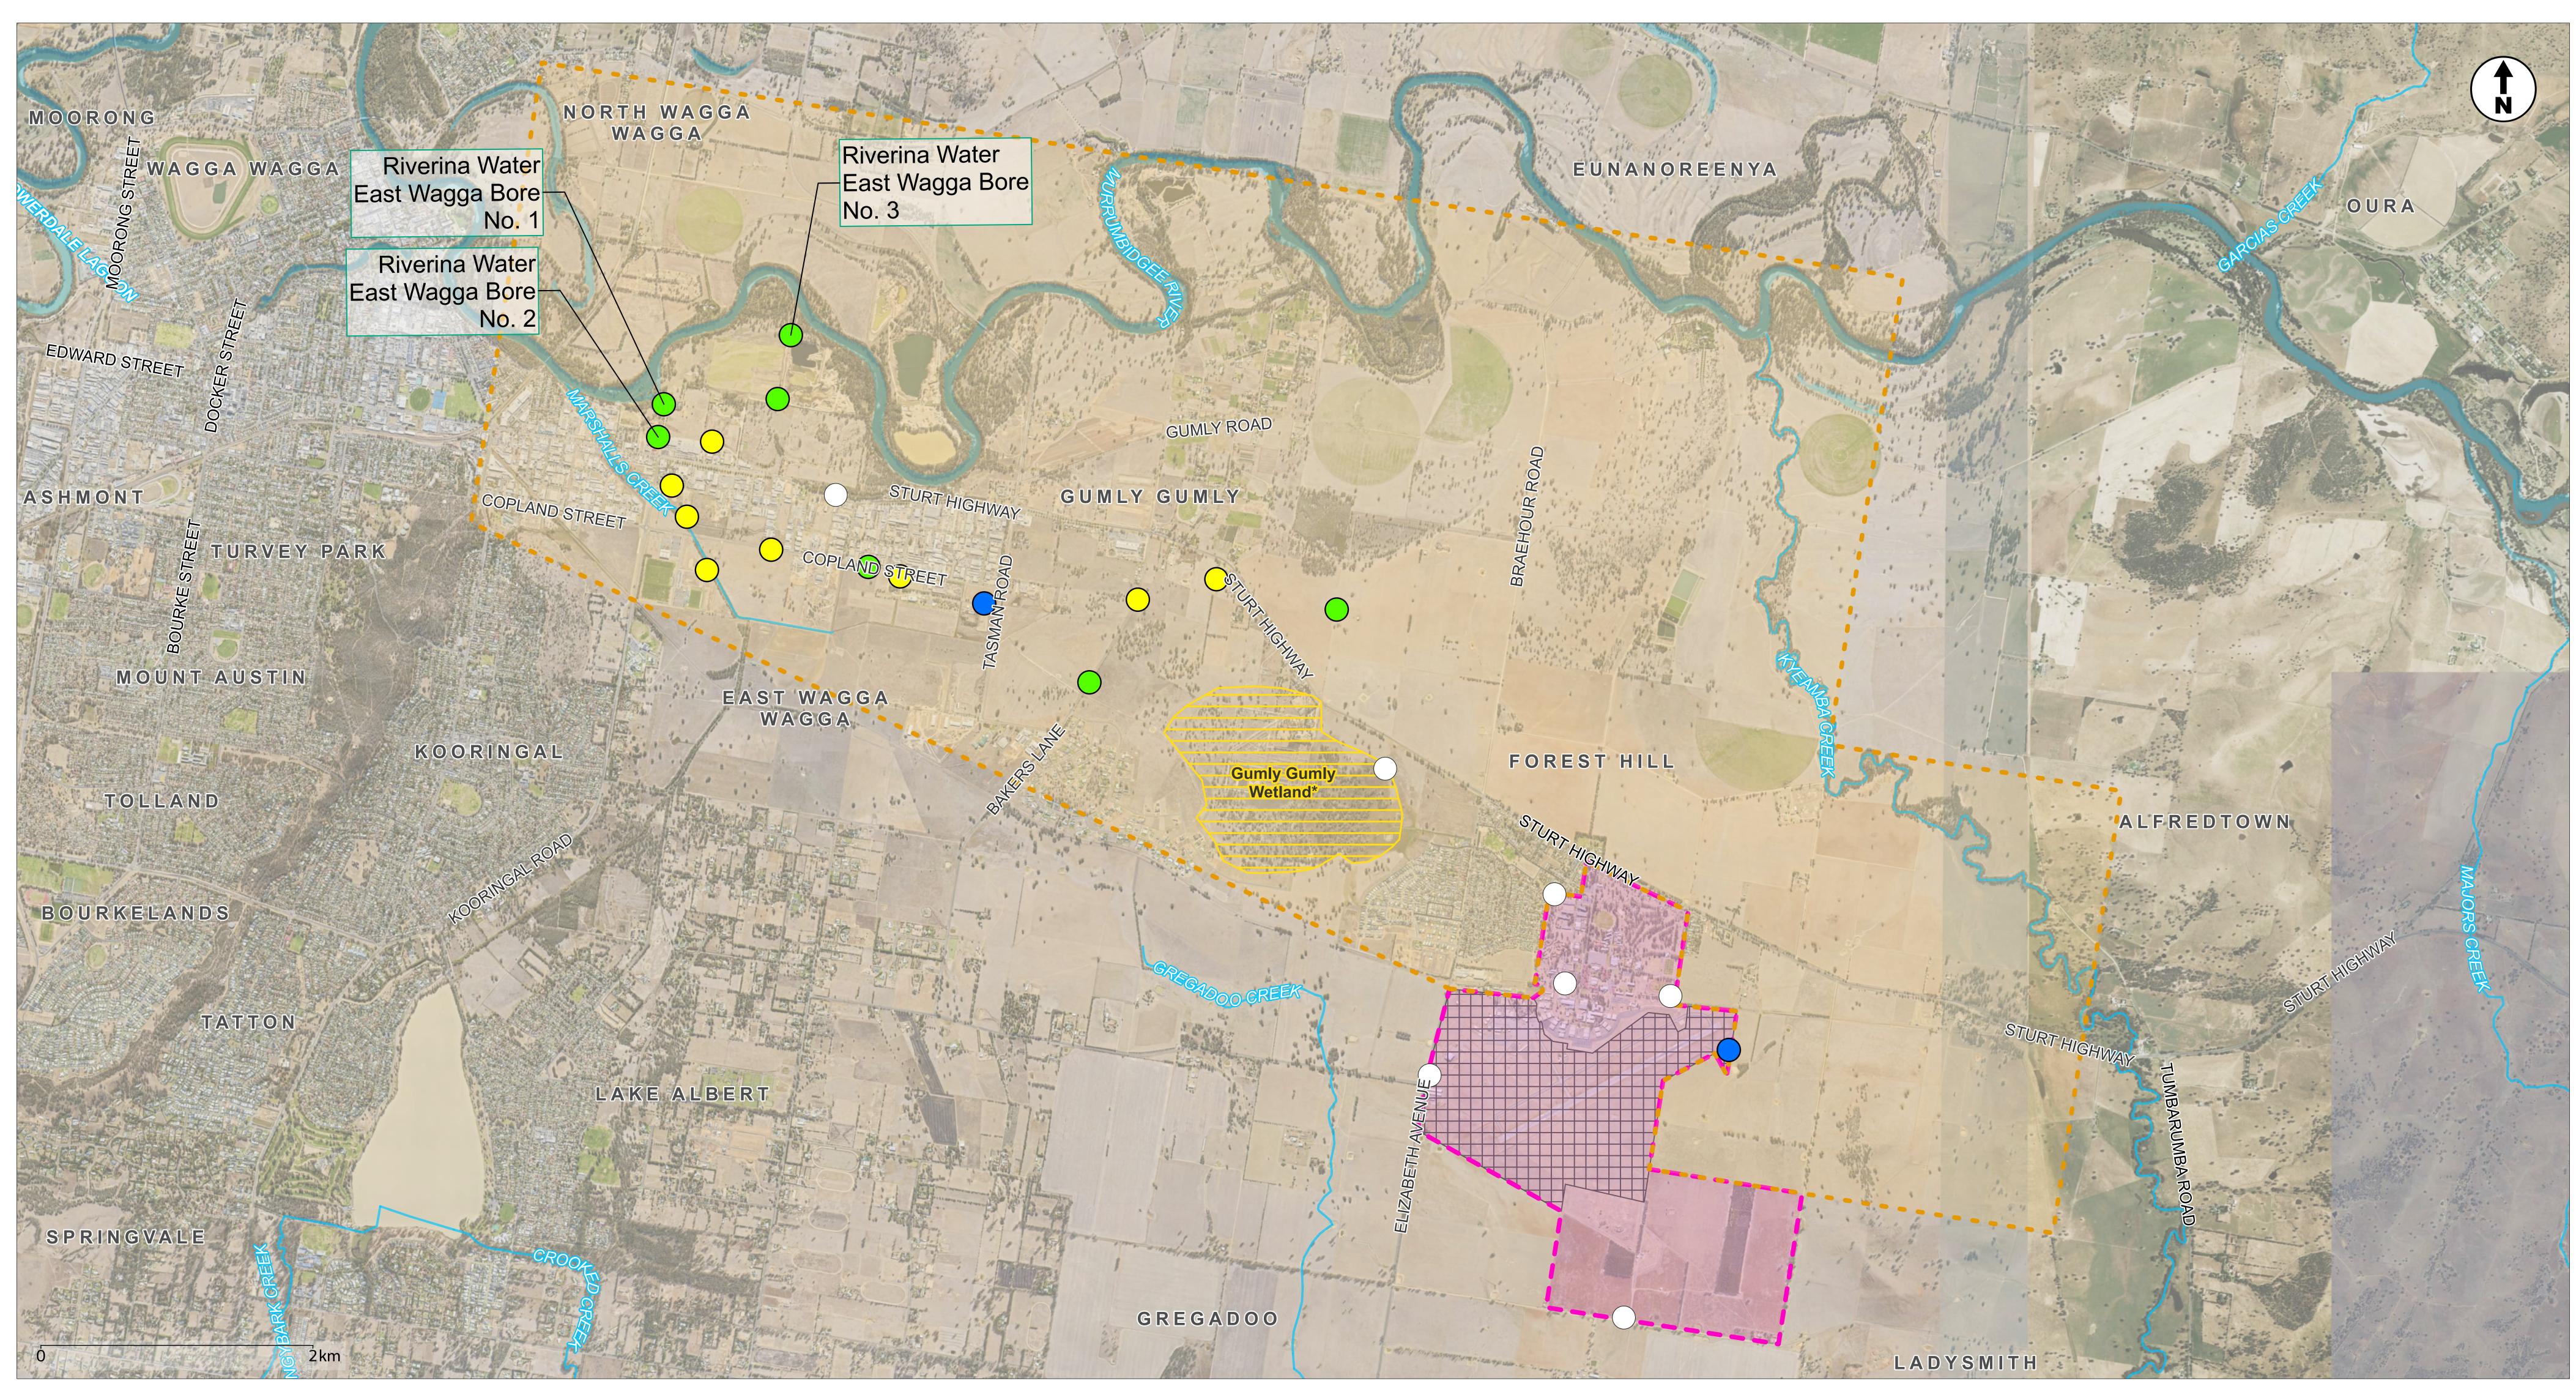
February 2025 Groundwater PFOS samples (result units are in  $\mu$ g/L)

#### Summary of findings Sample type PFAS in groundwater were similar to previous results. The highest PFAS concentrations were detected in the Gumly Gumly Wetland or at locations adjacent to Marshalls Creek. Groundwater New monitoring wells have been installed further to the west of the existing 79 samples collected network, between Marshalls Creek and Riverina Water extraction bores. from 57 locations PFAS has been detected within the new wells at concentrations exceeding drinking water guidelines. There has not been any exceedance of drinking water guidelines within any of the drinking water supply bores sampled. The drinking water is safe to drink. PFAS in surface water were similar to previous results. Concentrations exceeding drinking water guidelines were detected from **Surface water** the base boundary and drainage line, Marshalls Creek and Forest Hill 33 samples collected Sewage Treatment Plant. from 17 locations Samples from the Riverina Water drinking water intake at the

- PFAS have been detected in new monitoring wells installed by Defence between Marshalls Creek and the Riverina Water drinking water bores.
- The highest PFAS concentrations in groundwater were detected in Gumly Gumly wetlands and adjacent to Marshalls Creek, and within Marshalls Creek for surface water.
- No exceedances of drinking water guidelines were detected for any of the drinking water supply bores or the Murrumbidgee River intake location.
- The Wagga Wagga drinking water supply is safe.
