DETAILED SITE (CONTAMINATION) INVESTIGATION

Randwick Barracks
373A Avoca Street, Randwick, NSW

Defence Housing Australia
26 Brisbane Avenue,
Barton, ACT, 2600

SLR Ref: 610.30041-R01
Version No: -v1.3
February 2021

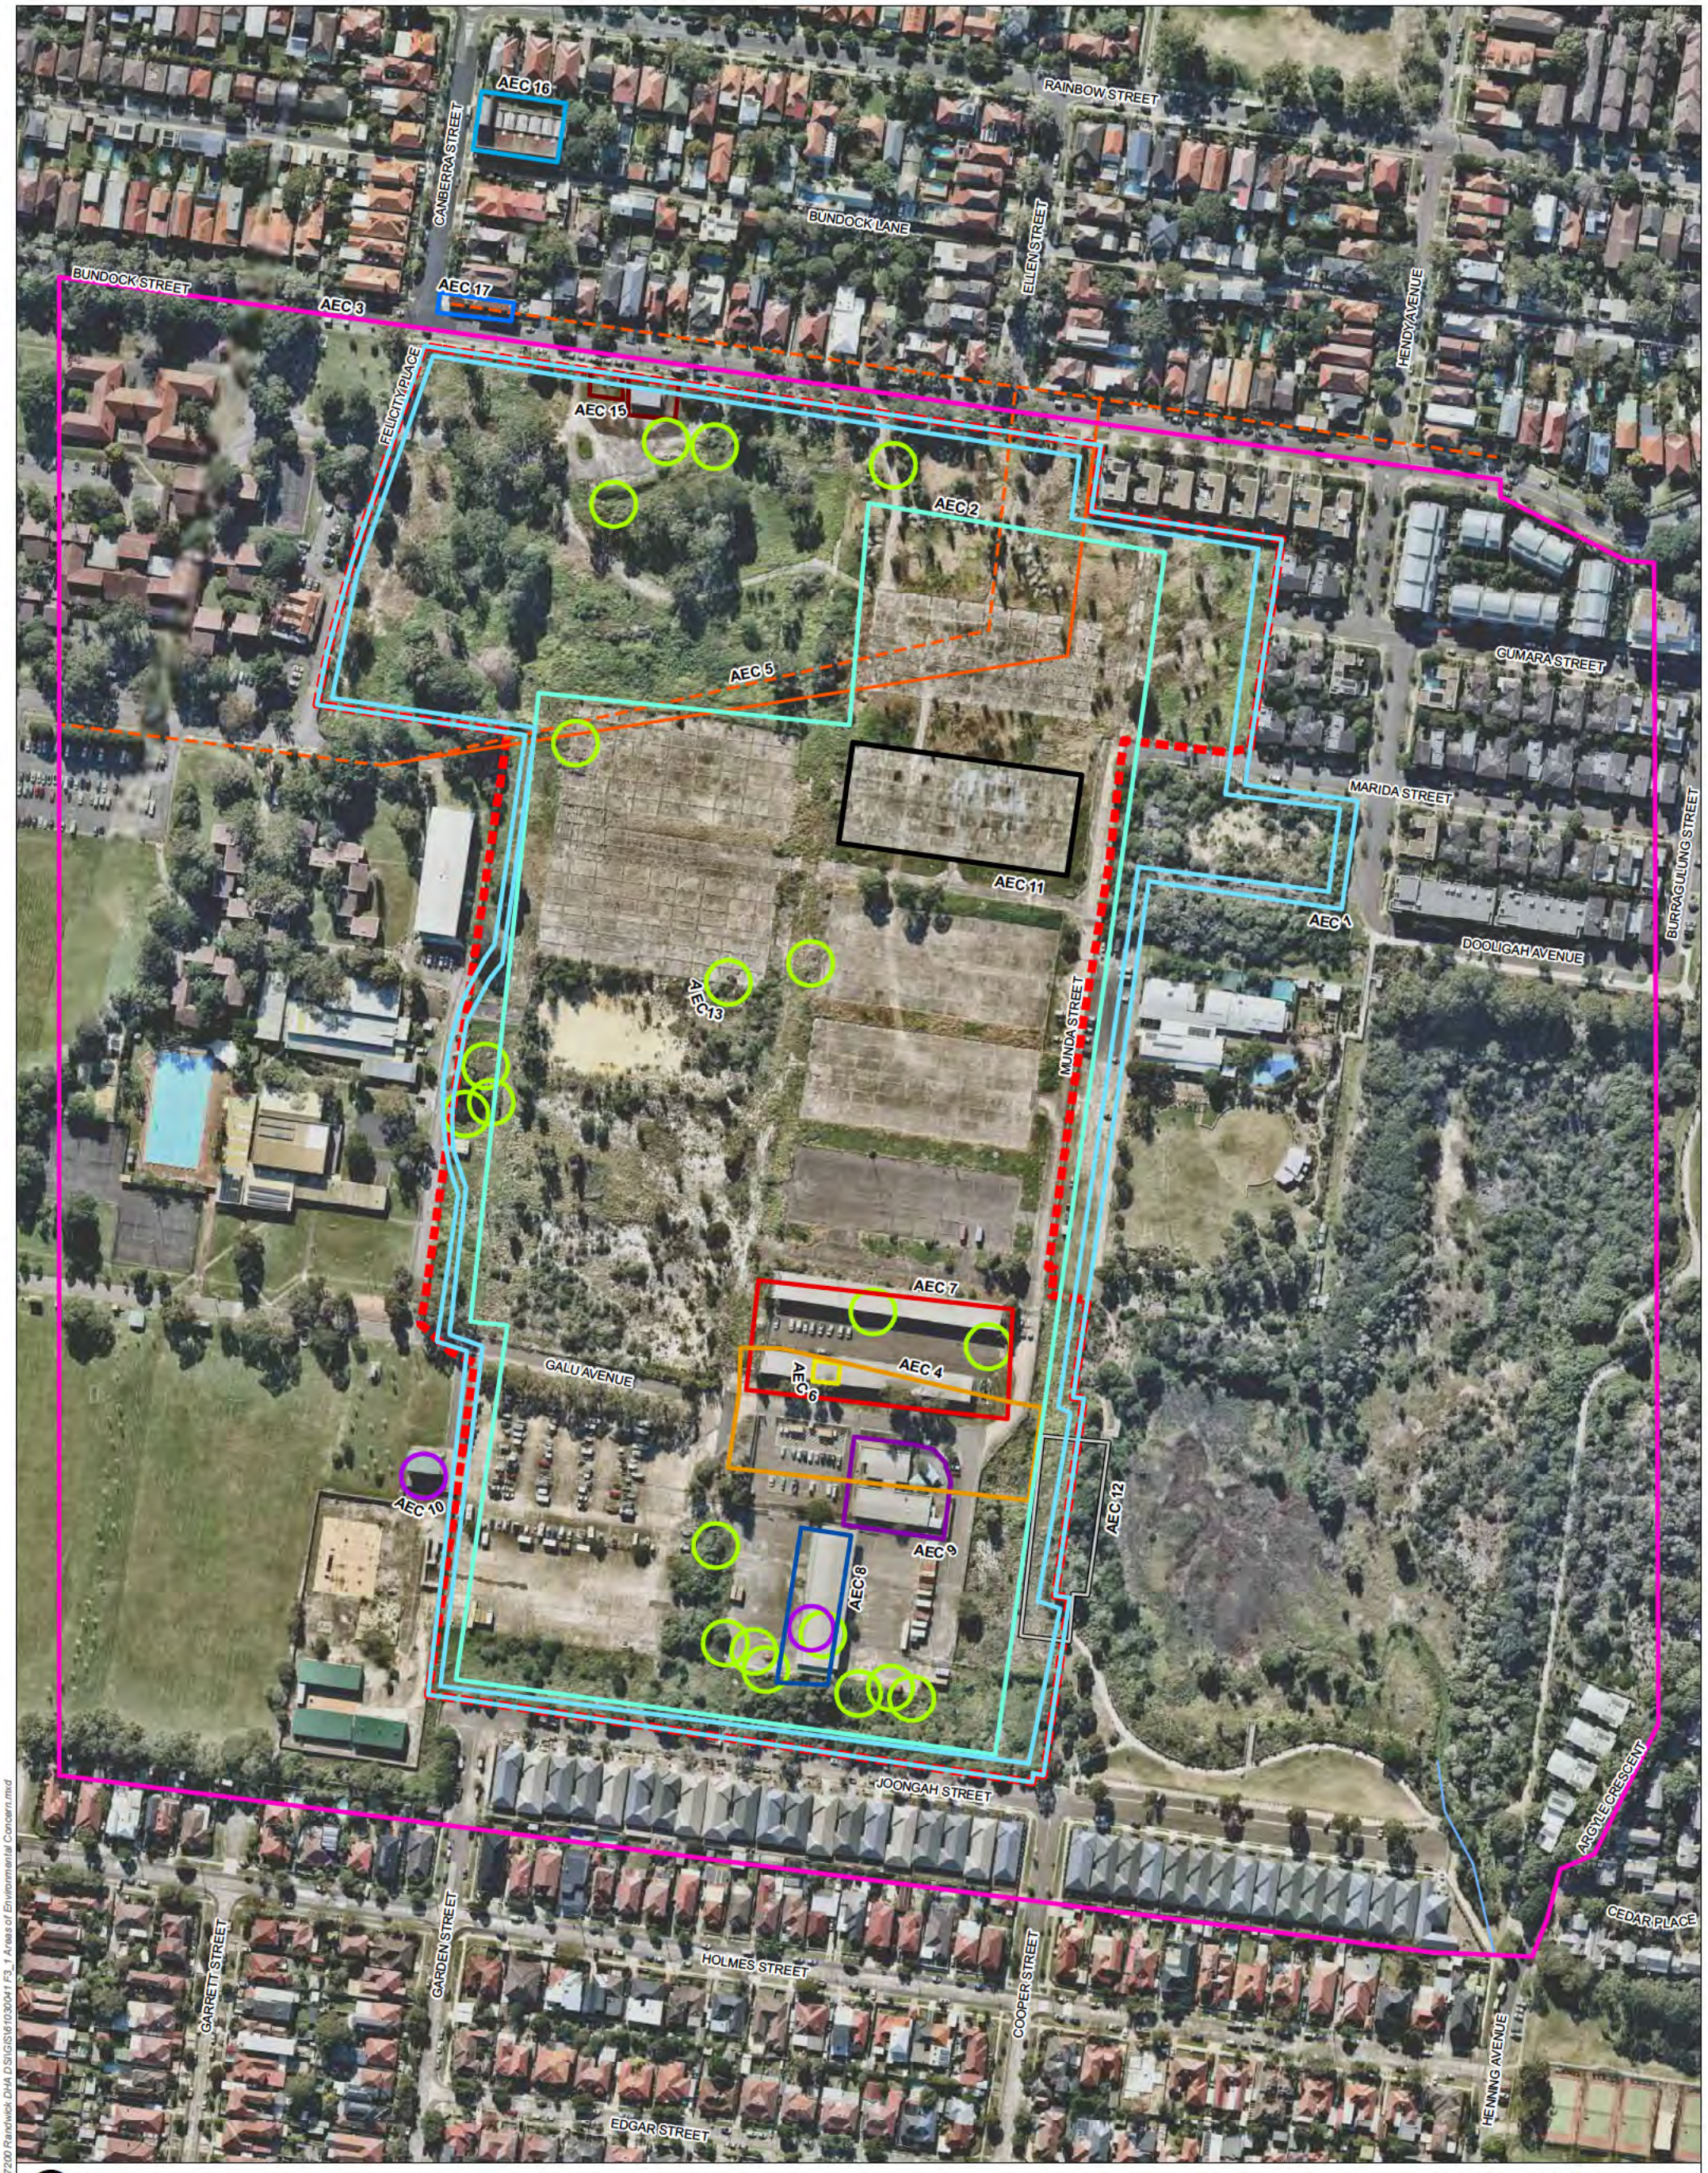
FIGURE 2

The site has an approximate elevation of 30 metres Australian Height Datum (mAHD). The highest point of the site is at the north west corner (in the vicinity of AEC15), with a downward slope towards Joongah Street towards the south and south east. The nearest surface water body is a detention basin located within the Randwick Environment Park, approximately 50 m beyond the eastern and south eastern boundaries of the Site (refer to **Figure 2** in **Appendix A**).

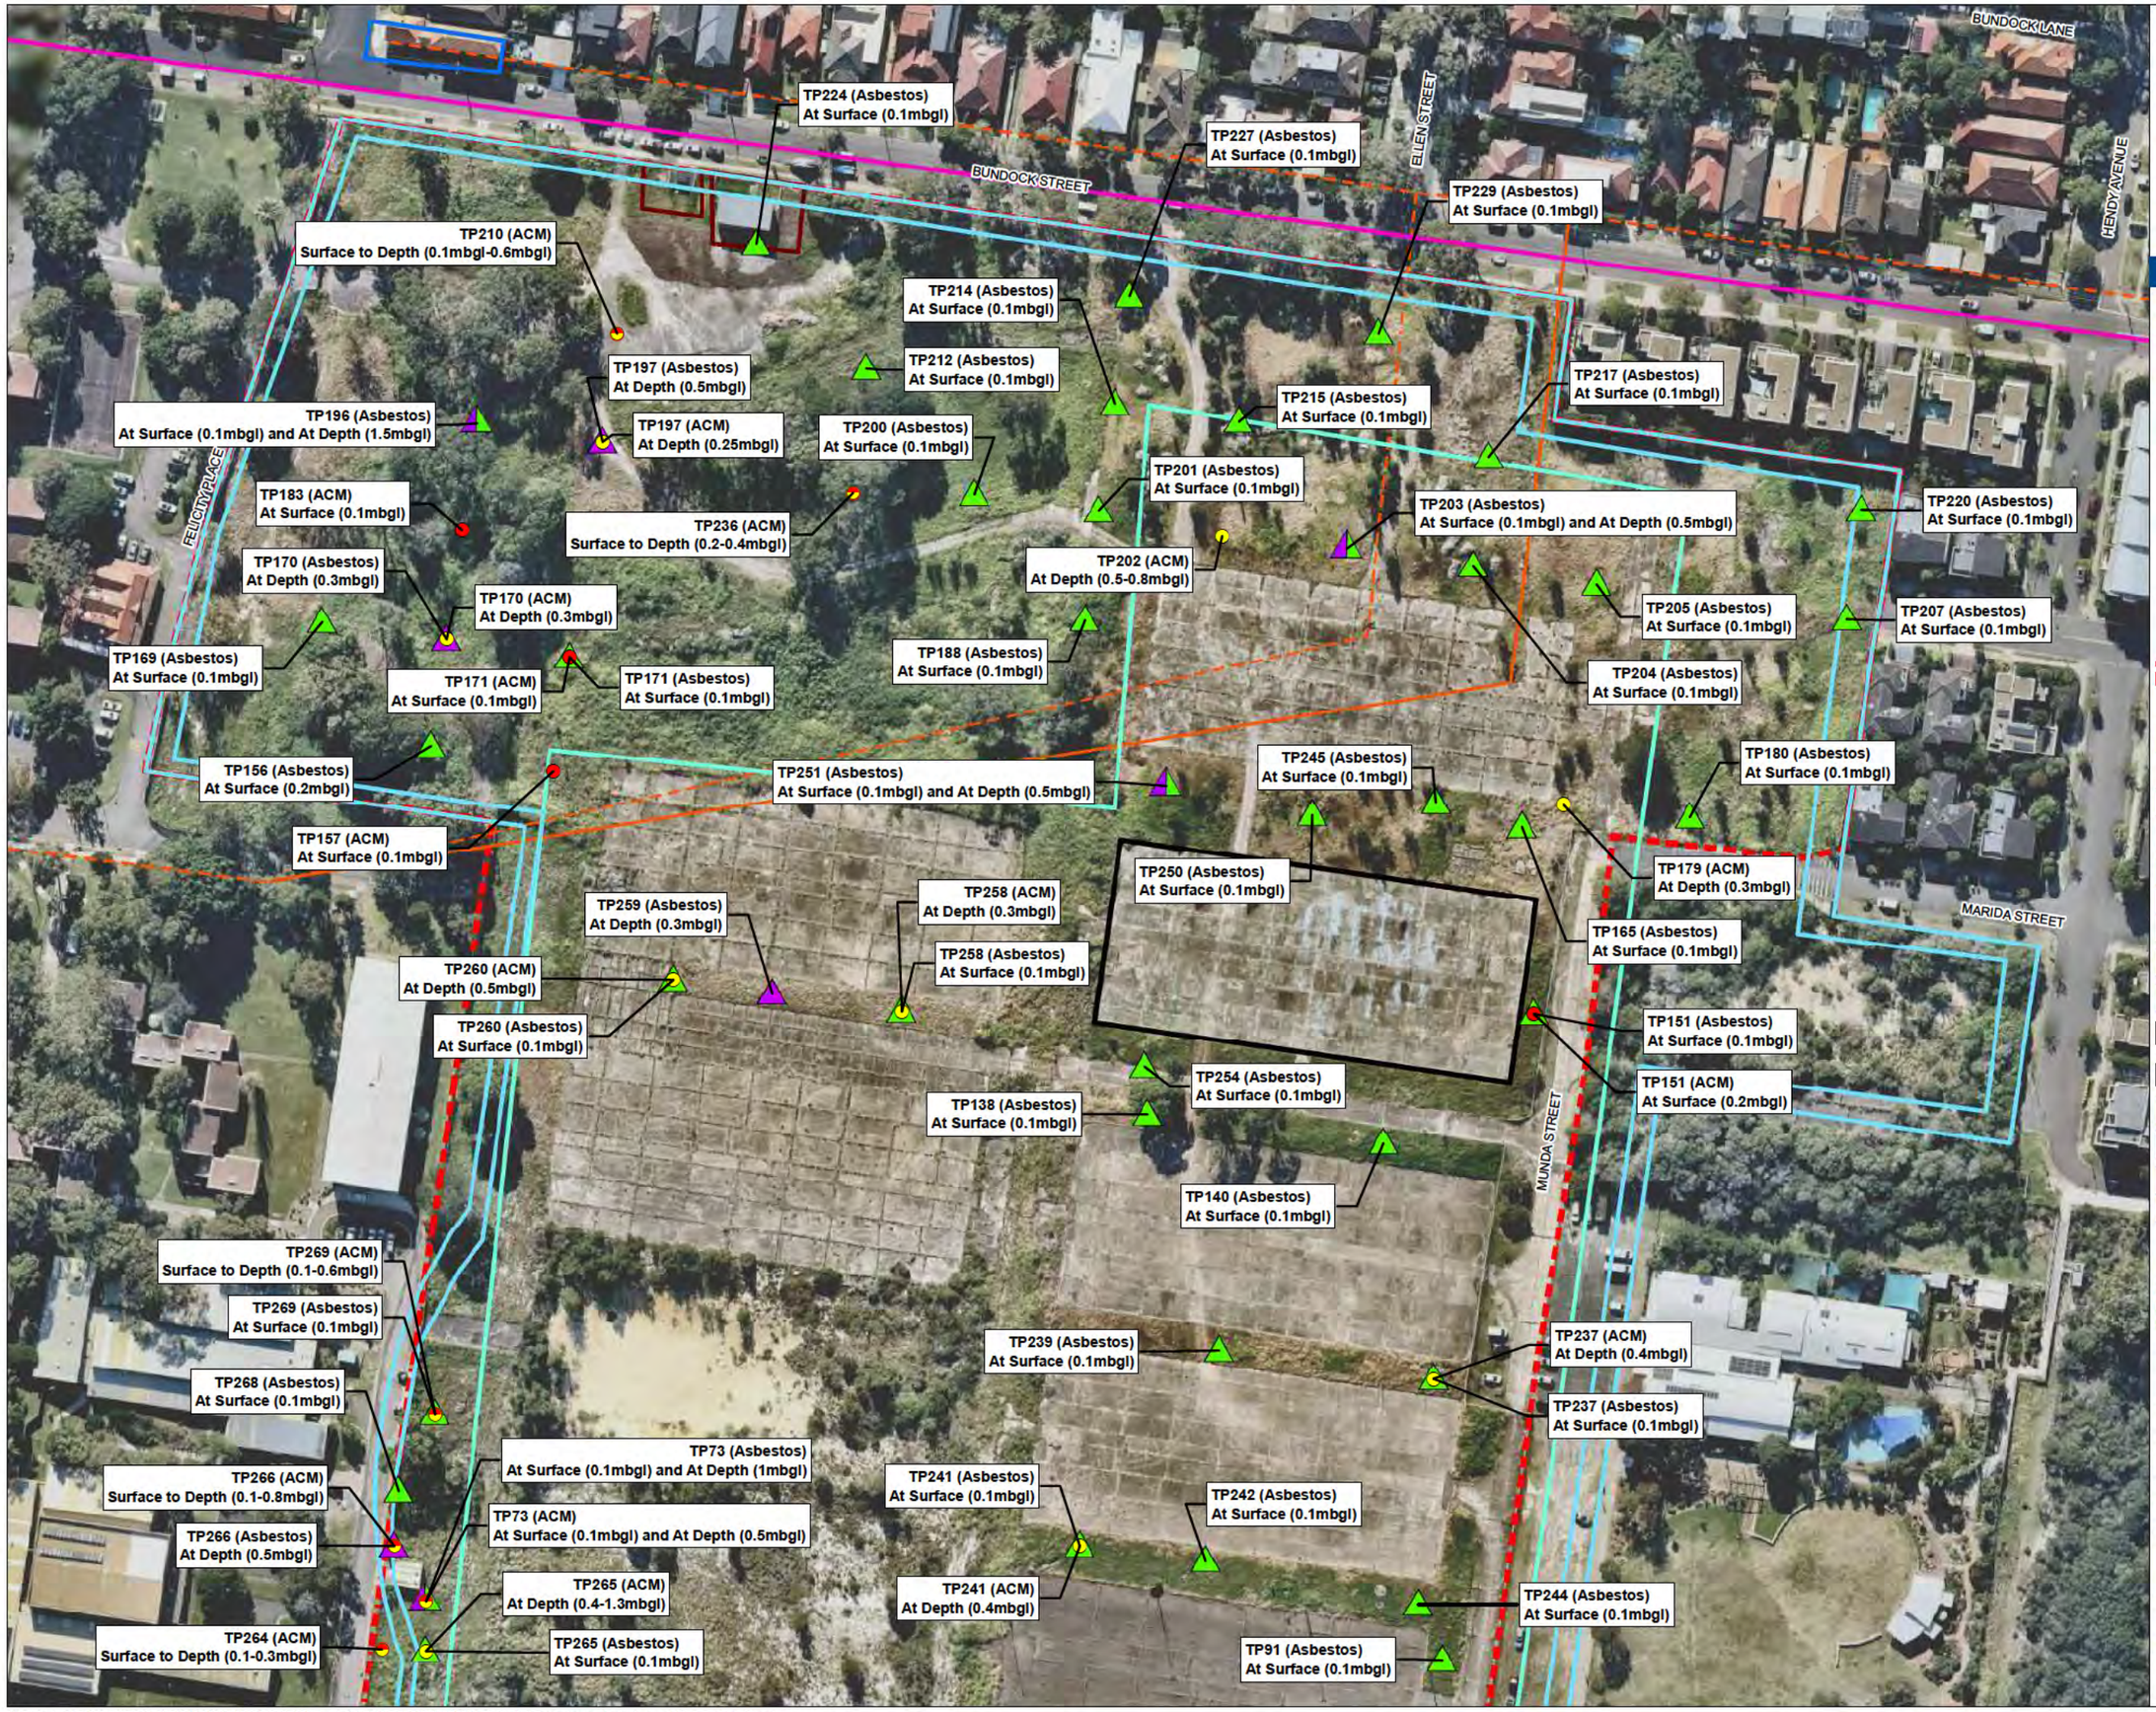
FIGURE 9-4A

Fragments of Asbestos Containing Materials (ACMs) were observed on the surface at various locations within the central and northern portion of the site, in non-operational areas (i.e. north of Galu Avenue and AEC07) including:

- In the north western portion of the non-operational areas, single ACM fragments were observed near TP201, TP199 and TP195.
- In the central portion near the western boundary, multiple ACM fragments were observed on the surface near TP94, TP95, TP104 and TP105. The number of ACM fragments increased towards the western boundary fence, especially in the area near TP232, TP266, TP267 and TP261.

Occurrences of asbestos fibres (fibrous asbestos and asbestos fines) and ACMs were observed to be widespread across the site. Asbestos was primarily detected in testpits advanced across vegetated areas along the northern portion of the site, beneath vegetated strips lining the verges of the concrete slabs across the site, in fill areas towards the south west boundary of the site, and to a lesser extent on the south eastern portion of the site (as illustrated in **Figure 9-4A** and **9-4B, Appendix A**).

Soil Exceedances (Asbestos [AF/FA] and ACM) Part 1 of 2

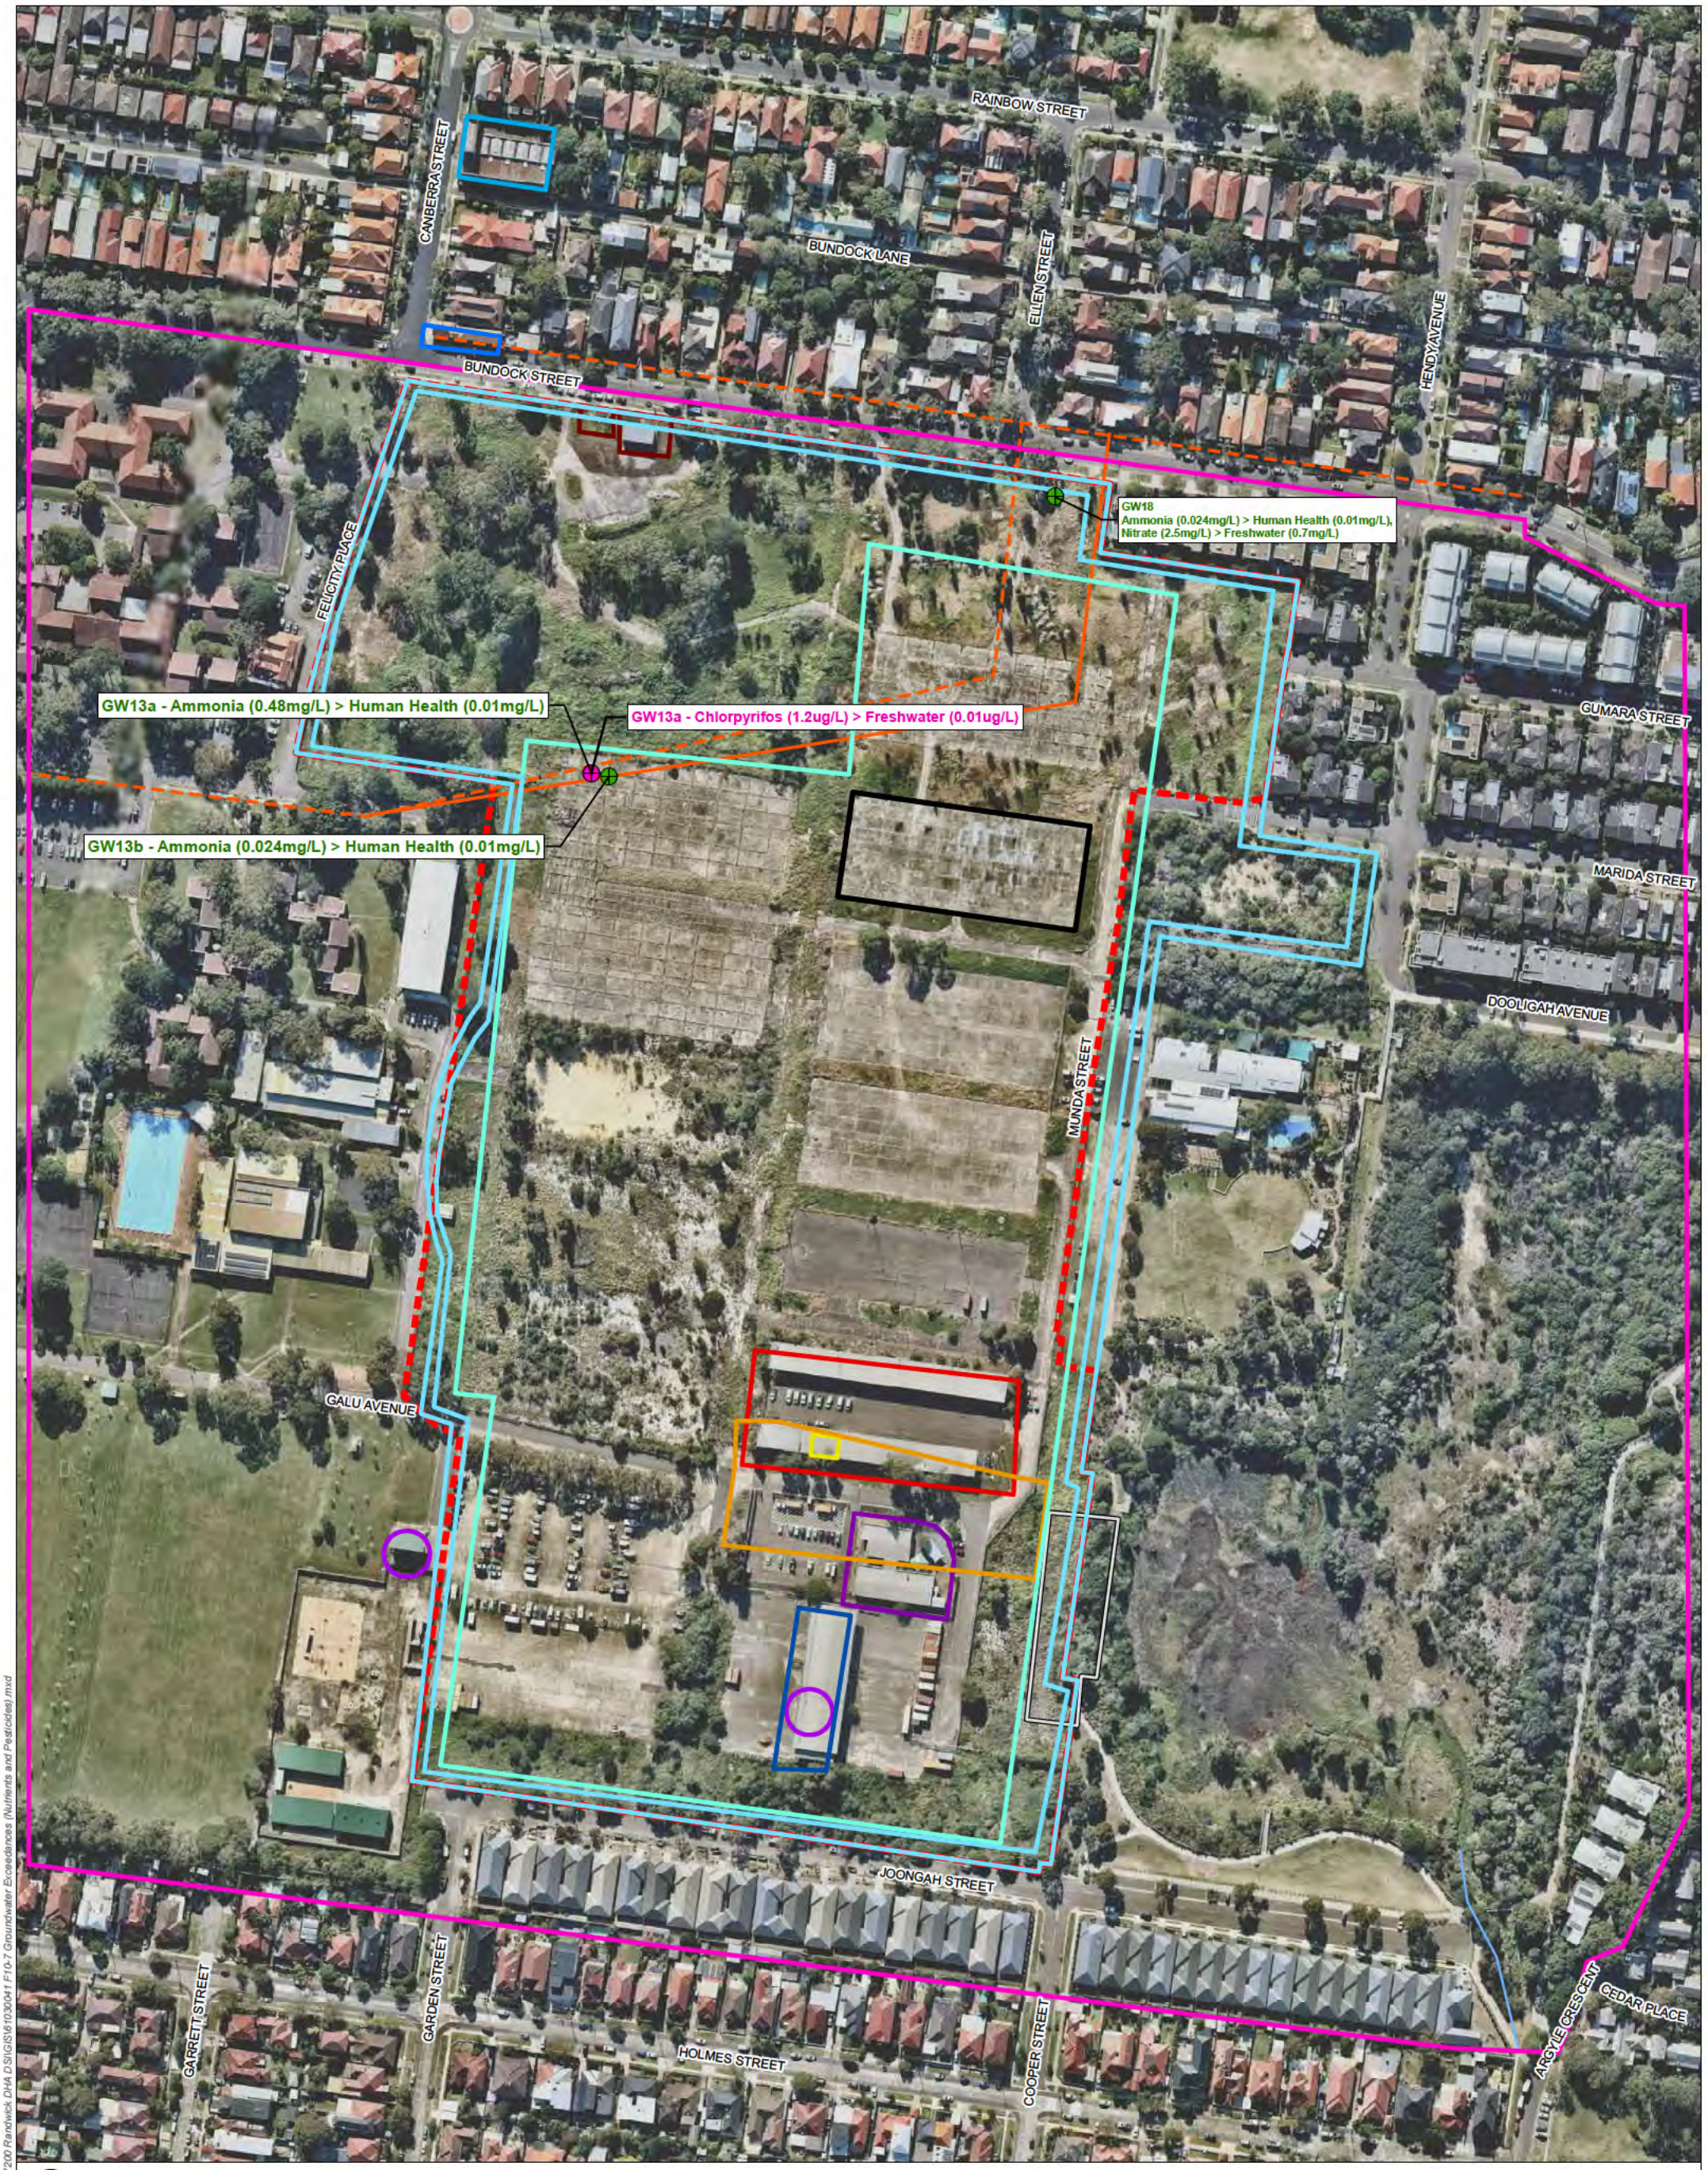
FIGURE 9-5

The concentrations of COPCs in groundwater were generally less than the adopted site assessment criteria for all CoPCs with the exception of exceedances for following CoPCs as shown on **Figures 9-5** to **9-8** in **Appendix A**:

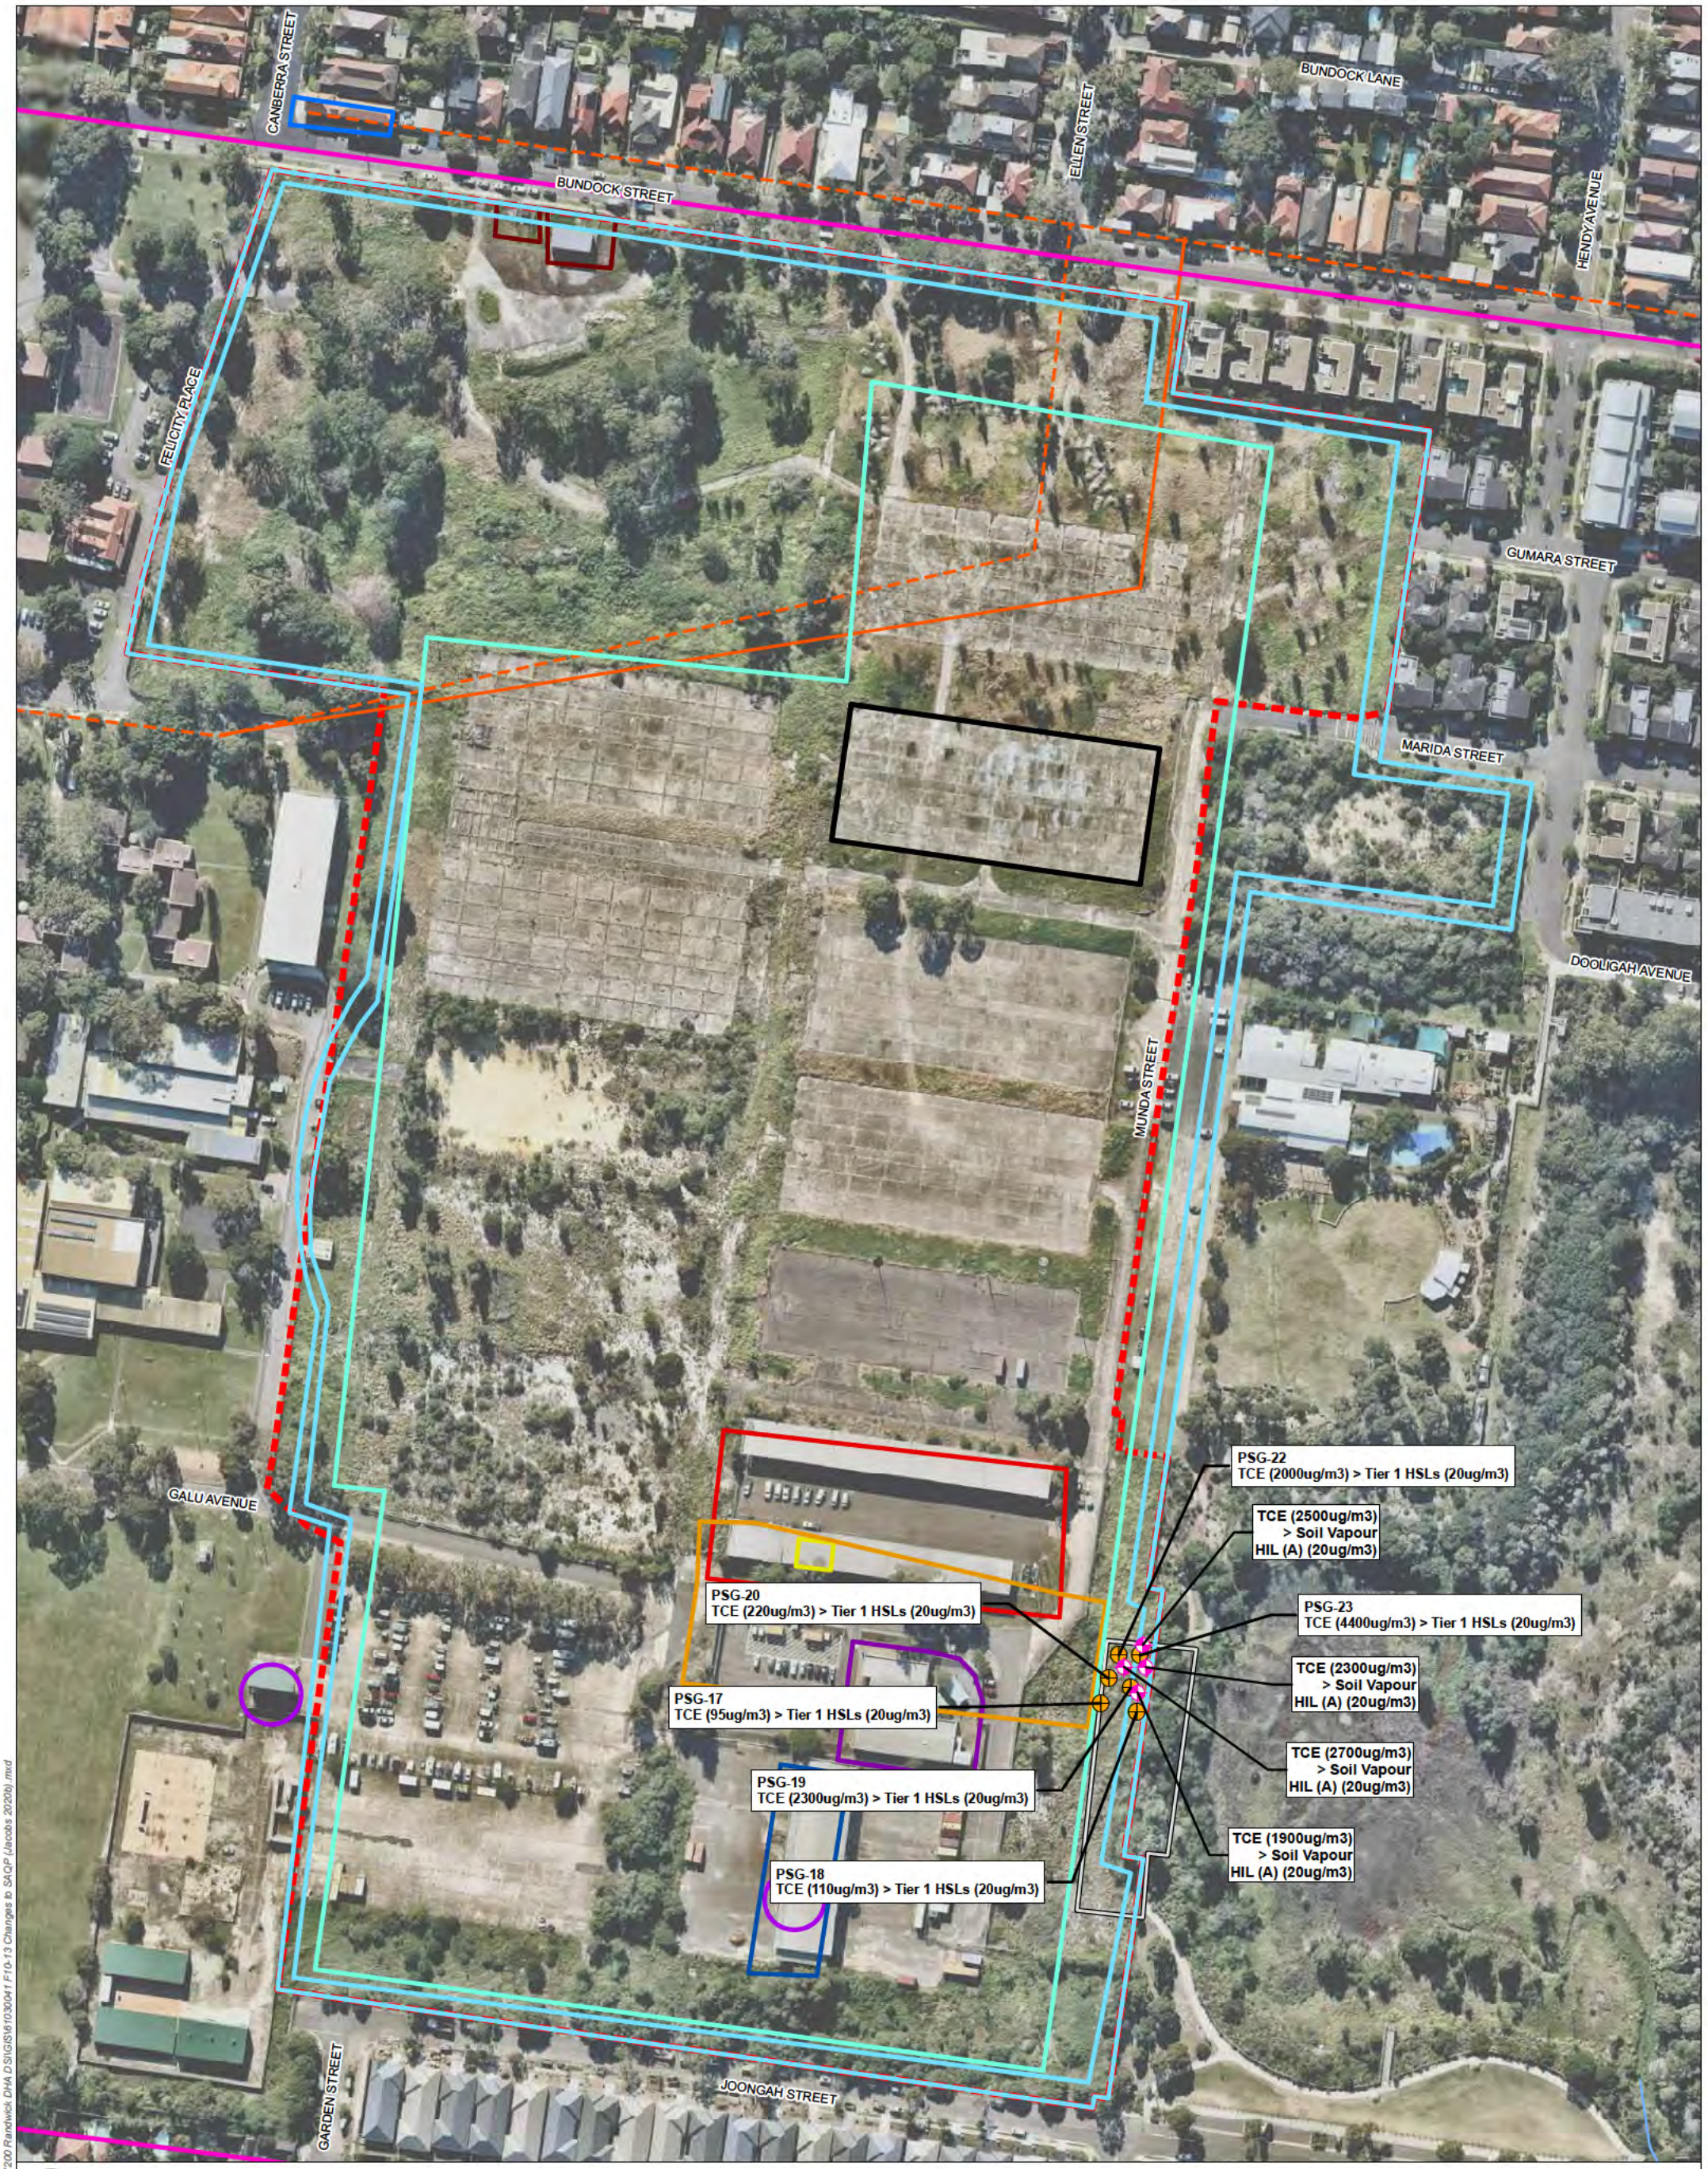
FIGURE 9-8

Groundwater Concentrations above LOR (Chlorinated Hydrocarbons and VOCs)
