ROYAL AUSTRALIAN NAVY

Fleet Command- Maritime Safety Bureau

MARITIME SAFETY INVESTIGATION – HMAS *MARYBOROUGH* - OHSIR 03/17

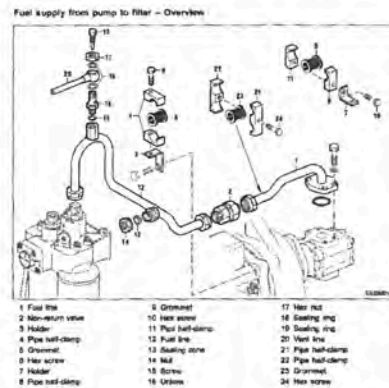
3. As mentioned previously in the entire material, the loss of control was the detachment of the bleed off screw from the assembly, as shown in Figure 1. Figure 2 presents a schematic of this assembly and its associated pipework. The nominal condition for this assembly can be seen at Figure 3, which was present in Engine 2 during the investigation.
4. With the detachment of the bleed screw, marine diesel was being discharged near the forward inward side of engine one of the bilge and deck plates, as well as a mist cloud forming between the two engines. A mist cloud sized to support a deflagration event was able to develop due to the engine being at approximately 1500 rpm (with only one turbo charger running) which leads to almost static air conditions within the main engine room.

Figure 2: Schematic of the pipework and bleed off assembly

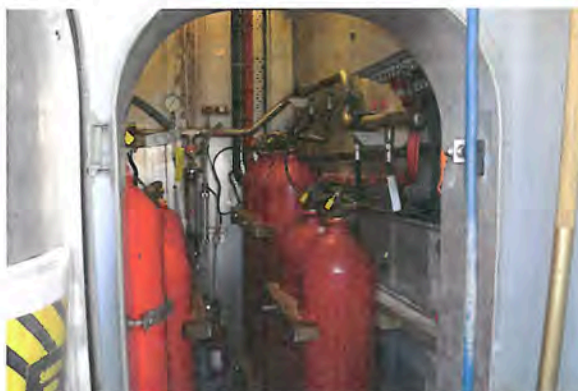
38. The second discharge occurred at approximately 23:49. As the space is too tight, s47F used an ELRSD instead of OCCABA to undertake this evolution, see Figure 17. After this the temperature reading started to decrease.

Figure 17: CO2 locker on HMAS Maryborough.

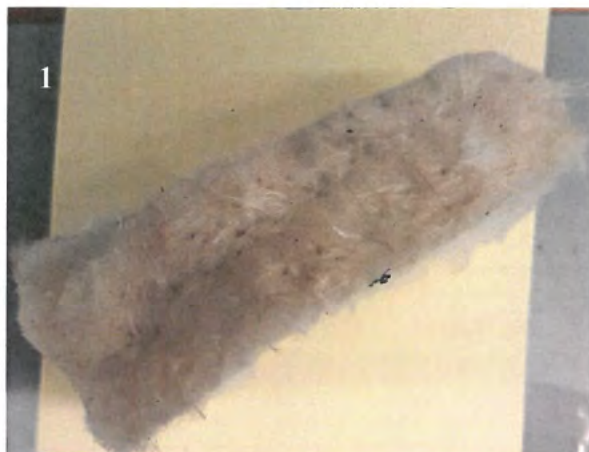
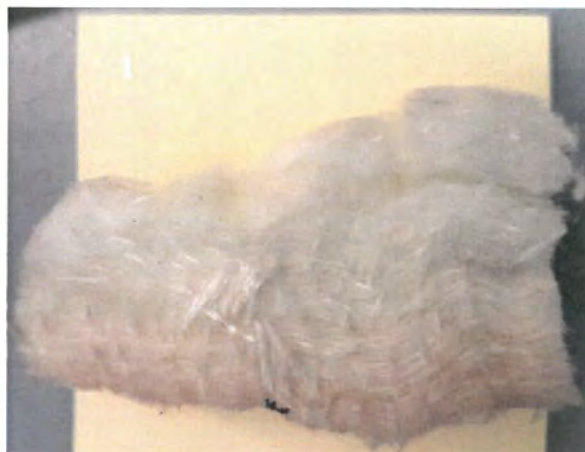
Sample 1, inner wool, back and front sides

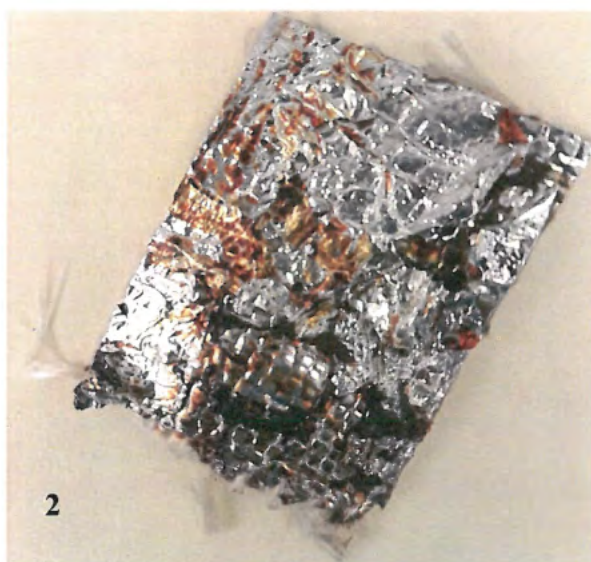
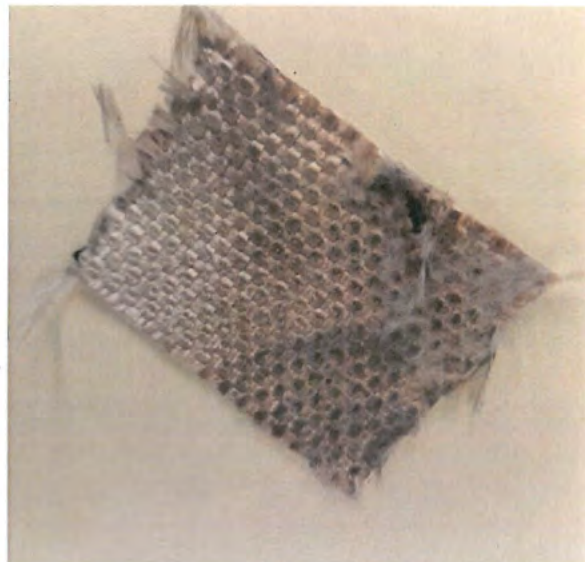
Sample 2 Image of front and back sides
