Australian Government Department of Defence

PFAS MANAGEMENT AREA PLAN REVISION 1

This is the Defence PFAS Management Area Plan (PMAP) Revision 1 for RAAF Base Williamtown.

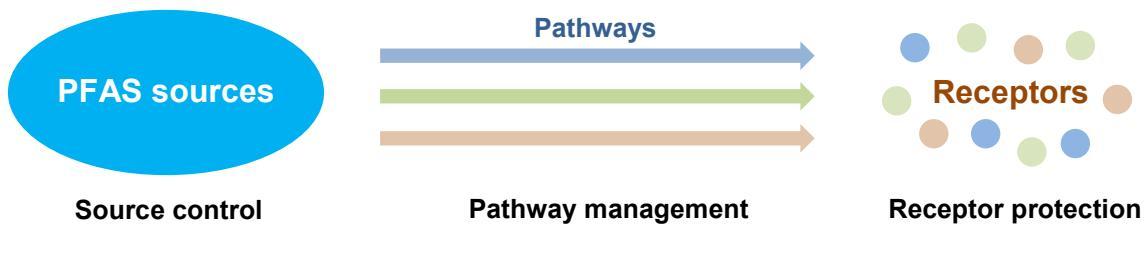
Figure 1 – Sources / Pathways / Receptors

This section provides a description of the PFAS sources on the base, the ways in which PFAS has moved in the environment (migration pathways), and the extent of PFAS in the environment outside the base. It also provides a summary of the potential human and ecological receptors that may be exposed to PFAS. This information is referred to as the Conceptual Site Model (CSM). A detailed CSM for Williamtown is provided in Appendix B.

This PMAP is based on the CSM, as it identifies:

- ongoing sources of PFAS and outlines the measures to control these sources
- PFAS migration pathways and outlines the measures to minimise PFAS leaving the base, and
- receptors (human or environmental) that might be exposed to PFAS, and what measures are in place to manage exposures.

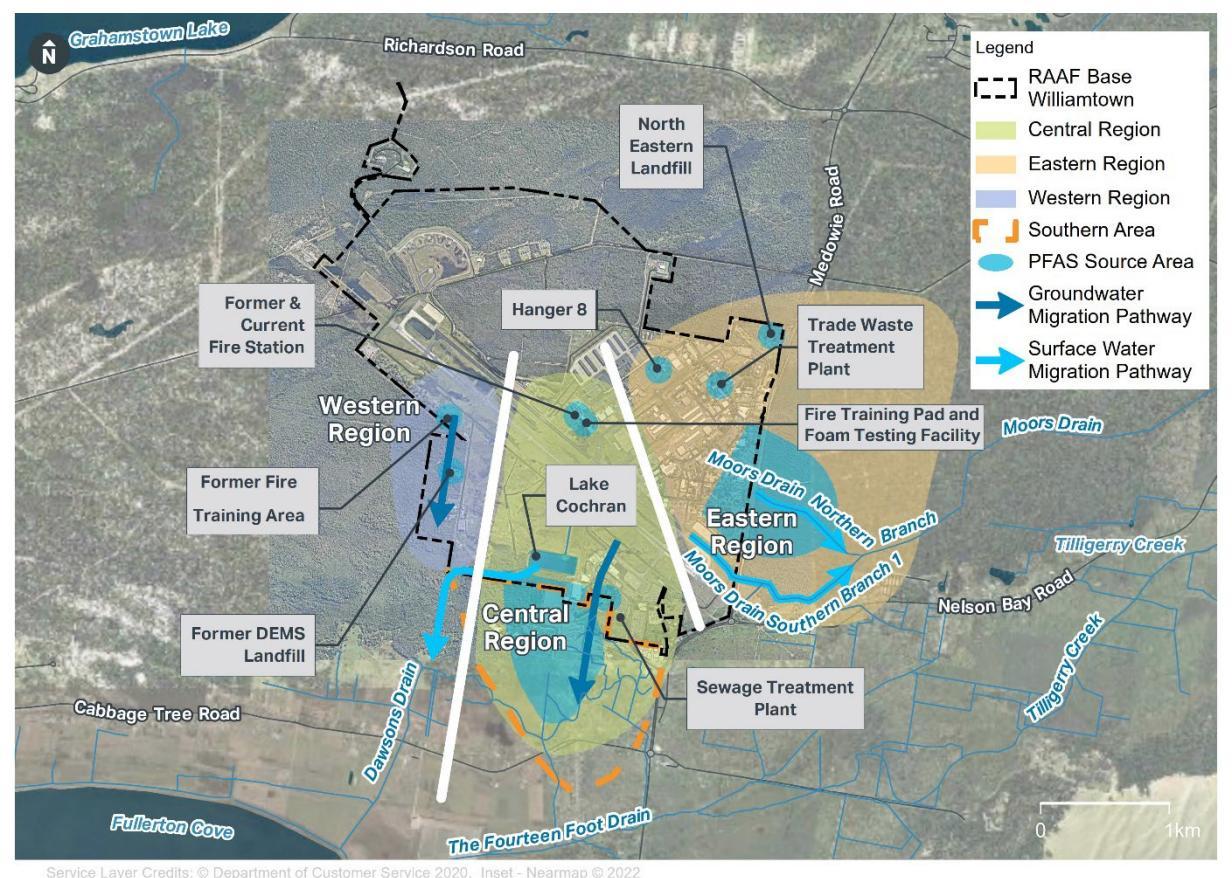
Figure 2 – Major PFAS Source Areas (Historical and Current)

A summary of the PFAS source areas, migration pathways and current status is provided in Table 1. A map showing these source areas is presented in Figure 2 below and Figure F2 in Appendix C.

In the 2019 PMAP, a total of 14 PFAS source areas were prioritised for risk management based on the amount of PFAS they contained. Since then, additional monitoring and investigation has improved the understanding of these source areas to inform the management requirements.

PFAS can be transported from a source to human or environmental receptors by surface water and groundwater. These are referred to as "migration pathways". The groundwater and surface water flow directions within the Management Area are shown on Figure F3 in Appendix C. The Strategy Review categorised the PFAS migration pathways based on the natural catchments across the base and Management Area:

- Western Region characterised by the Former Fire Training Area (FFTA) source that is now remediated, and a PFAS groundwater plume extending south away from the source. A substantial proportion of the western plume is still on base, and this presents management opportunities that are detailed in Section 4.
- Central Region characterised by ongoing sources at the Former Fire Training Pad / Current Fire Station (Facility 165) and the Sewage Treatment Plant (Facility 410); with PFAS groundwater plumes extending south across the base boundary. The concentrations of PFAS south of the site and north of Cabbage Tree Rd were likely sourced from Lake Cochran, which was impacted when AFFF foams were still in use at the base. However, Lake Cochran is no longer considered a significant ongoing PFAS source to groundwater. PFAS in the central southern plume discharges into Leary's and Dawsons Drain.

• Eastern Region - characterised by likely sources at the Trade Waste Treatment Plant (Facility 480) and a Former Fuelling Area, with PFAS groundwater plumes extending east across the base boundary, and PFAS impacted surface water discharges to Moors Drain.

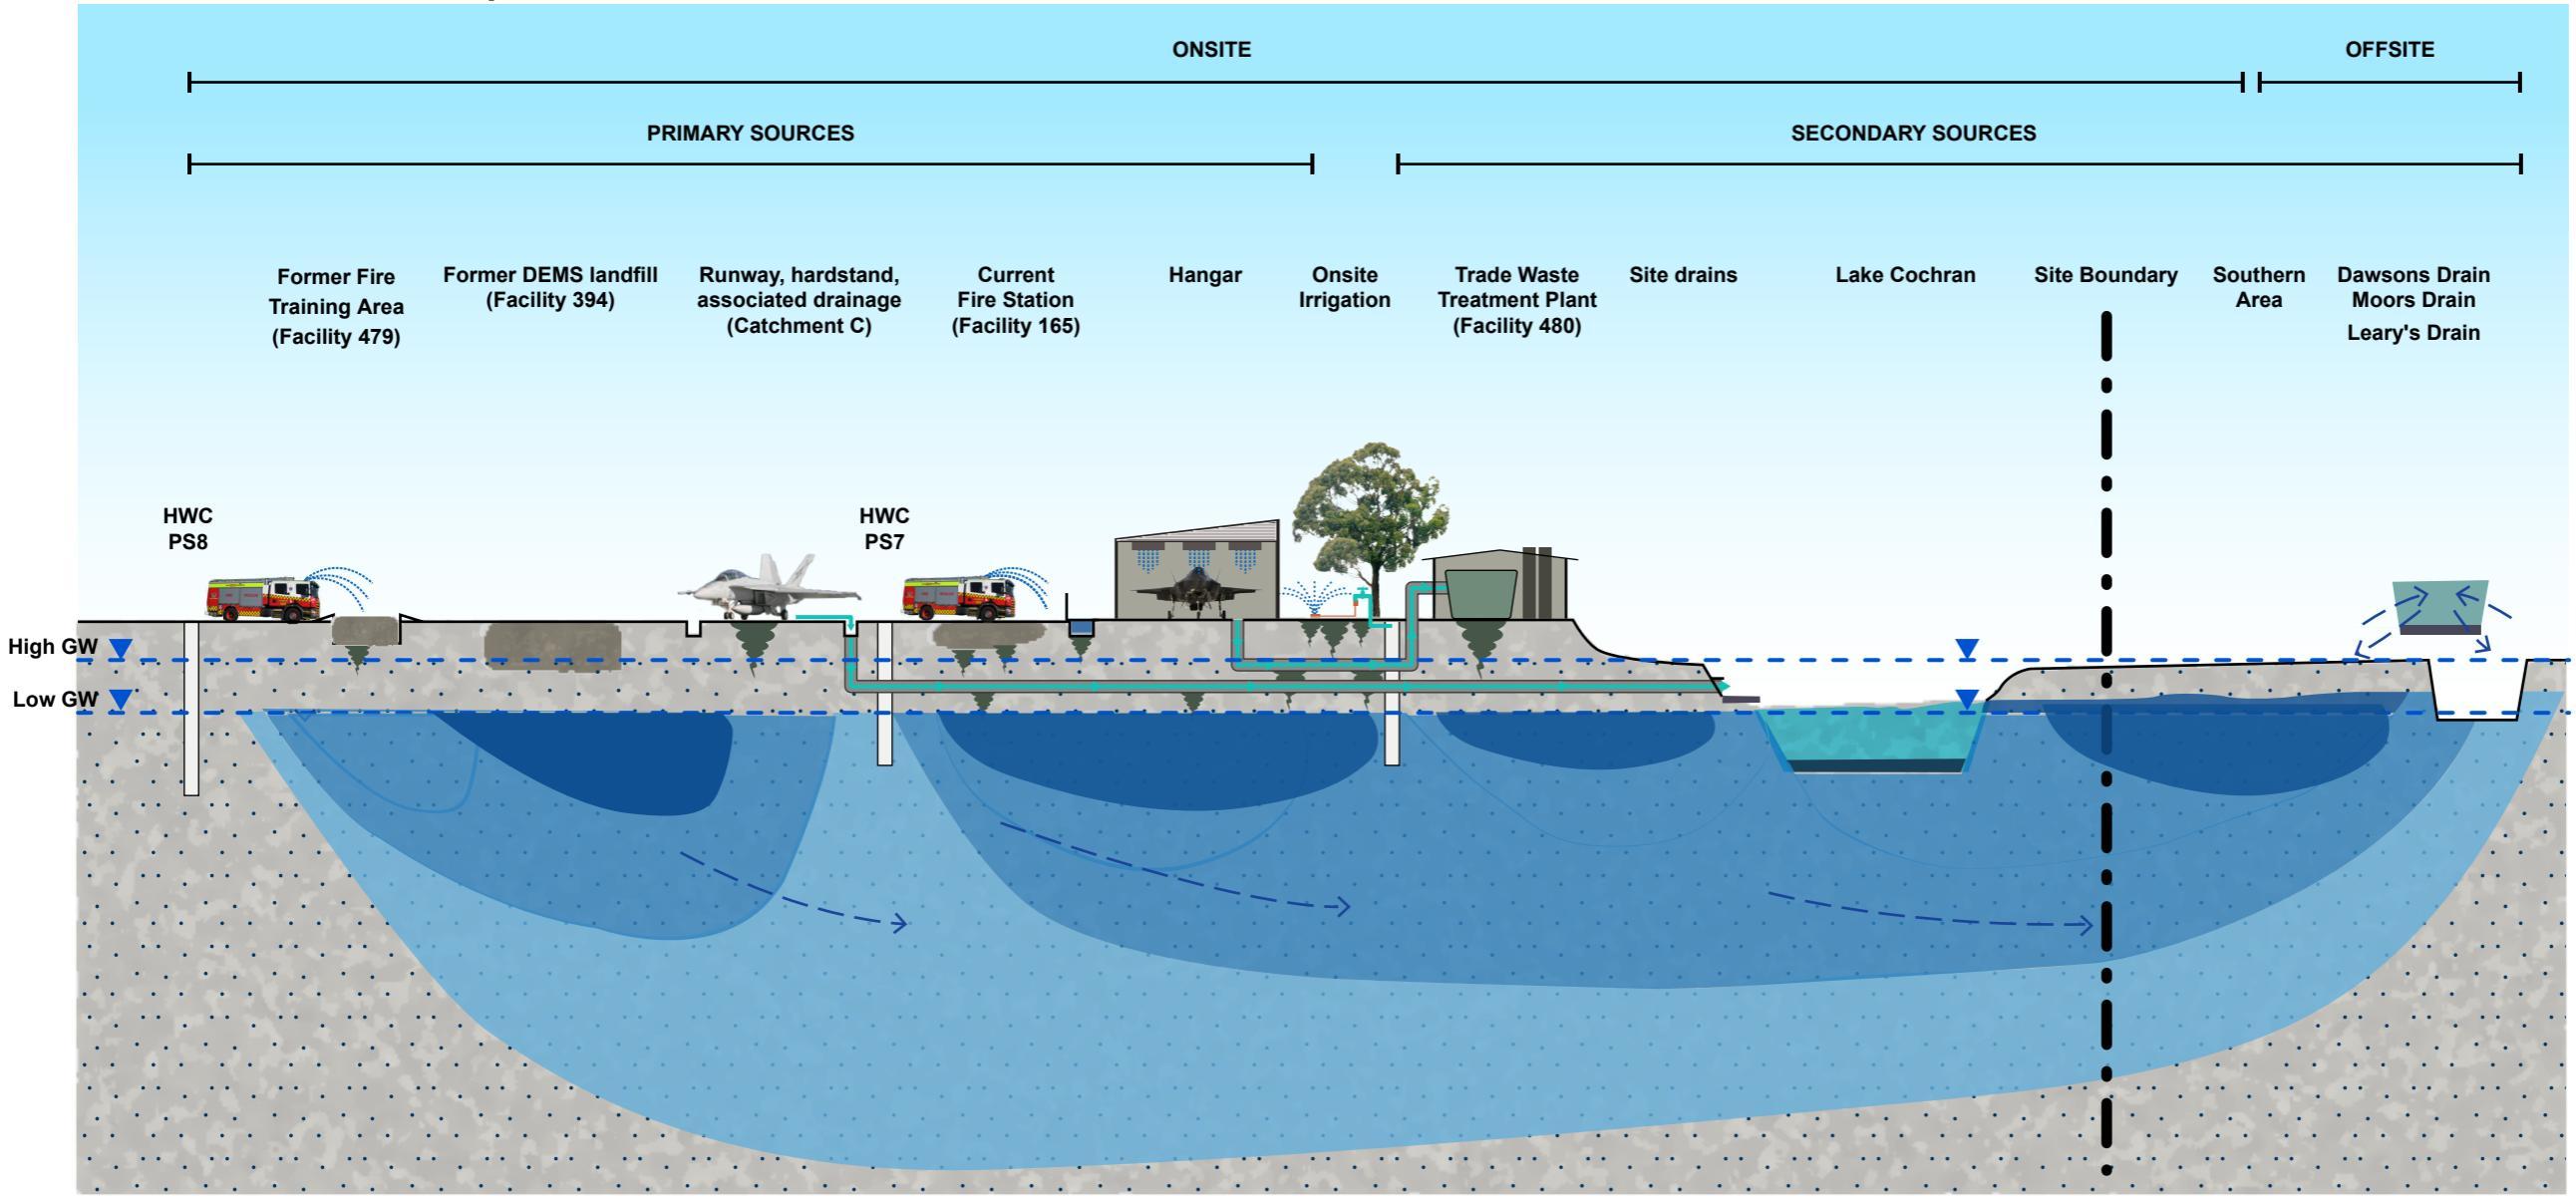
APPENDIX B Conceptual Site Model

This Appendix provides visualisations of the source – pathway – receptor relationships in the form of a Conceptual Site Model.

Source

Source						
Former AFFF Training (Soil excavated, groundwater treatment ongoing)	Not a significant source	Former AFFF EmergencyResponse	Legacy Soil Impact from past training	Former Foam Dis- charge in Hangars	Spillage/overflow	No longer a significant ongoing source
Migration Pathway						
Soil Impact Leaching to groundwater Groundwater migration Impact to vegetation	Groundwater impacted	PFAS Runoff to site surface water drains Sorbtion/leaching from pavements	PFAS Runoff to surface water drains Surface water leaching and runoff NB. Current system no discharge: water captured and treated. Groundwater ingress to drainage network when High groundwater levels	Foam / water runoff to trade waste drainage to Trade Waste Treatment Plant (Facility 480)	Treated water still containing PFAS discharged to Sewerage Treatment Plan (Facility 410) Leaching to groundwater Surface water losses from drainage and trade waste network Groundwater ingress to drainage network	Drain leakage to groundwater when water table is low (losi drains) Inflow of contaminated groundwater into drains when water table is high (gaining drains) Flow of impacted surface water and losses from drainage network Groundwater migration and ingress to drainage network

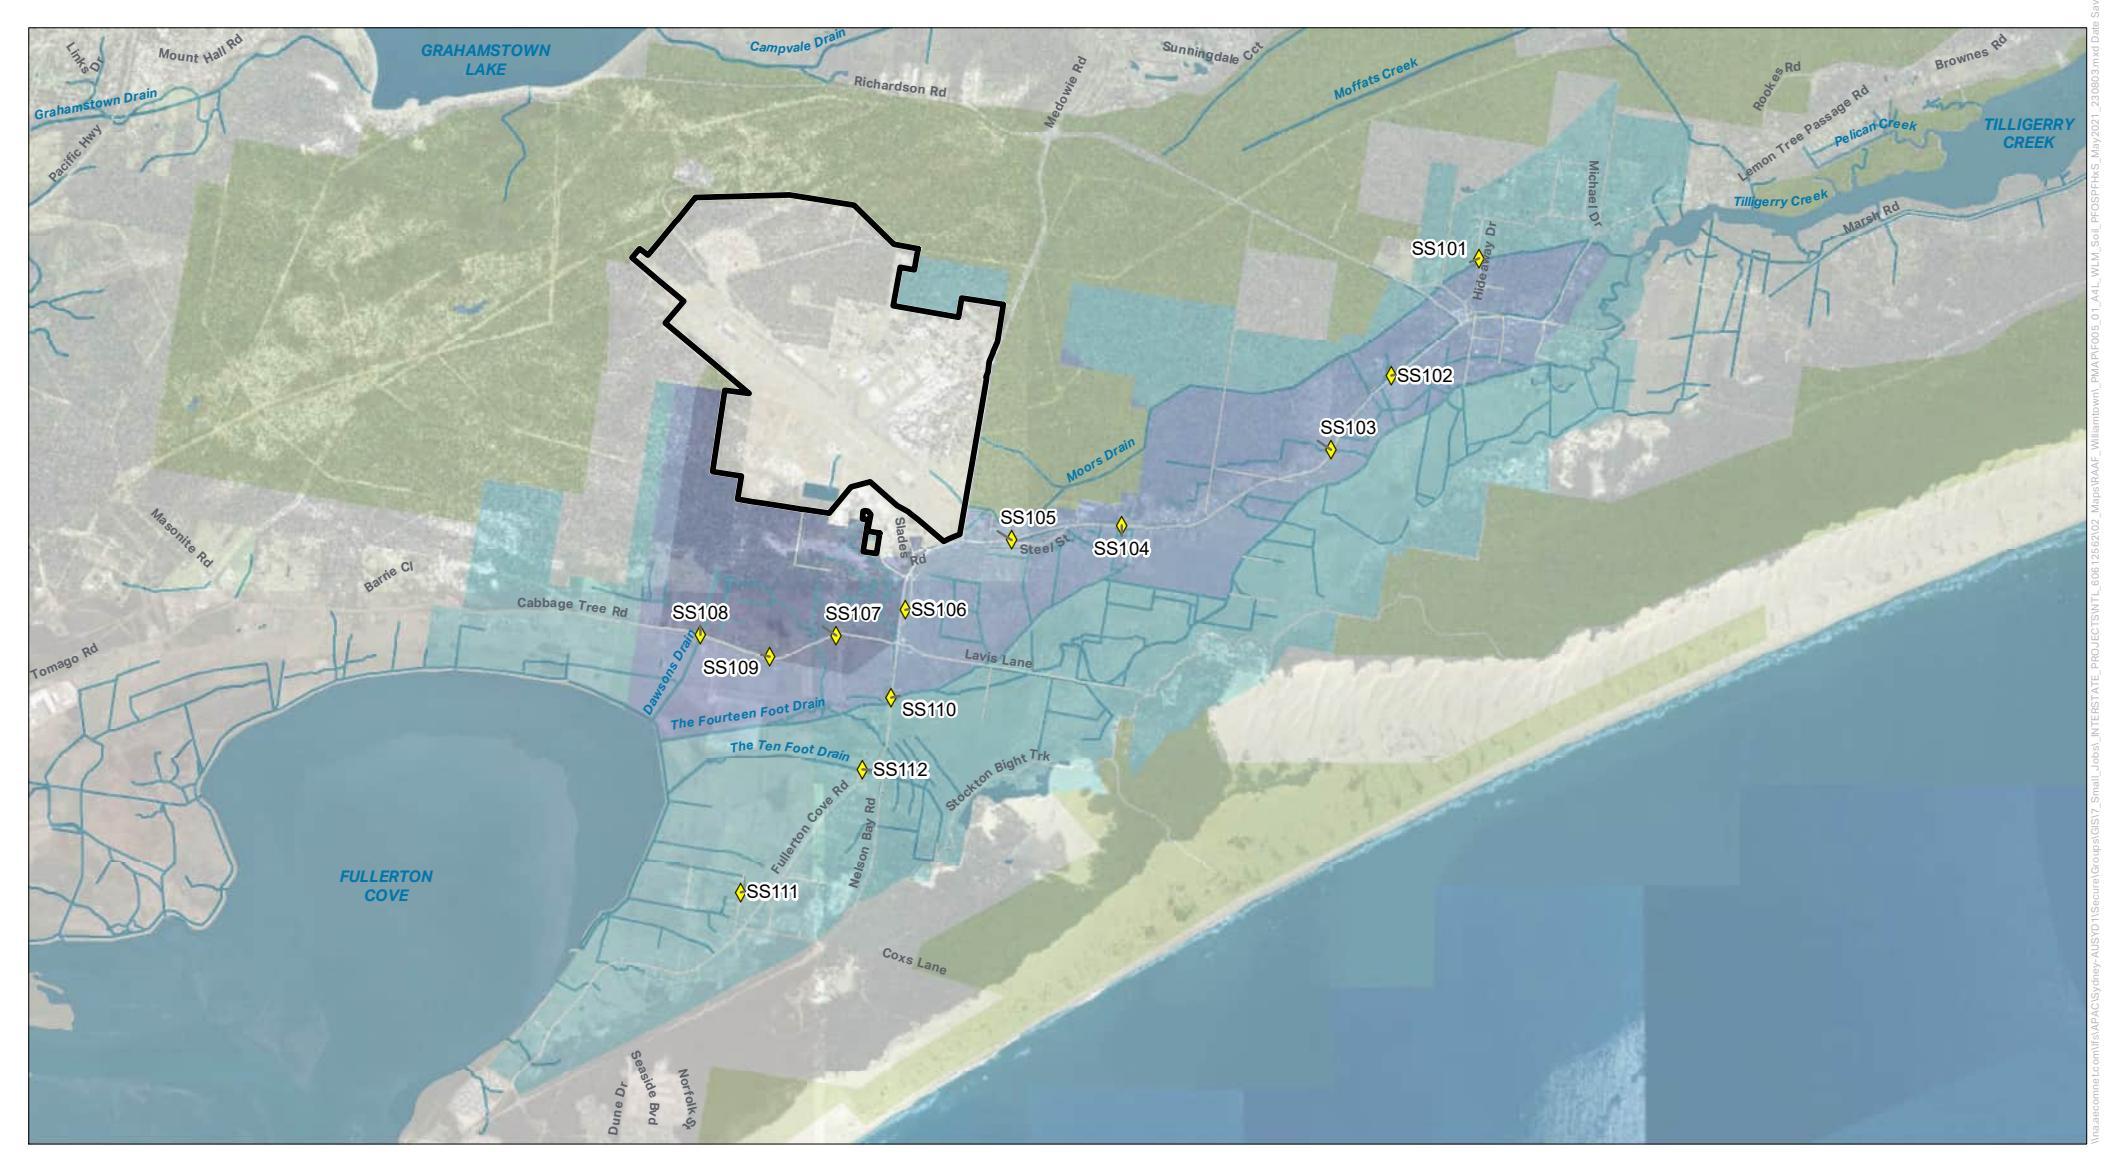
FIGURE F5: SOIL ANALYTICAL RESULTS - PFOS+PFHXS - MAY 2021 Legend PFOS + PFHxS (mg/kg)

- RAAF Base Williamtown
- ♦ > 10
- Primary Management Zone
 - ♦ > 1 10
- Secondary Management Zone 🔶 > 0.3 1 ♦ > Limit of Reporting - 0.3
- Broader Mangement Zone
- < Limit of Reporting</p>
- Soil Location (Not Sampled)

Figures showing the distribution of PFAS in groundwater (Figure F4), soil (Figure F5), surface water (Figure F6) and sediment (Figure F7) are provided in Appendix C. Additionally, the inferred extent of PFOS + PFHxS impacts in groundwater are shown on Figure F8 in Appendix C.

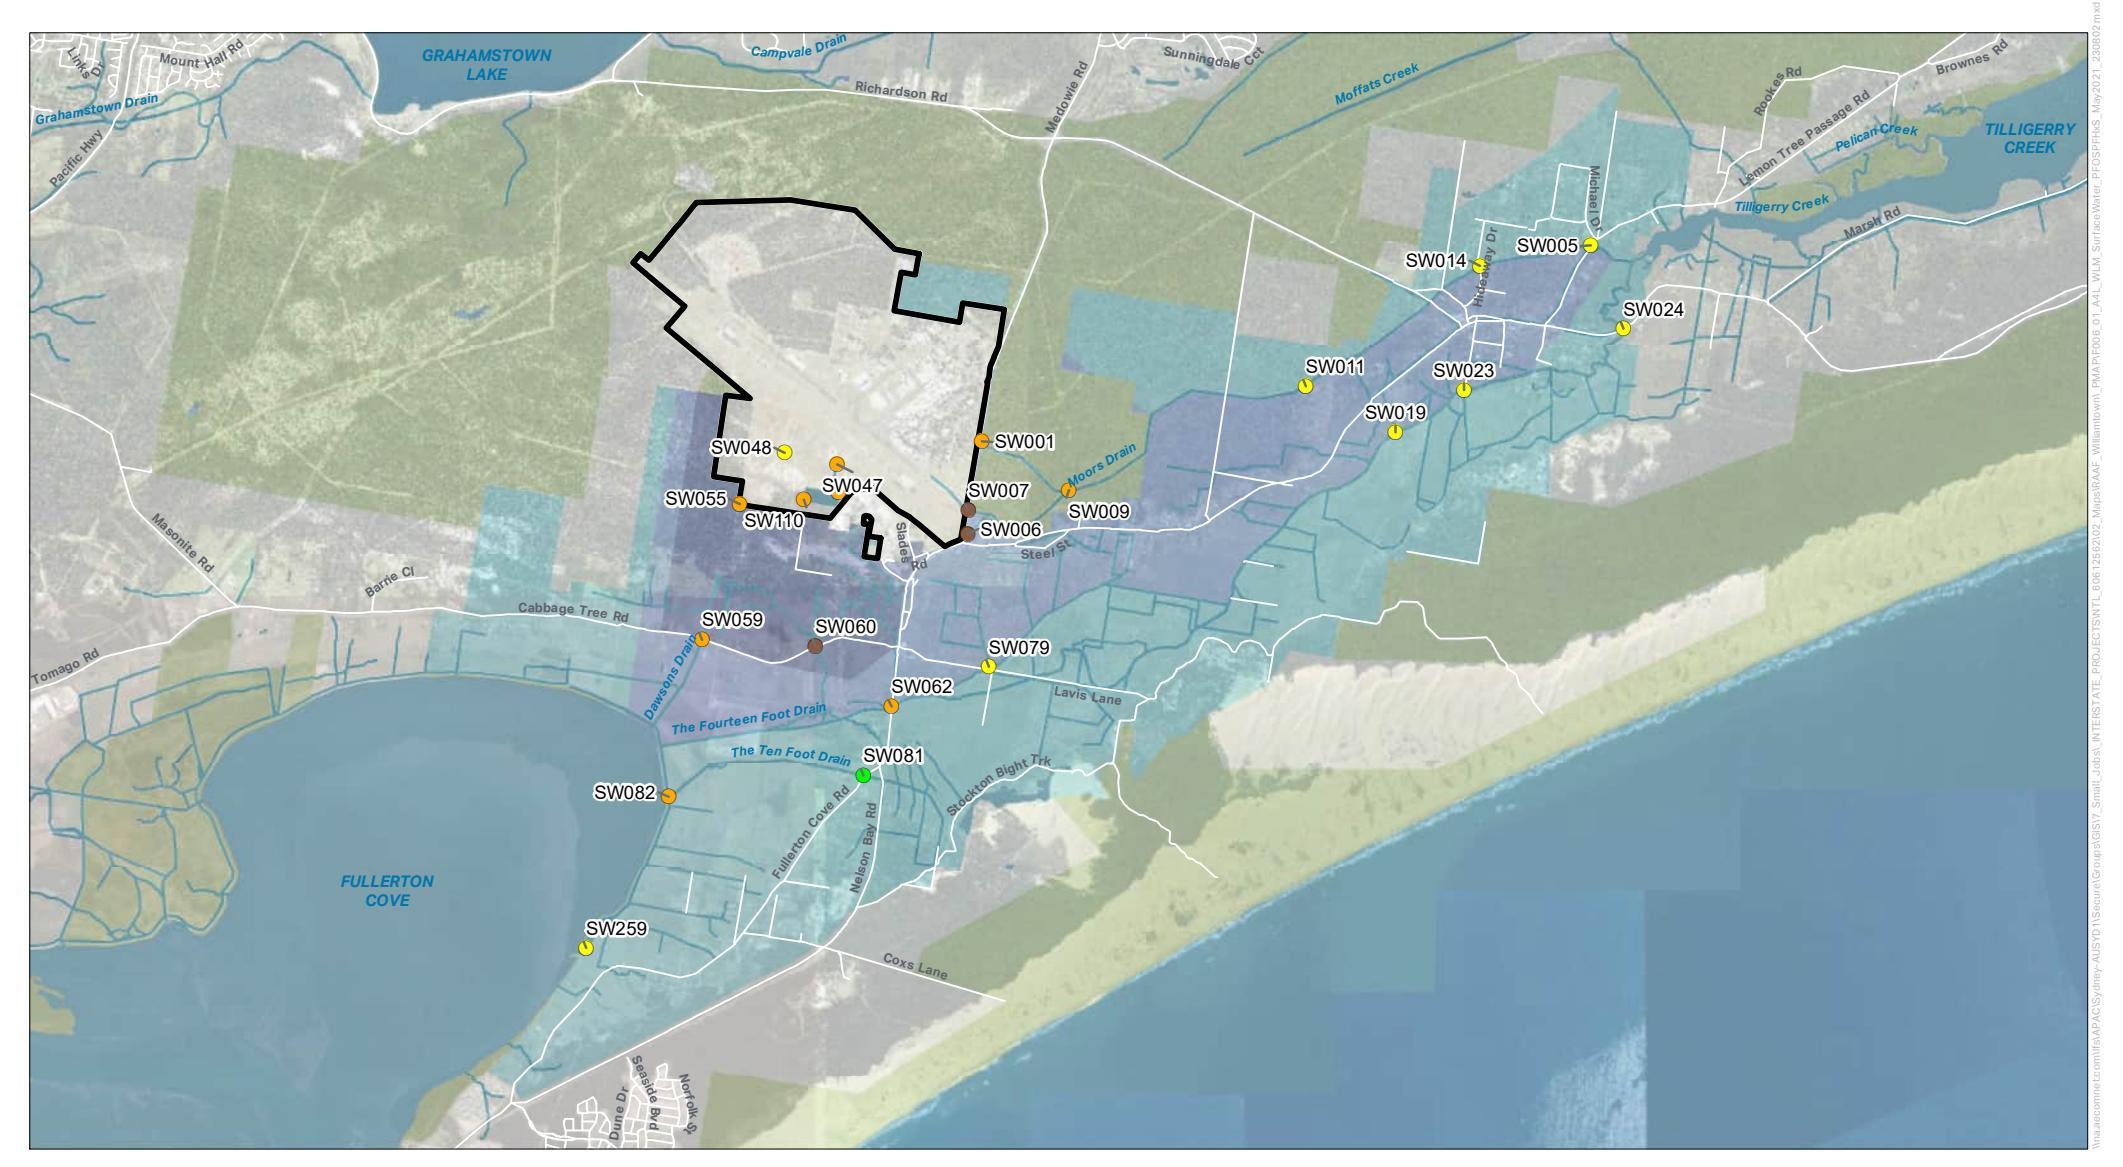
FIGURE F6: SURFACE WATER ANALYTICAL RESULTS - PFOS+PFHXS - MAY 2021

• > 10 - 50

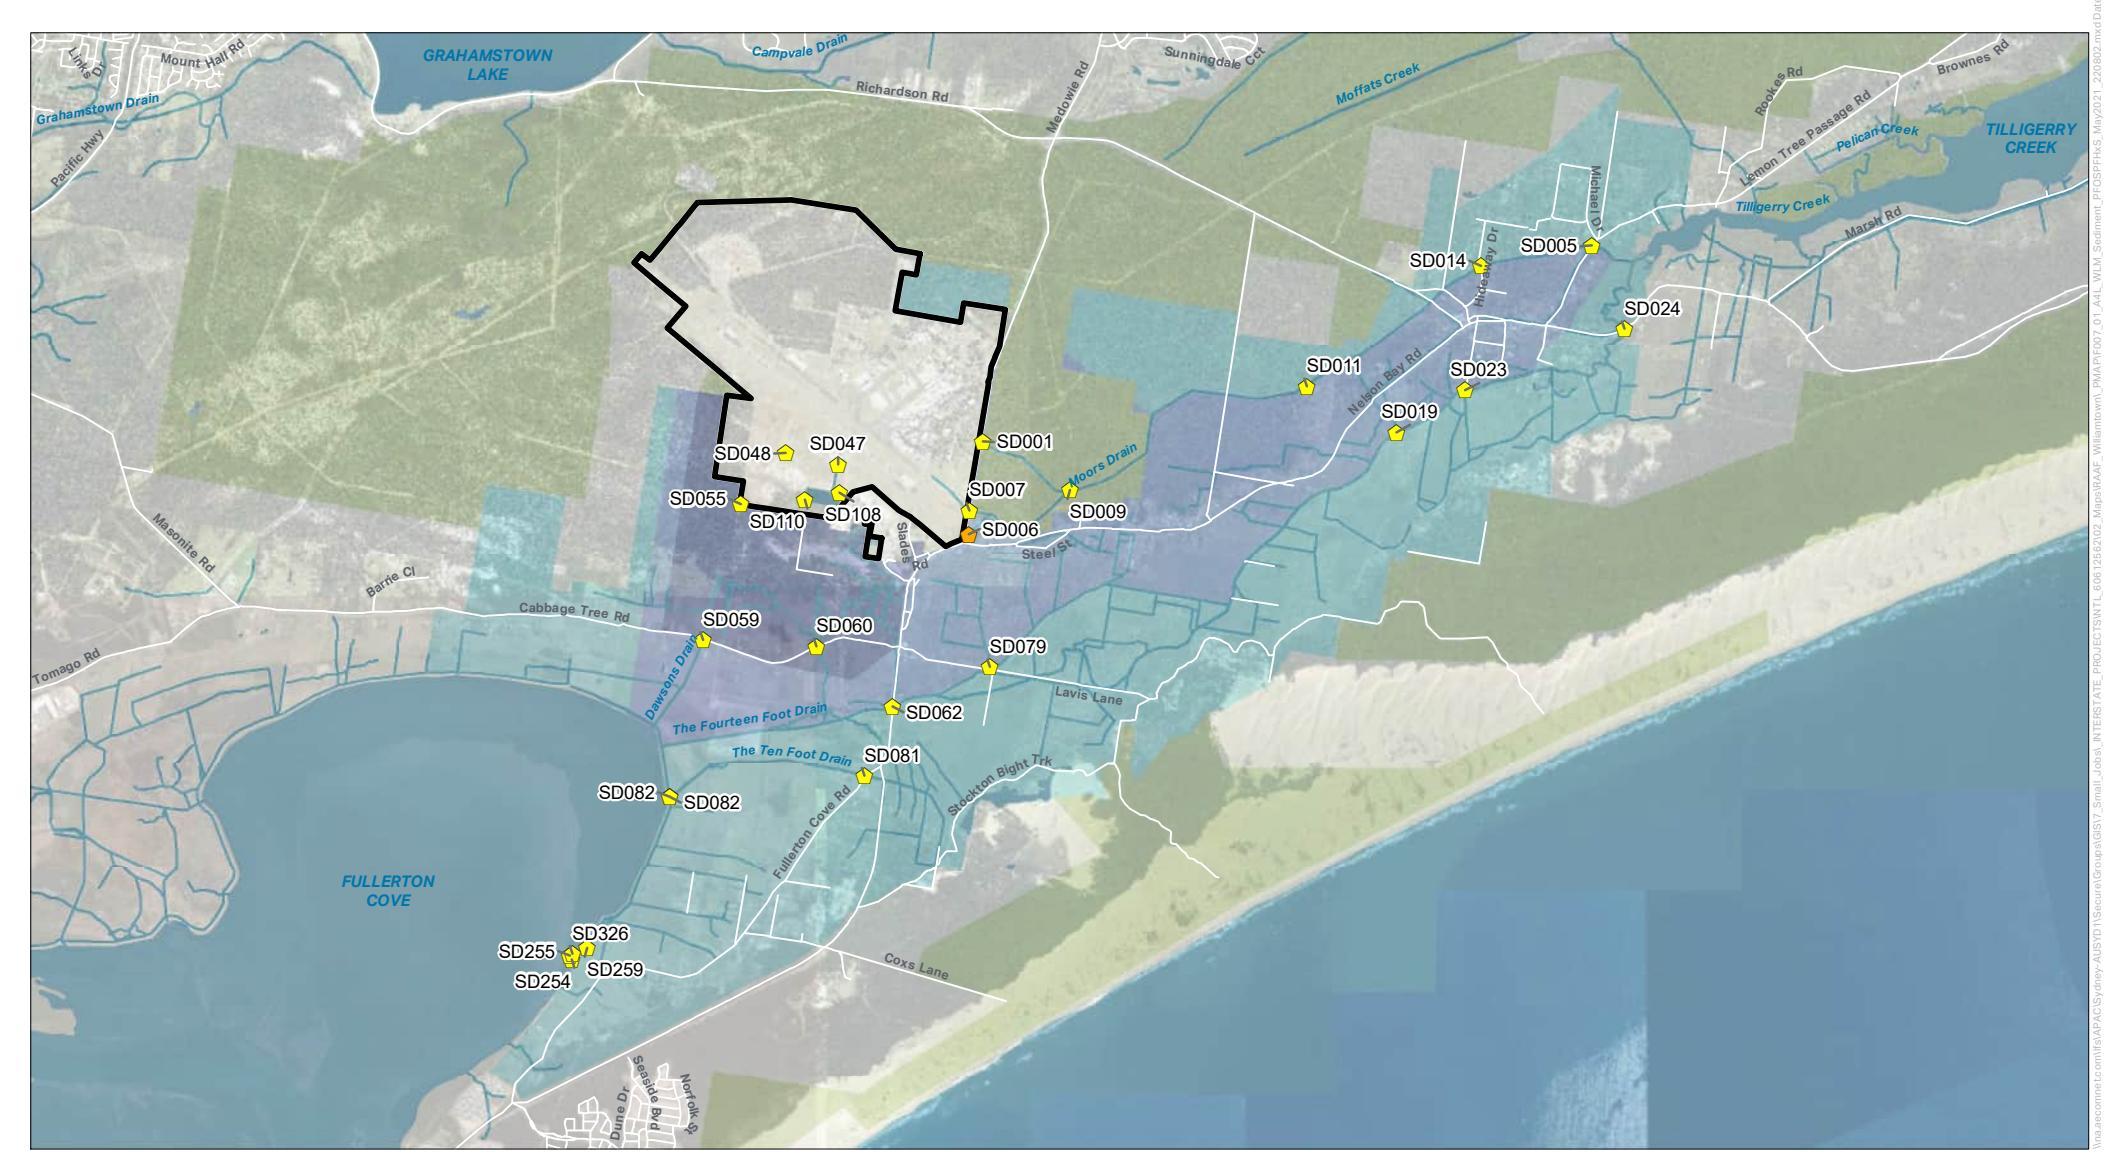
FIGURE F7: SEDIMENT WATER ANALYTICAL RESULTS – PFOS+PFHXS – MAY 2021 Legend PEOS + PEHXS (mg/kg)

• > 1 - 10
