### **Heavy Roller Options Study - Review of RAAF Amberley Roller Modifications**

### **RAAF Amberley Roller Modifications**

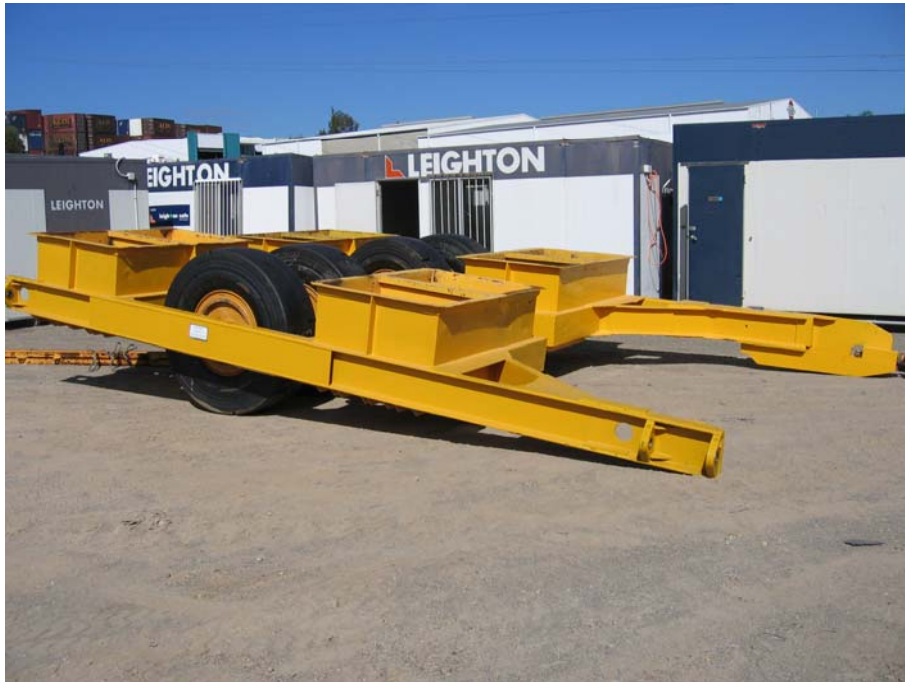
**Photograph 1. Overview of Roller.**

The heavy roller hired to Leighton Contractors for the MRTT project was inspected by SKM staff on 12 April 2006. The roller was located at Leighton's plant depot at Darra (Brisbane). A photographic record from the inspection is included in **Annex A**. A general view of the roller is shown in **Photograph 1**.

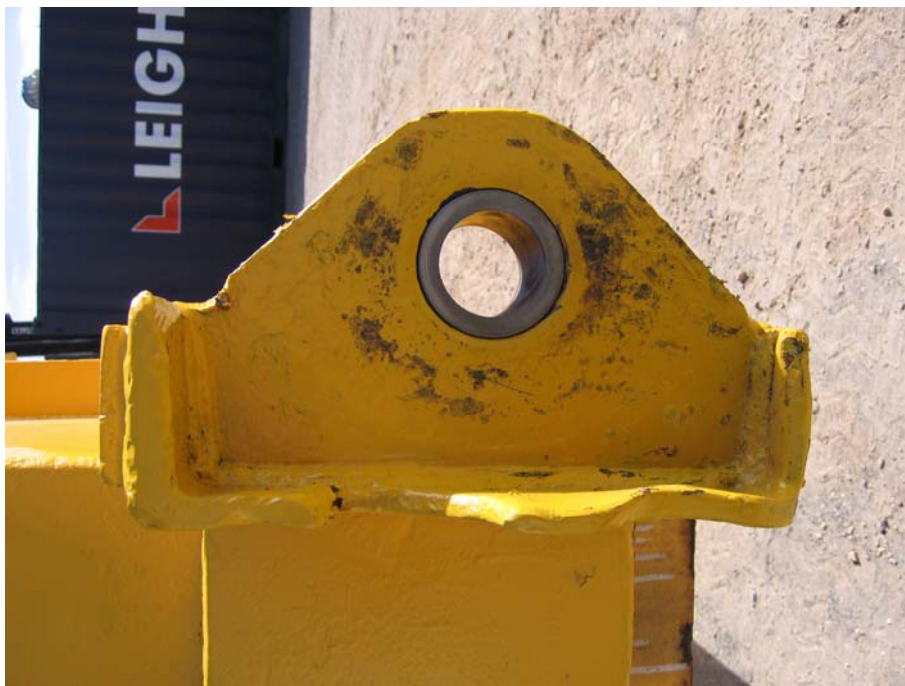
**Photo 2. Replaced hardened steel bushes.**

- The six bushes for joining the two roller halves were replaced with hardened steel (**Photograph 2**).
- A new axle was fitted as the existing axle was buckled (**Photograph 3**).
- The existing hubs were cut out of the existing wheels and fitted to new wheels (**Photograph 4**).
- New wheels (rims) were manufactured and fitted to accommodate the change in tyre size (**Photograph 5**).

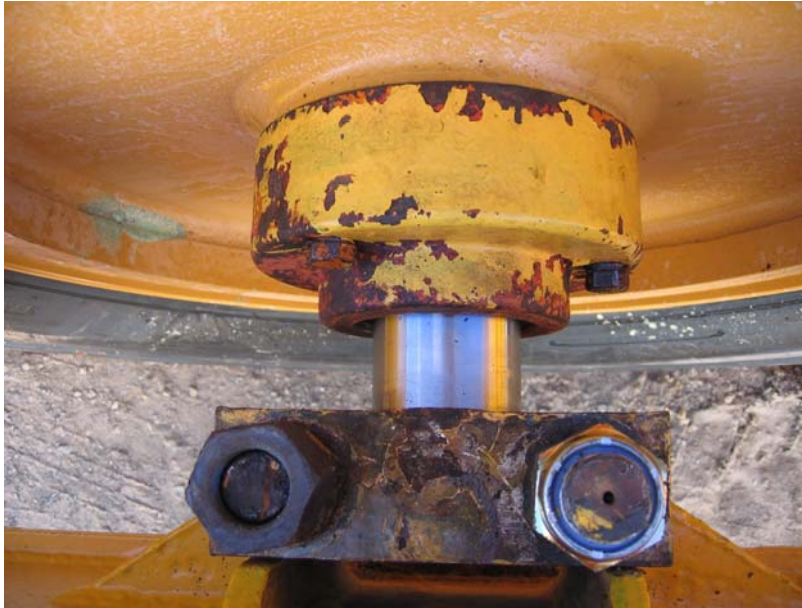
**Photograph 3. Replaced axle.**

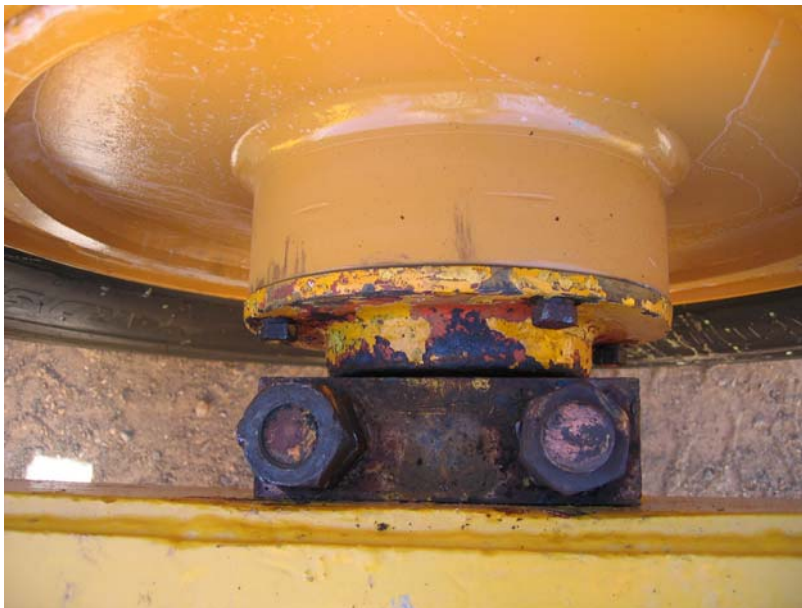
**Photograph 4. Existing wheel hubs.**

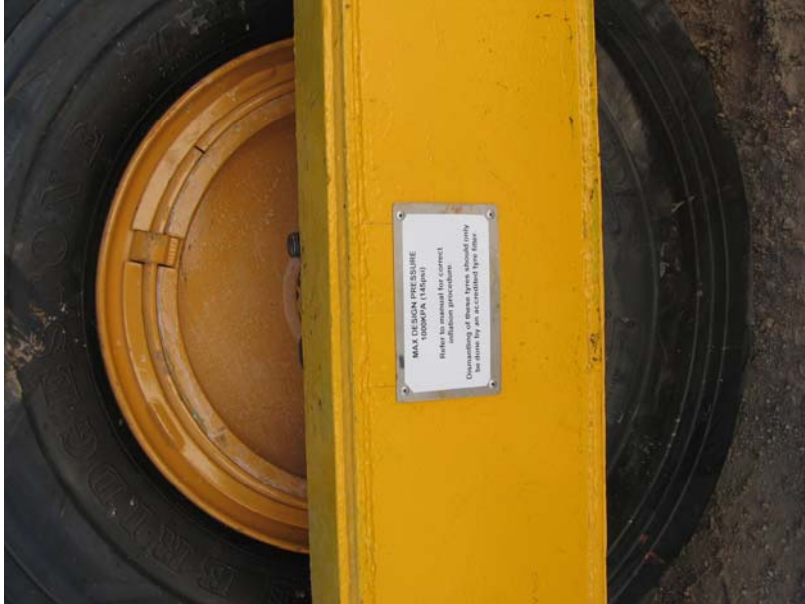
**Photograph 5. New Wheel Rims.**

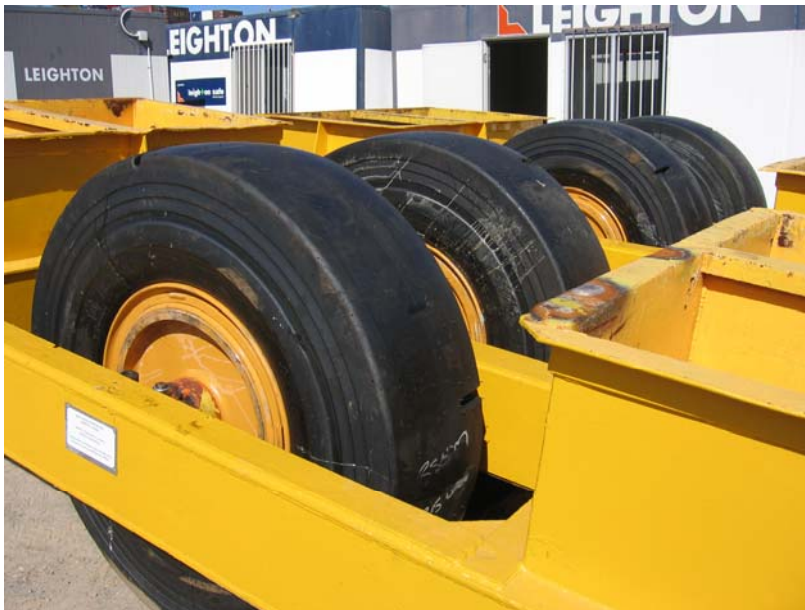
**Photograph 6. New Bridgestone 16.00-25 32 Ply YS2 tyres.**

- New tyres (Bridgestone Industrial Service 16.00-25 32 Ply YS2) were purchased and fitted (**Photograph 6**).
- New bearing were installed to all hubs.
- Two of the wheels were swapped so that the larger hubs were on the outside as this would provide greater resistance to cornering stresses by having the larger hubs located on the outside of the roller.
- The rear flanges were straightened (**Photograph 7**).
- The draw-bar pin was replaced with hardened steel (**Photograph 8**).
- Minor rust was treated with rust inhibiting paint.
- Some steel plates were replaced where the existed plates presented a cut hazard (**Photograph 9**).
- The roller was painted.
- Four new tyre inflation instruction plates were fitted (**Photograph 10**).

The tyres purchased by Leighton's were supplied by Bridgestone and are forklift tyres. Discussion with a tyre consultant suggested that other earthmoving tyres would also be suitable but were unavailable at the time of purchase. The tyres currently fitted have the following capabilities according to Bridgestone's technical data sheets:

- Inflation pressure. 1000 kPa.
- Load per wheel (at 10 km/h). 16,875 kg.

The tyres fitted to the roller by Leightons are significantly squarer in profile than the original roller tyres. This may lead to increased shear stresses induced by the walls of the tyres and this has the potential to lead to shearing of pavement layers not experienced with the original roller configuration. Only through site trials will this issue be quantified.

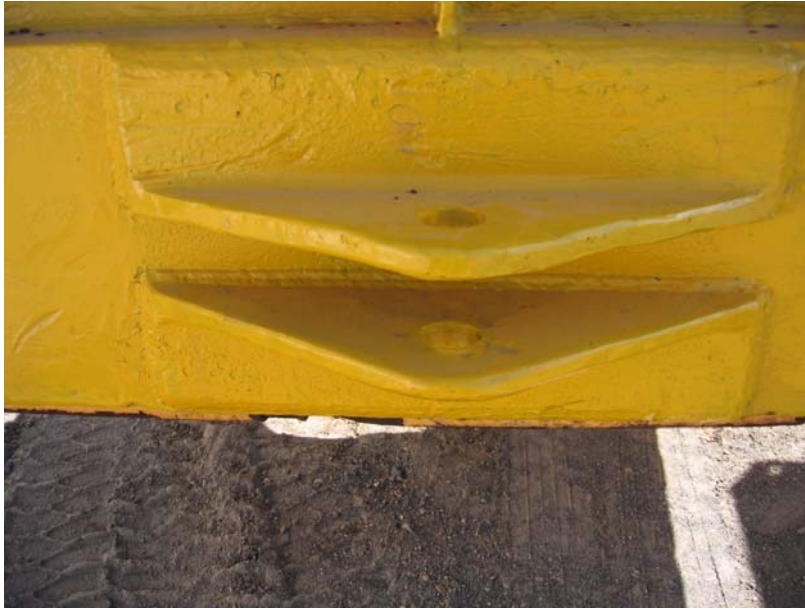
**Photograph 7. New rear flanges.**

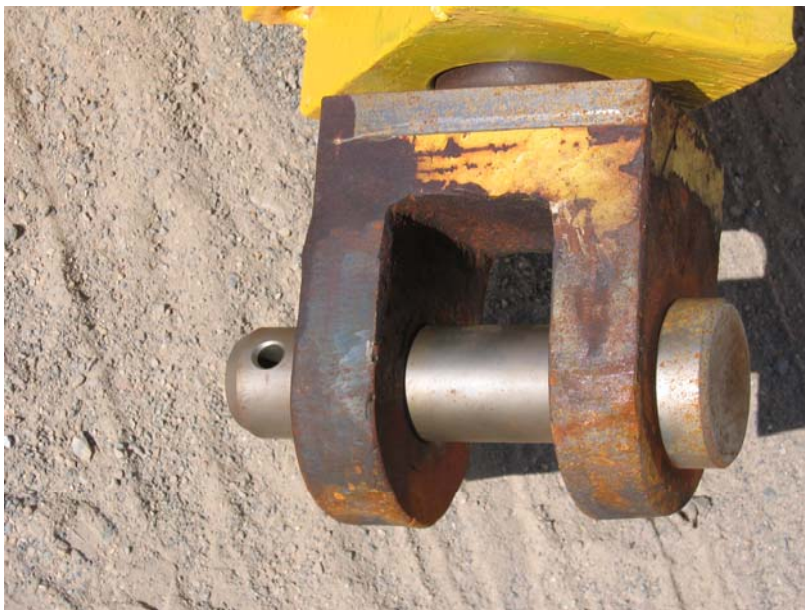
**Photograph 8. Replaced hardened steel draw-bar pin.**

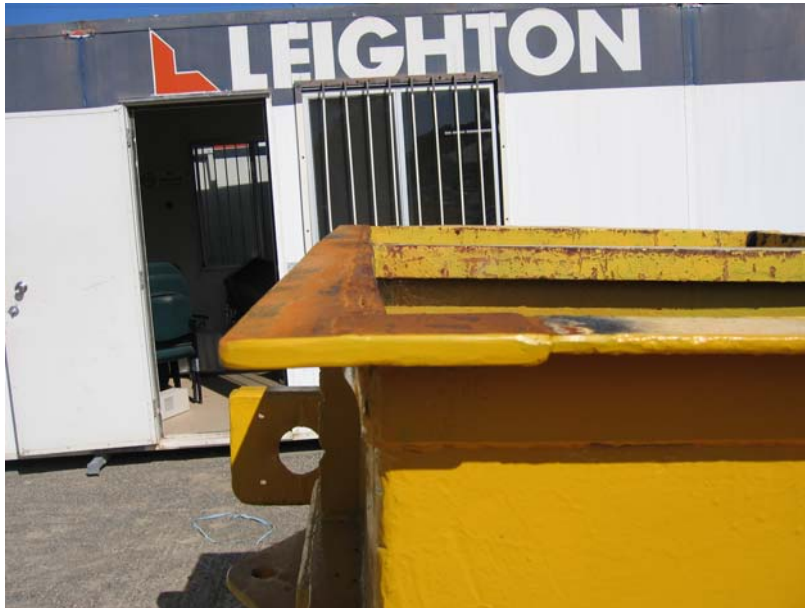
**Photograph 9. Replaced steel plates.**

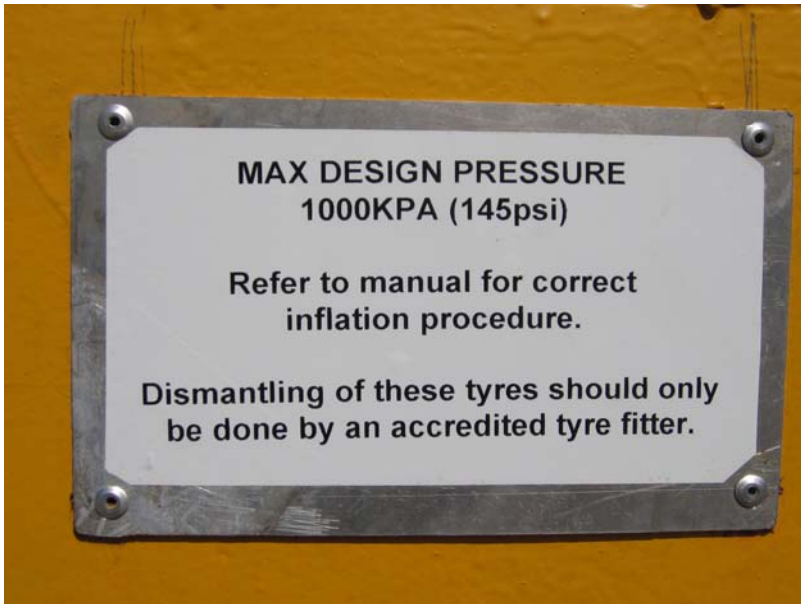
**Photograph 10. New tyre inflation instruction plate.**
